OPEN-FILE REPORT 00-16

# **Naturally Degraded Surface Waters Associated with Hydrothermally Altered Terrane in Colorado**

By John T. Neubert

Colorado Geological Survey  
Department of Natural Resources  
Denver, Colorado  
2000

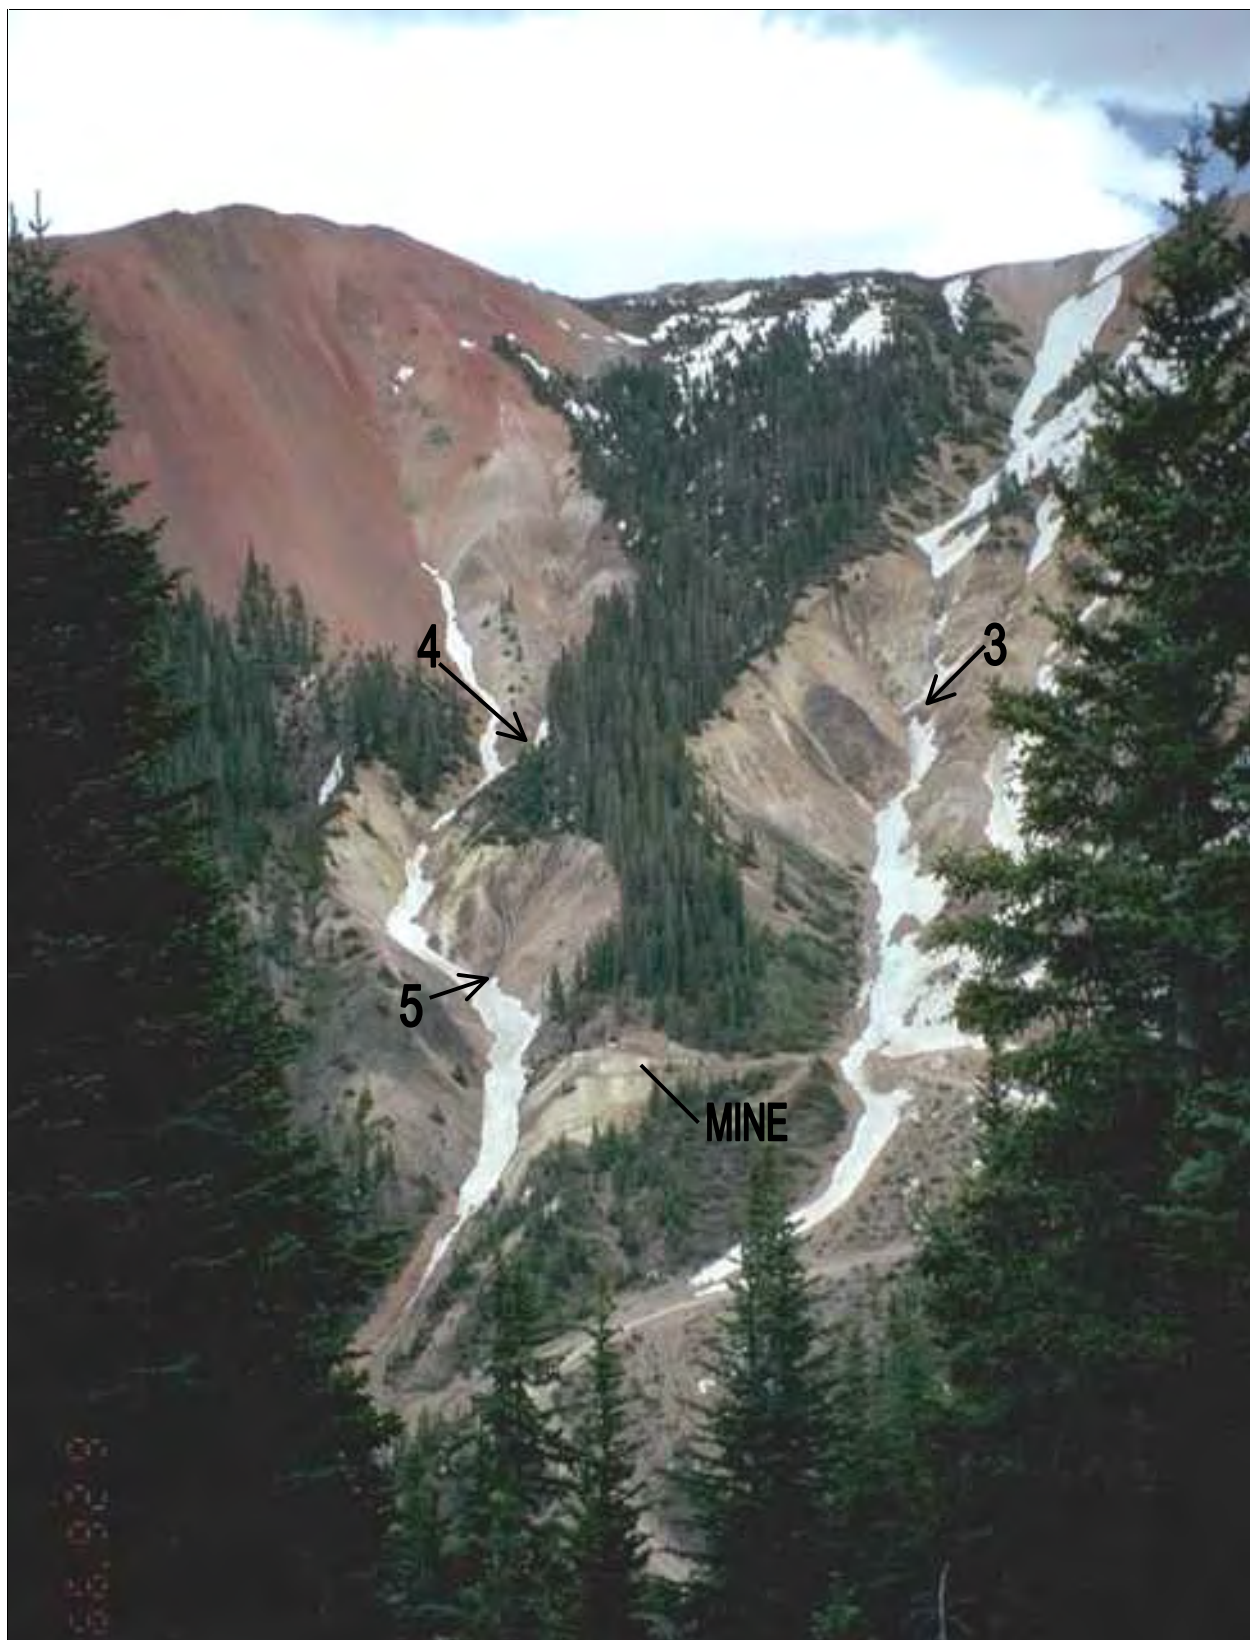
**Figure 3. Photograph showing sample sites NW3-5 on the west side of Red Mountain #1.**

Samples had low hardness (6 to 18 mg/L) except for sample NW8, which was 70 mg/L. Low hardness “lowers the bar” for metals with hardness-related stream standards. For several metals, the low hardness created situations where the detection limit of the analytical method was higher than the state standard, and comparison between the samples and stream standards was not possible. However, if the metals were not detected, they are not contributing appreciably to metal loading into Corkscrew Gulch. Sample NW8 had the highest metal content. Samples NW3, 6, and 7 were moderately degraded; and samples NW2, 4, and 5 were slightly degraded.

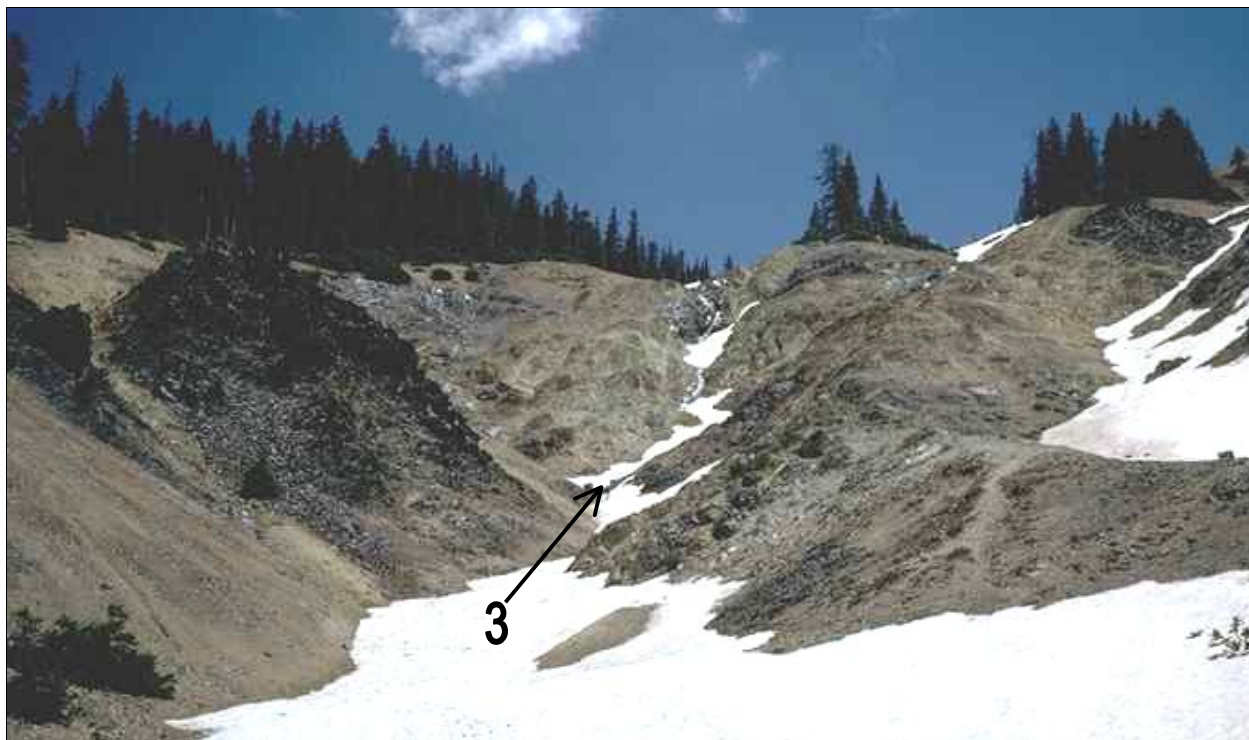
**Figure 4. Photograph showing sample site NW3 on the altered western slope of Red Mountain #1.**

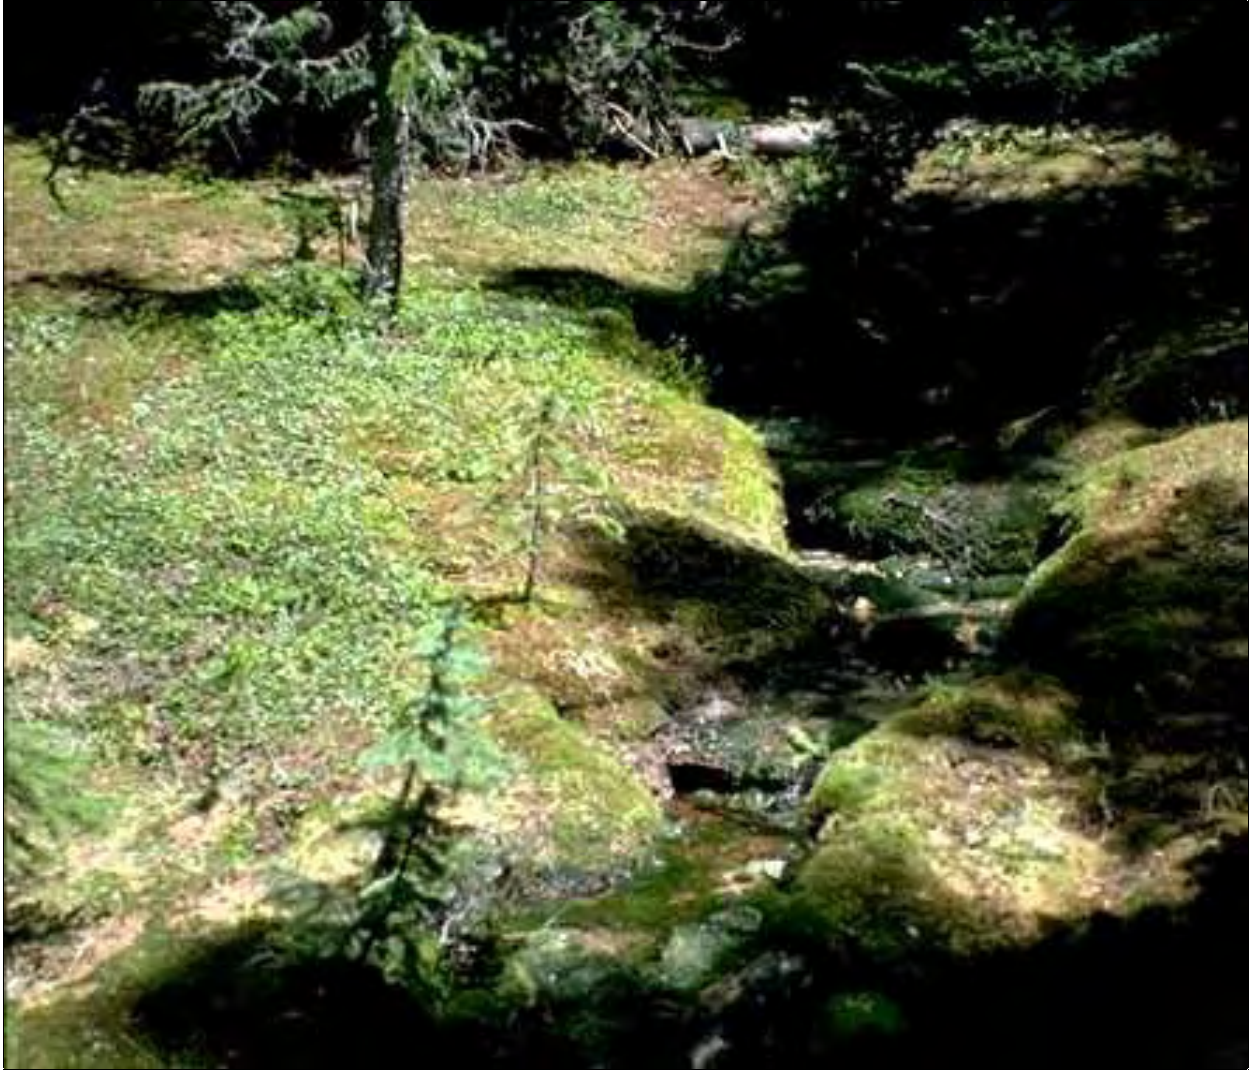
**Figure 5. Photograph showing spring on the northwestern slope of Red Mountain #1 at sample site NW7.**

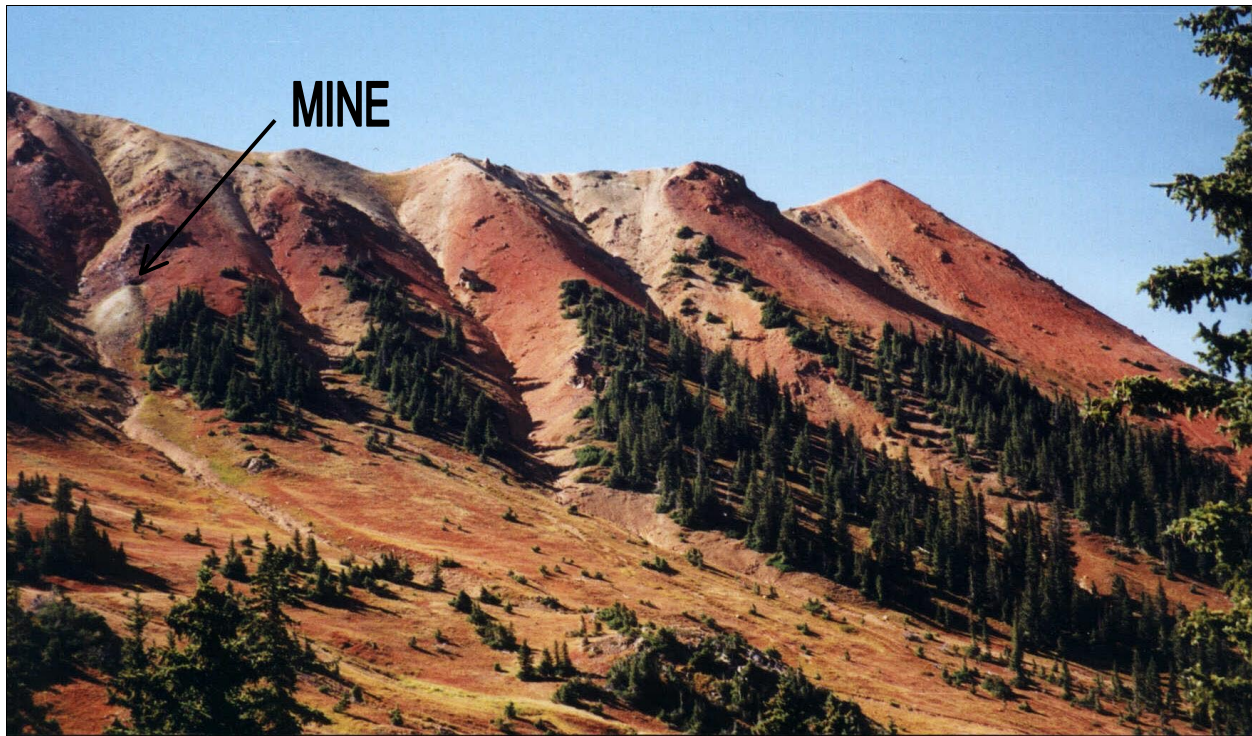
**Figure 6. Photograph of the east side of Red Mountain #1. Sample NW66 was collected upstream of any influence from the mine shown at left.**

On the east side of Red Mountain #1, in the upper reaches of Gray Copper Creek and above all known draining mines or mines of moderate size or larger, sample NW66 (Figure 2) was collected from a stream lined with well-indurated ferricrete. The mountainsides to the northwest are highly fractured and stained red, brown, and yellow (Figure 6). Upstream of the sample site, brown staining is prevalent. Disseminated pyrite commonly occurs in the fine-grained gravels in the streambed. The creek was flowing at 4 gpm and had 2.66 pH and 1,265  $\mu\text{S/cm}$  conductivity. This water was extremely degraded, especially with respect to aluminum, iron, copper, lead, and chloride. Zinc concentration approached state standards (Table 1). The detection limit for calcium was elevated in this sample, and calcium was not detected. Because calcium was not detected, the hardness and the hardness-related water-quality standards, could not be calculated.

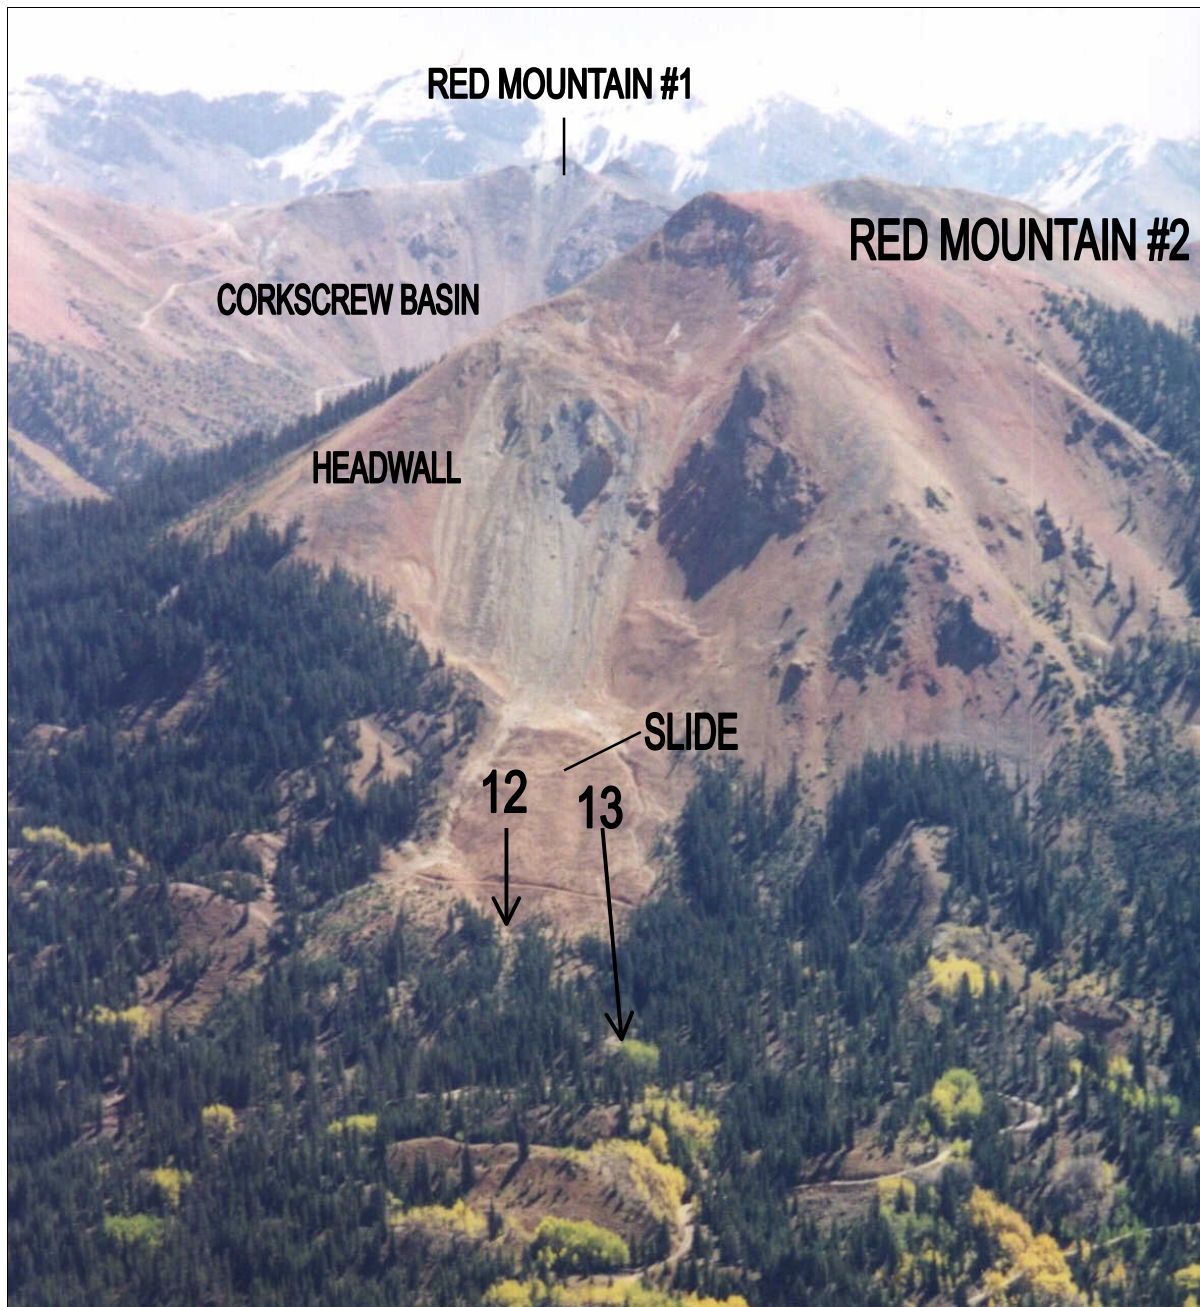
**Figure 7. Photograph showing sample sites NW12-13 on the western slope of Red Mountain #2.**

Samples NW9 to NW13 were collected from streams flowing from Red Mountain #2 (Figures 2, 7). All samples were collected from above the known large and/or draining mines. Lab results indicate that most of the non-mining-related runoff from Red Mountain #2 is moderately to highly degraded. The sampled streams had flows ranging from 50 to 280 gpm, pH was 2.16 to 3.92, and conductivity ranged from 18 to 1,640  $\mu\text{S}/\text{cm}$  (Table 1).

Sample NW13 from a stream on the south side of the slide was the most degraded sample collected near Red Mountain #2, but the water was relatively clear and no precipitate was apparent. At the sample site, the high acidity apparently kept most metals in a dissolved state, however, ponds within 100 feet downstream of the site had abundant light-green precipitate coating their bottoms and attached to algae. The color of the precipitate may be related to the high copper content of the water (150  $\mu\text{g}/\text{L}$ ).

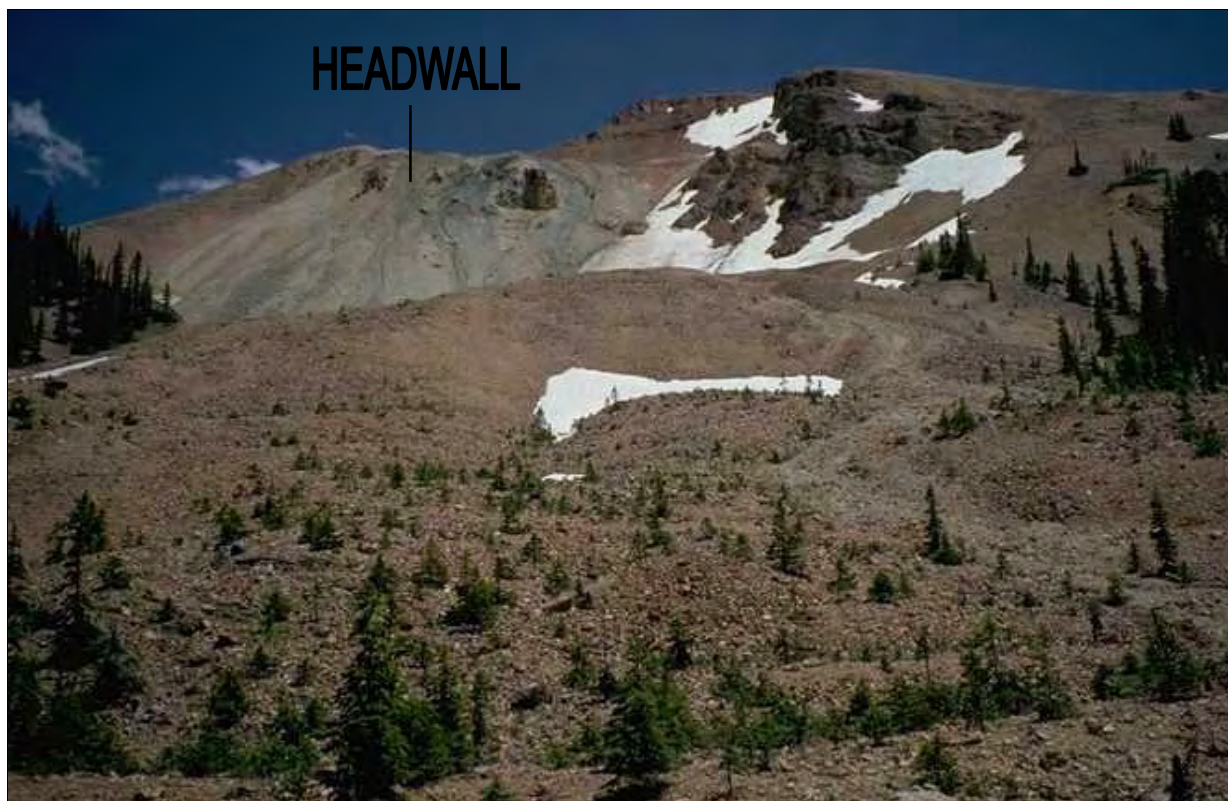
**Figure 8. Photograph showing the headwall of the slide above sample sites NW12-13.**

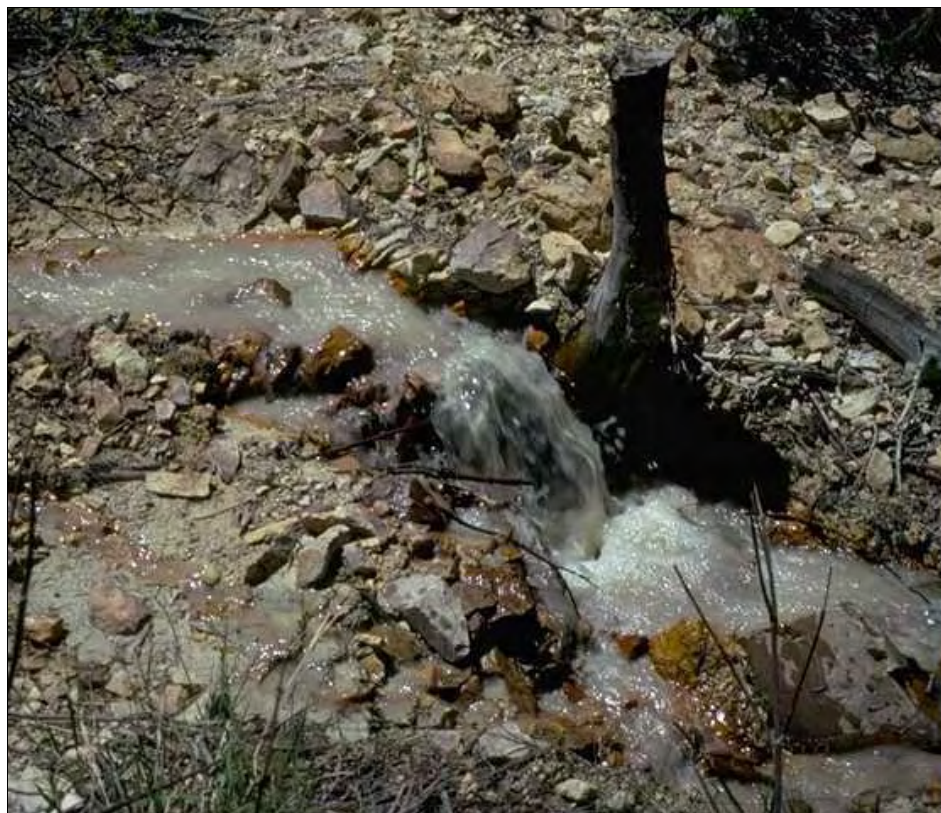
**Figure 9. Photograph showing the milky water of NW12.**

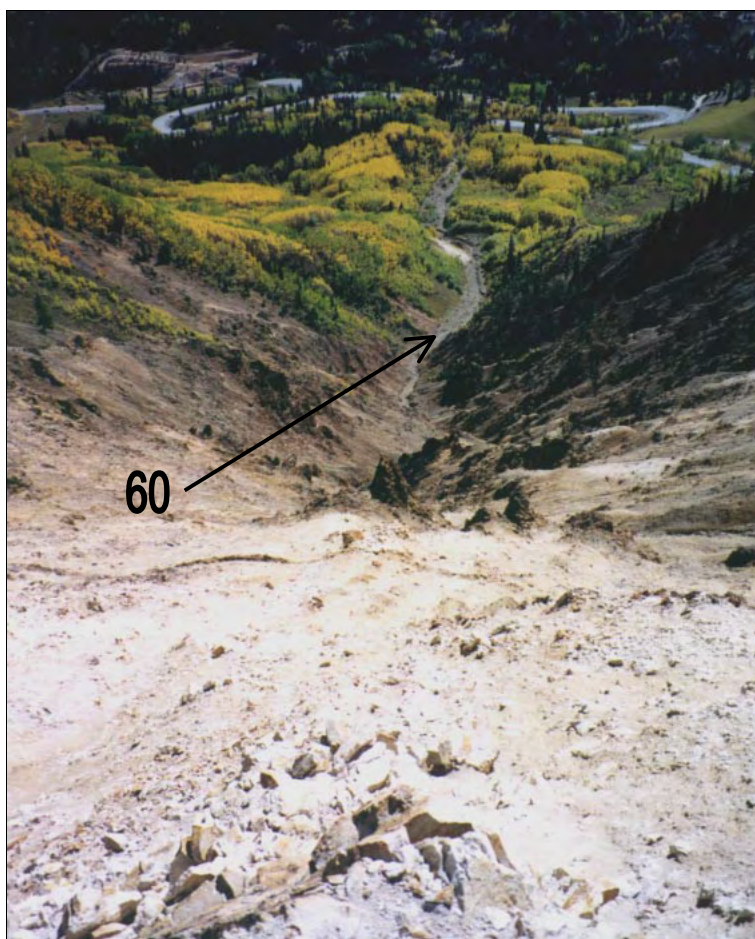
**Figure 10. Photograph showing sample site NW60 and the headwaters of Governor Gulch.**

Intensely altered brown-yellow and light-yellow rocks with seams of white clay in fractures are exposed in upper Governor Gulch, above sample site NW60 (Figure 10). In addition to aluminum, sample NW60 contained high manganese (4,000  $\mu\text{S}/\text{cm}$ ), sulfate (440 mg/L), and zinc (590  $\mu\text{g}/\text{L}$ ), though zinc was below standards because of the high hardness of the sample (1,066 mg/L).

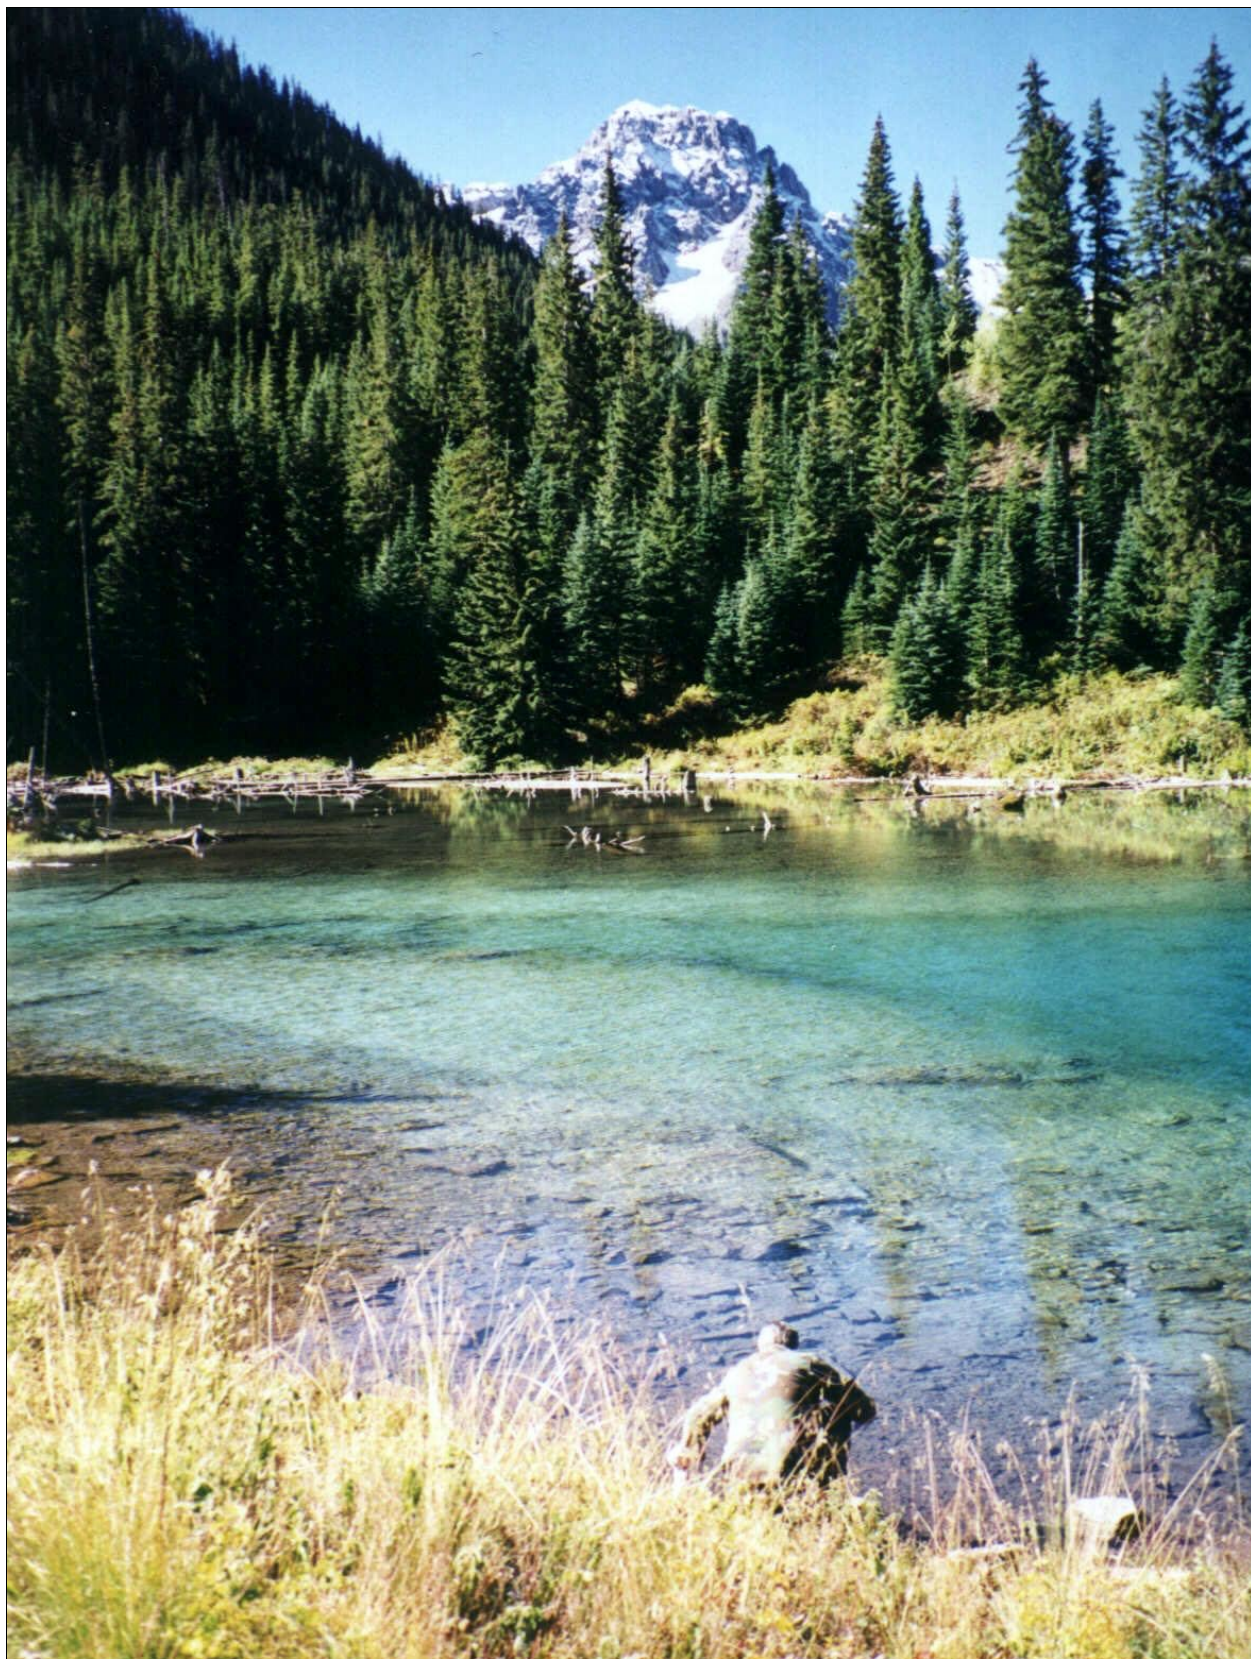
**Figure 12. Photograph showing a lake with blue-green water at sample site NW79.**

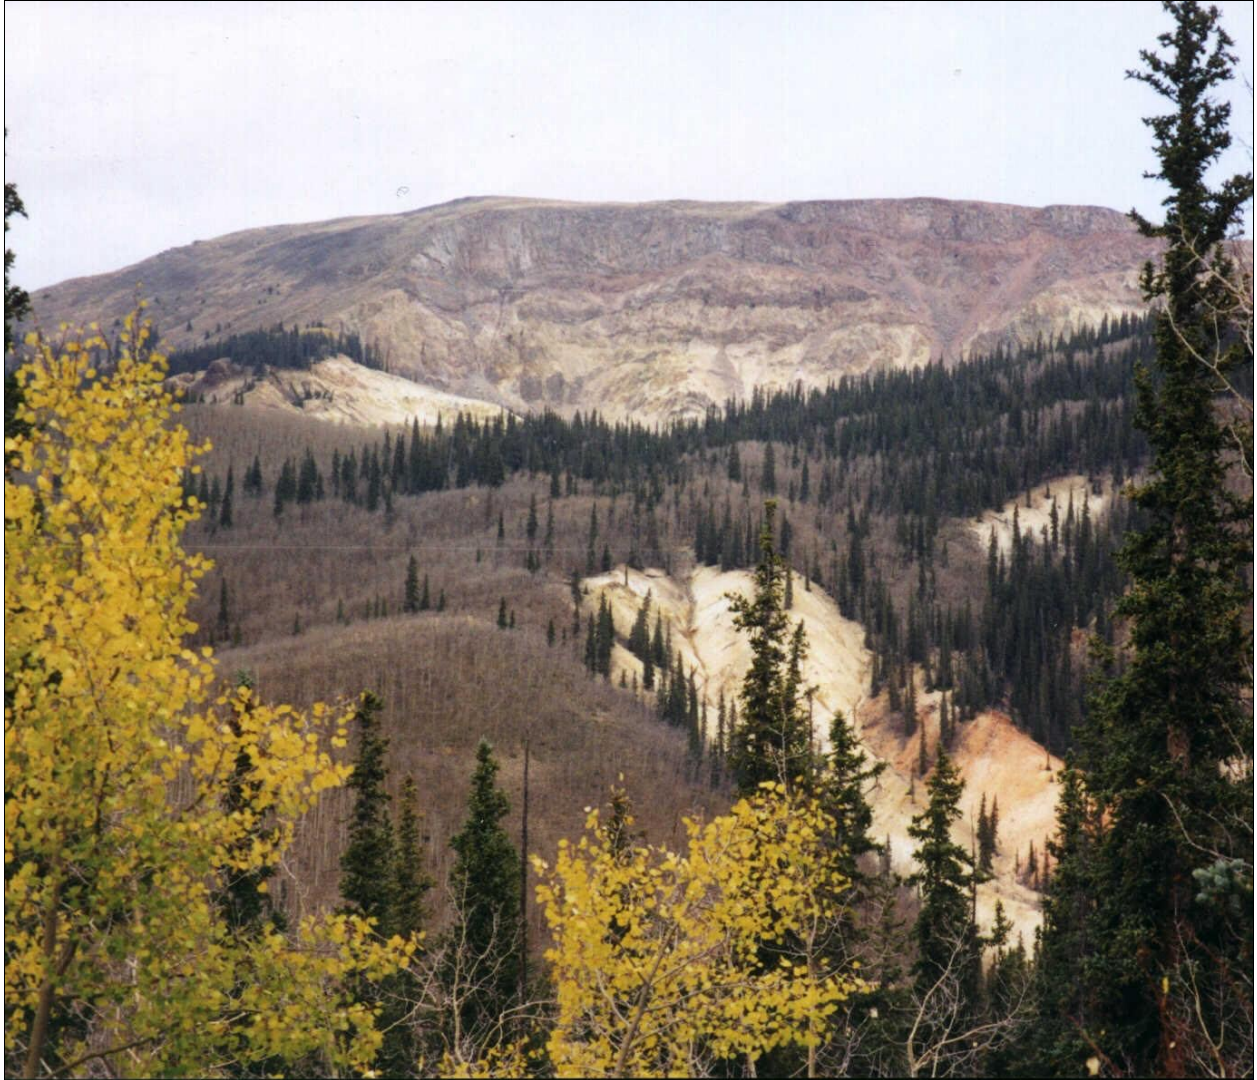
**Figure 14. Photograph showing headwall and upper reaches of Slumgullion Slide. Sample NW88 was collected from the stream to the right and near the bottom of the barren, eroded gulch in foreground. The eroded gulch is not part of the slide, but shows the intensely clay-altered bedrock prevalent in this area.**

Sample NW88 was collected from a stream draining severely altered rocks south of the slide (Figures 14, 15). Samples NW89 to NW91 were collected from streams within or bordering the Slumgullion Slide. All of these samples were acidic, had moderate to high conductivity, and moderate to high hardness. Aluminum, iron, and manganese concentrations exceeded state standards in all of the samples (Table 2).

At sample site NW88, partly eroded ferricrete formed the banks of the stream in some areas. Alluvium was mostly argillized porphyry with yellow and red stain. Fragments of ferricrete, brick-red, fine-grained volcanic(?) rock, and yellow- and brown-stained silicified rocks also occurred as alluvium. Flow was about 4 gpm, pH was 3.26, and conductivity was 743  $\mu\text{S}/\text{cm}$ . Aluminum greatly exceeded standards; iron and manganese exceeded by more than an order of magnitude; and copper and chloride concentrations were also above standards. The chloride concentration was exceptionally high compared to most samples collected for this study.

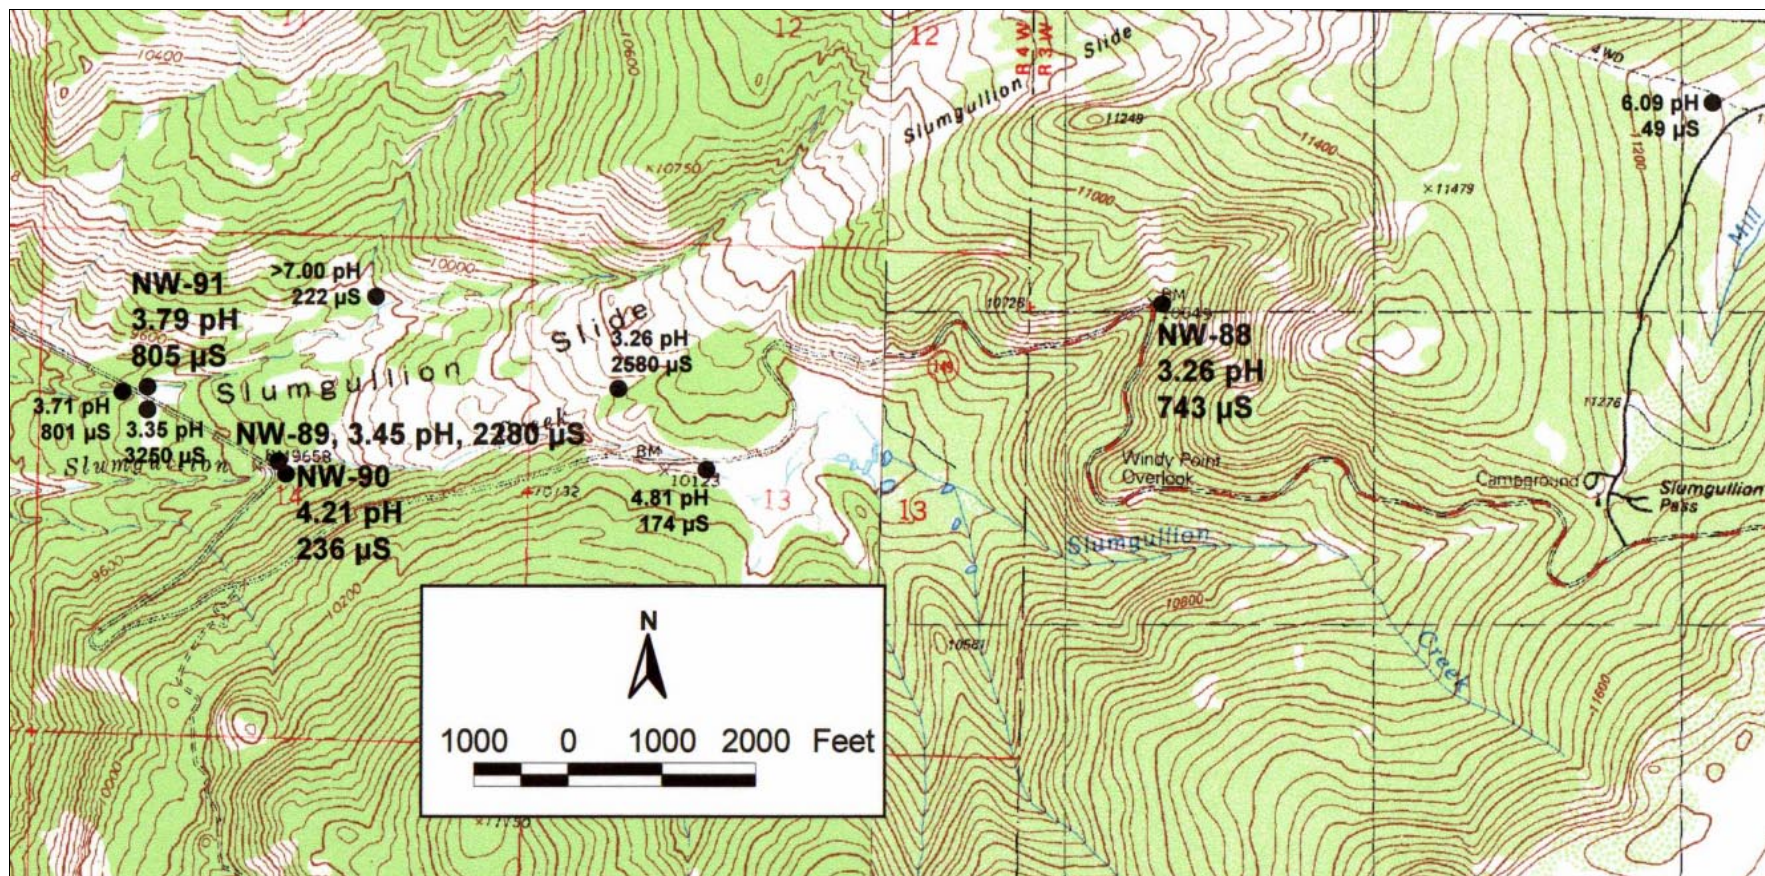
Figure 15. Map showing sample sites NW88-91 and water test results from the Slumgullion Slide area.

Sample NW91 was from a creek flowing near the northwestern border of the slide (Figure 15). Within this stream's drainage basin, a few small and dry mines were driven in bedrock north of the slide, but these probably do not significantly affect water quality. Red-orange precipitate coated the streambed (Figure 16). Flow was 72 gpm, pH was 3.79, and conductivity was 805  $\mu\text{S}/\text{cm}$ . Aluminum and manganese significantly exceeded standards, and iron exceeded to a lesser extent. Much of the high conductivity may be explained by relatively high concentrations of sulfate and major cations such as calcium, magnesium, sodium, and silica. Sample NW91 was degraded despite the diluting effect of an unnamed tributary joining this stream from the north, about  $\frac{1}{2}$  mile upstream. A test from the northern tributary showed neutral pH and moderate conductivity. A test in some wetlands near site NW91, on the south side of State Highway 149, showed acidic water with conductivity of more than 3,000  $\mu\text{S}/\text{cm}$  (Figure 15).

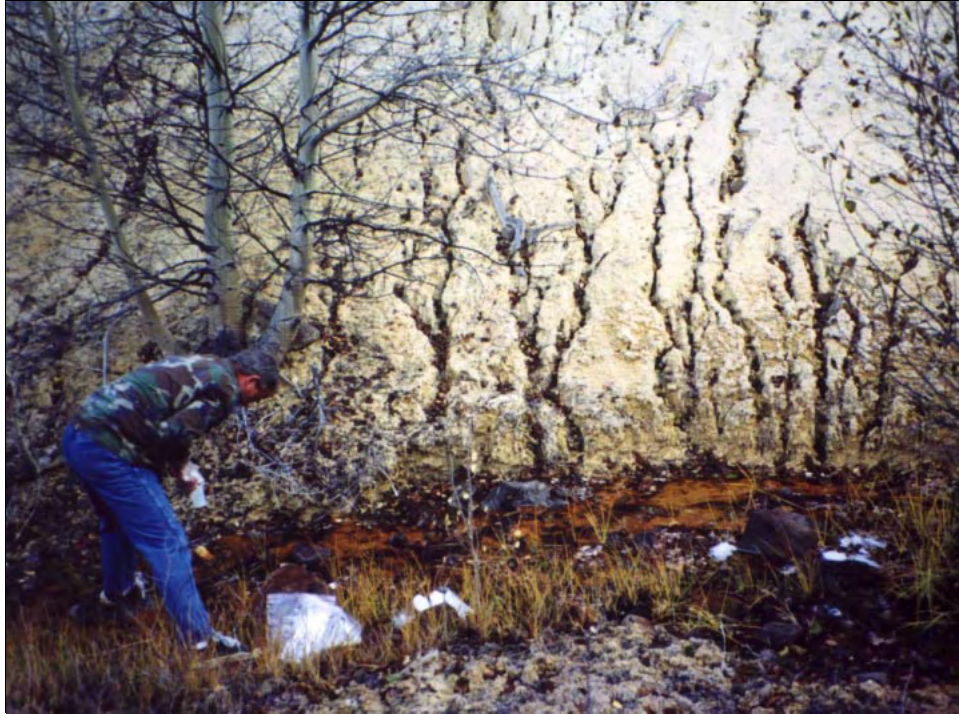
**Figure 16.** Photograph showing sample site NW91 near the northwest margin of Slumgullion Slide. The eroded creek bank comprises yellow, moist clay typical of much of the slide.

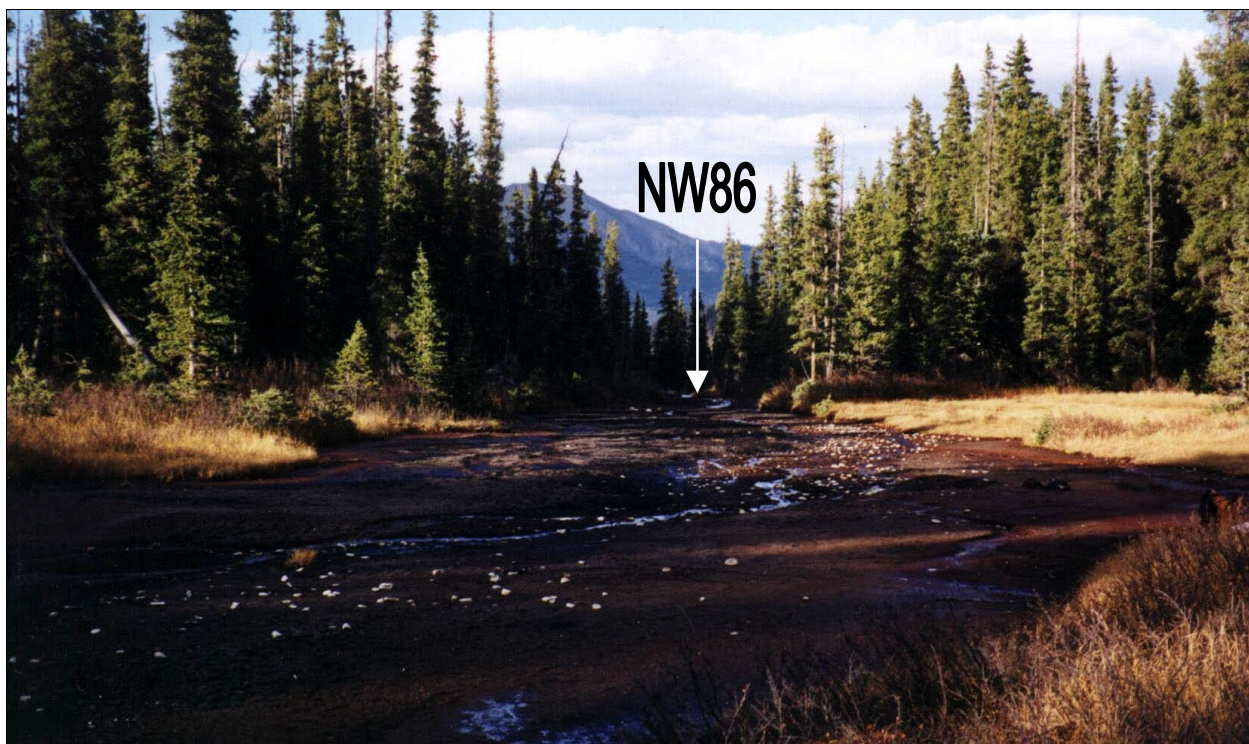
**Figure 18. Photograph showing sample site NW86 and ferrosinter deposit near Wager Gulch.**

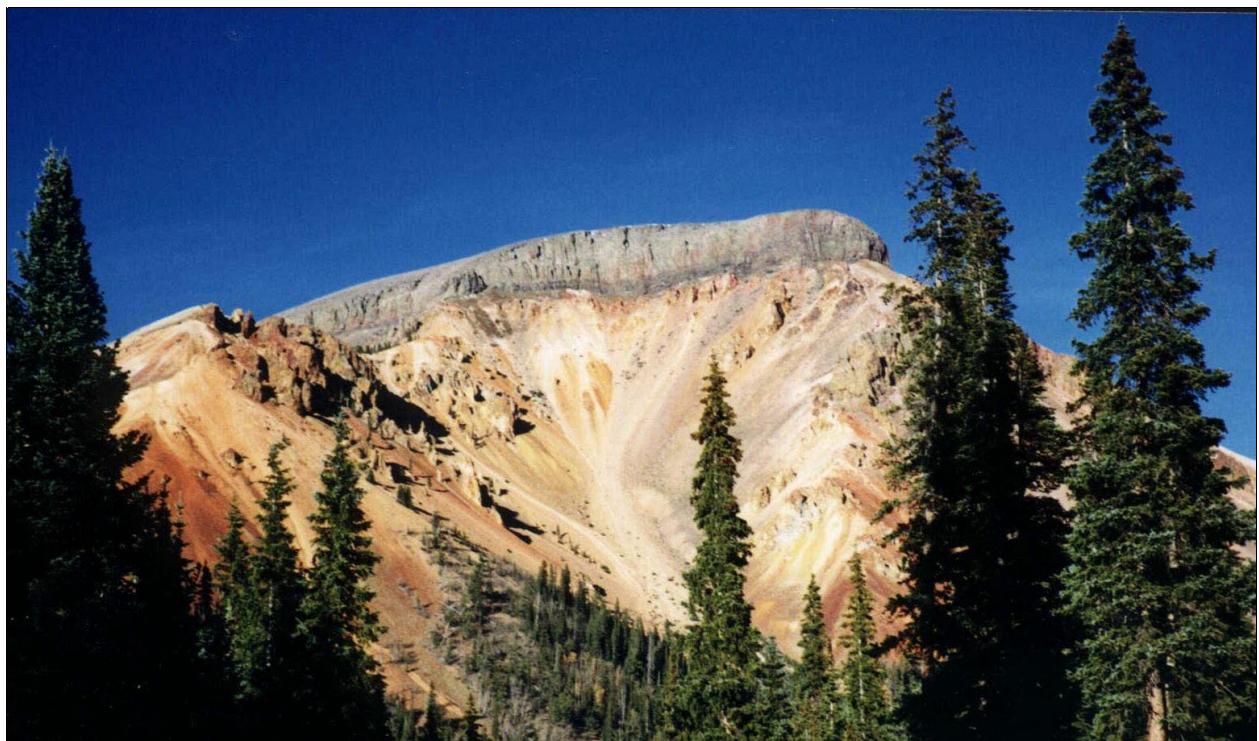
**Figure 19. Photograph showing intense alteration on the south side of Lookout Mountain, in the Iron Creek drainage basin.**

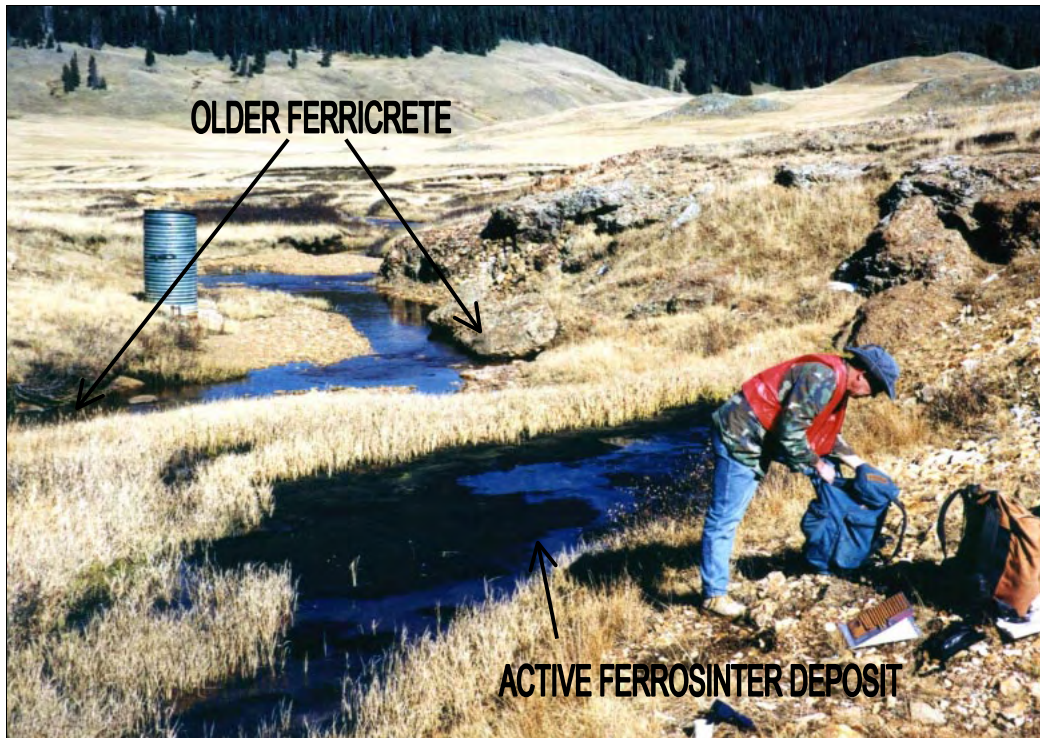
**Figure 21. Photograph showing ferrosinter deposit at sample site NW95, adjacent to Iron Creek.**

Sample NW95 was from a spring with an associated, actively forming ferrosinter deposit (Figure 21) near the headwaters of Iron Creek, on the eastern side of the Continental Divide. A nearby shallow prospect pit was not considered a factor in the water quality of the spring. Bedrock exposed at a small waterfall about 200 feet downstream of the sample site comprised silicified and pyritized, gray, aphanitic volcanic rock. Old, well-indurated ferricrete deposits (Figure 22) on both sides of Iron Creek adjacent to the sample site suggest a long history of degraded water emerging in this area. Both upstream and downstream of the spring, a thin layer of red precipitate coated much of the channel of Iron Creek. The sampled spring was flowing at 3 gpm, had 3.58 pH, and conductivity of 203  $\mu\text{S}/\text{cm}$ . Aluminum concentration significantly exceeded state standards, and iron, copper, manganese, and thallium also exceeded standards (Table 4).

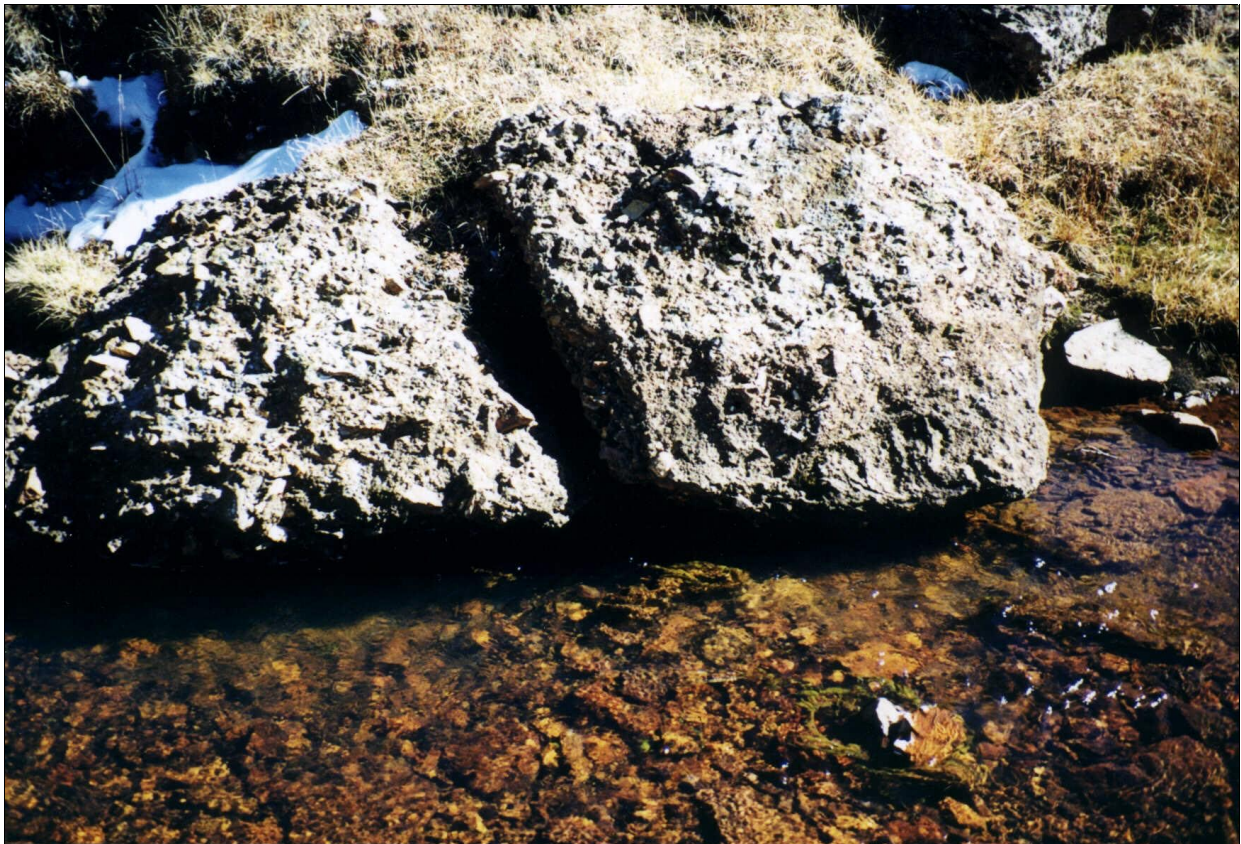
**Figure 22. Photograph showing ferricrete along upper Iron Creek near sample site NW95.**

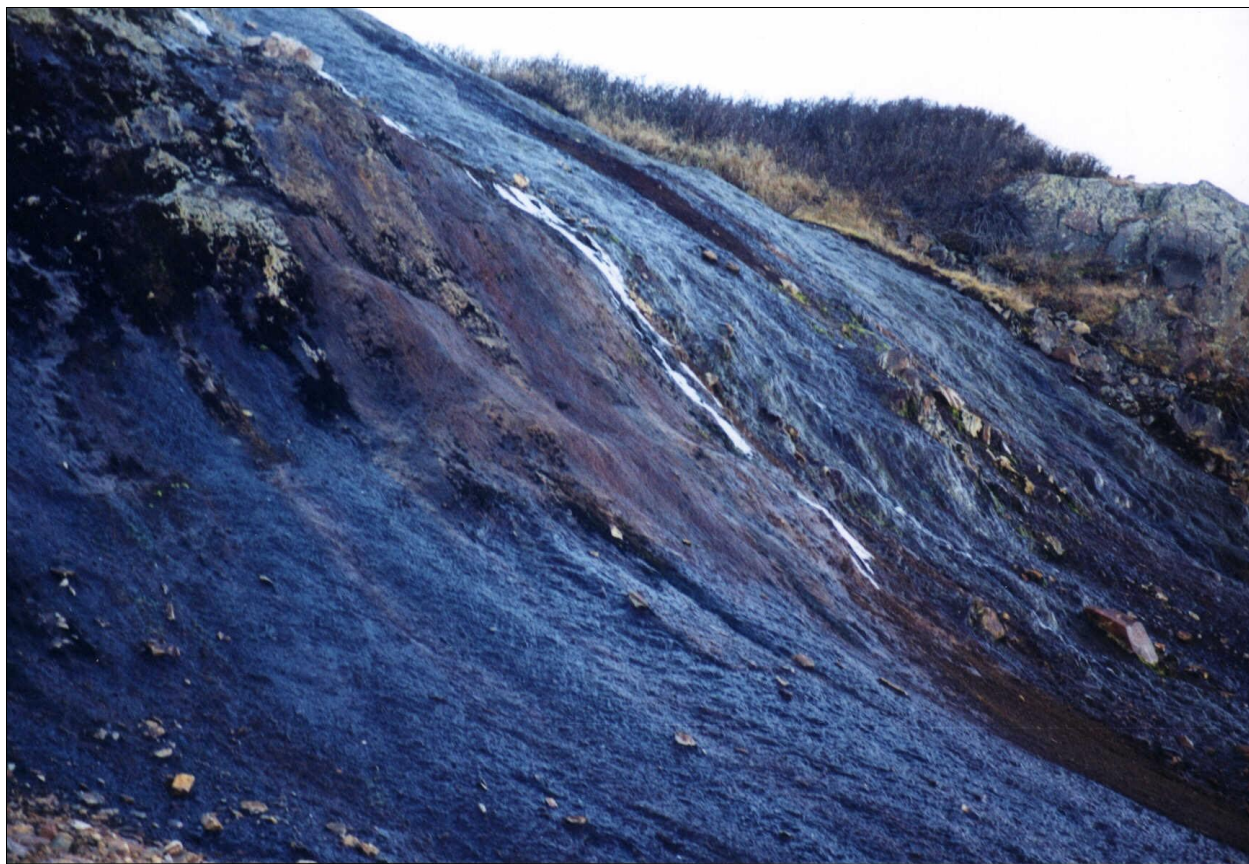
**Figure 24. Photograph showing ferrosinter deposit near Kite Lake, near sample site NW93.**
