OPEN-FILE REPORT 00-16

# **Naturally Degraded Surface Waters Associated with Hydrothermally Altered Terrane in Colorado**

By John T. Neubert

Colorado Geological Survey  
Department of Natural Resources  
Denver, Colorado  
2000

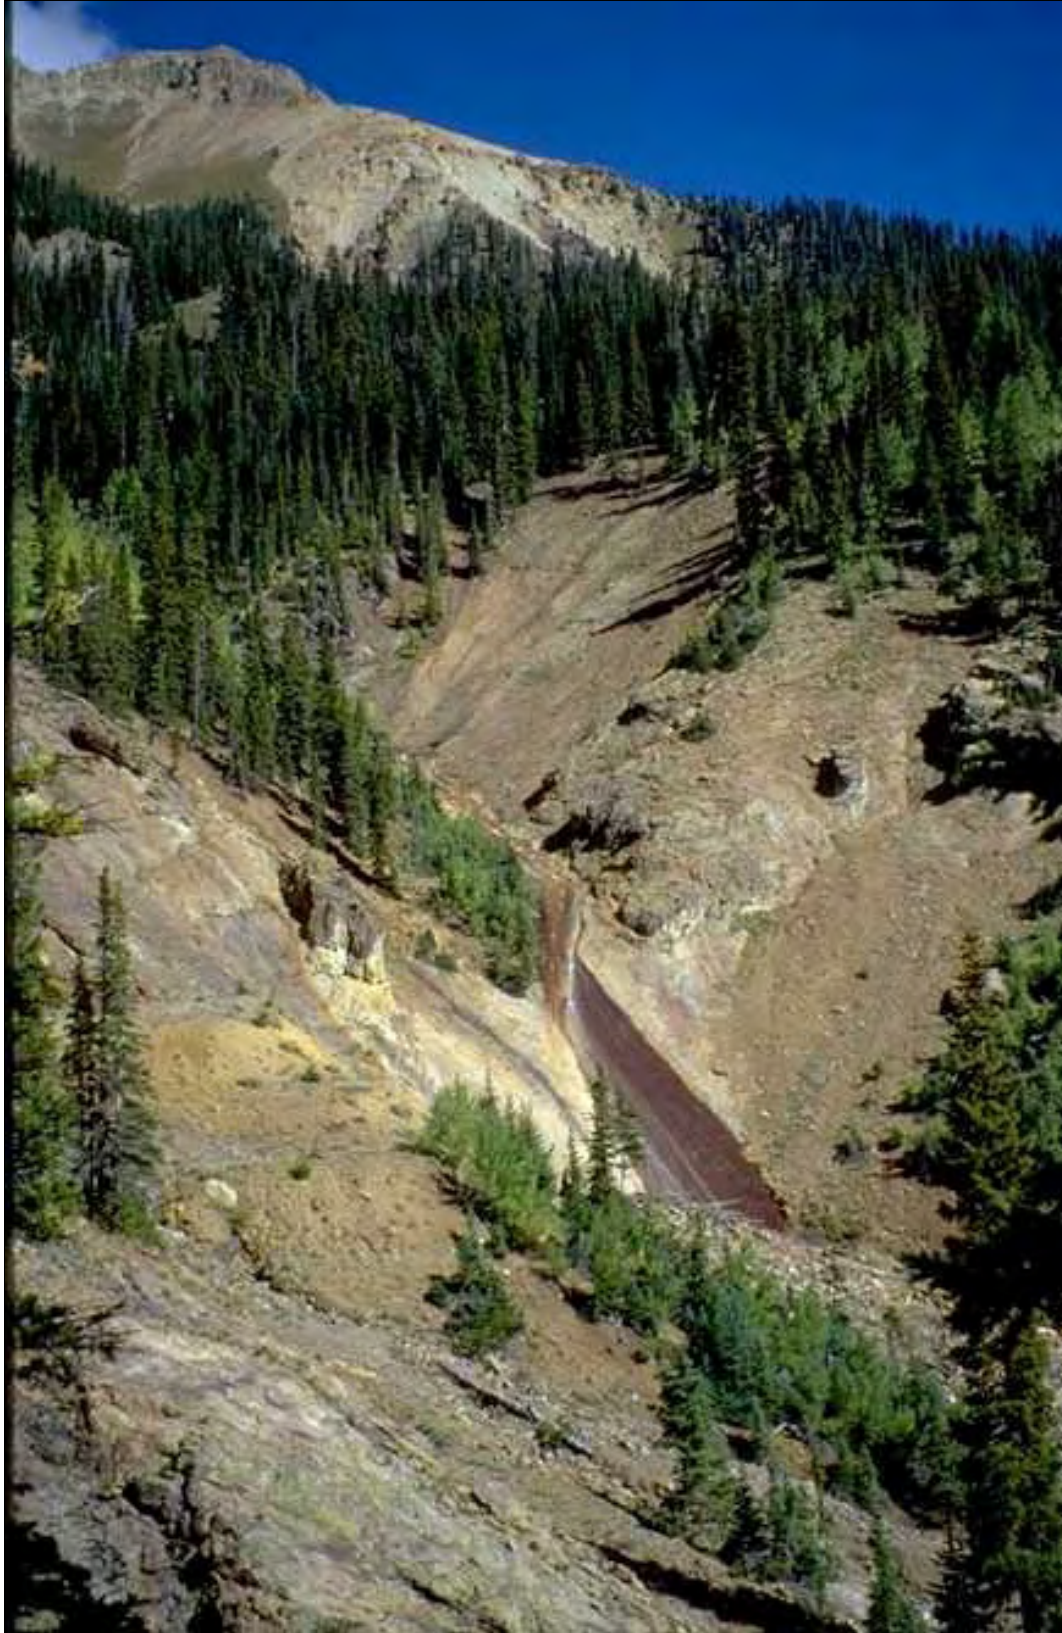
**Figure 27. Photograph of Bedrock Creek showing cascade flowing across precipitate-coated, mineralized intrusive rock and altered slopes.**

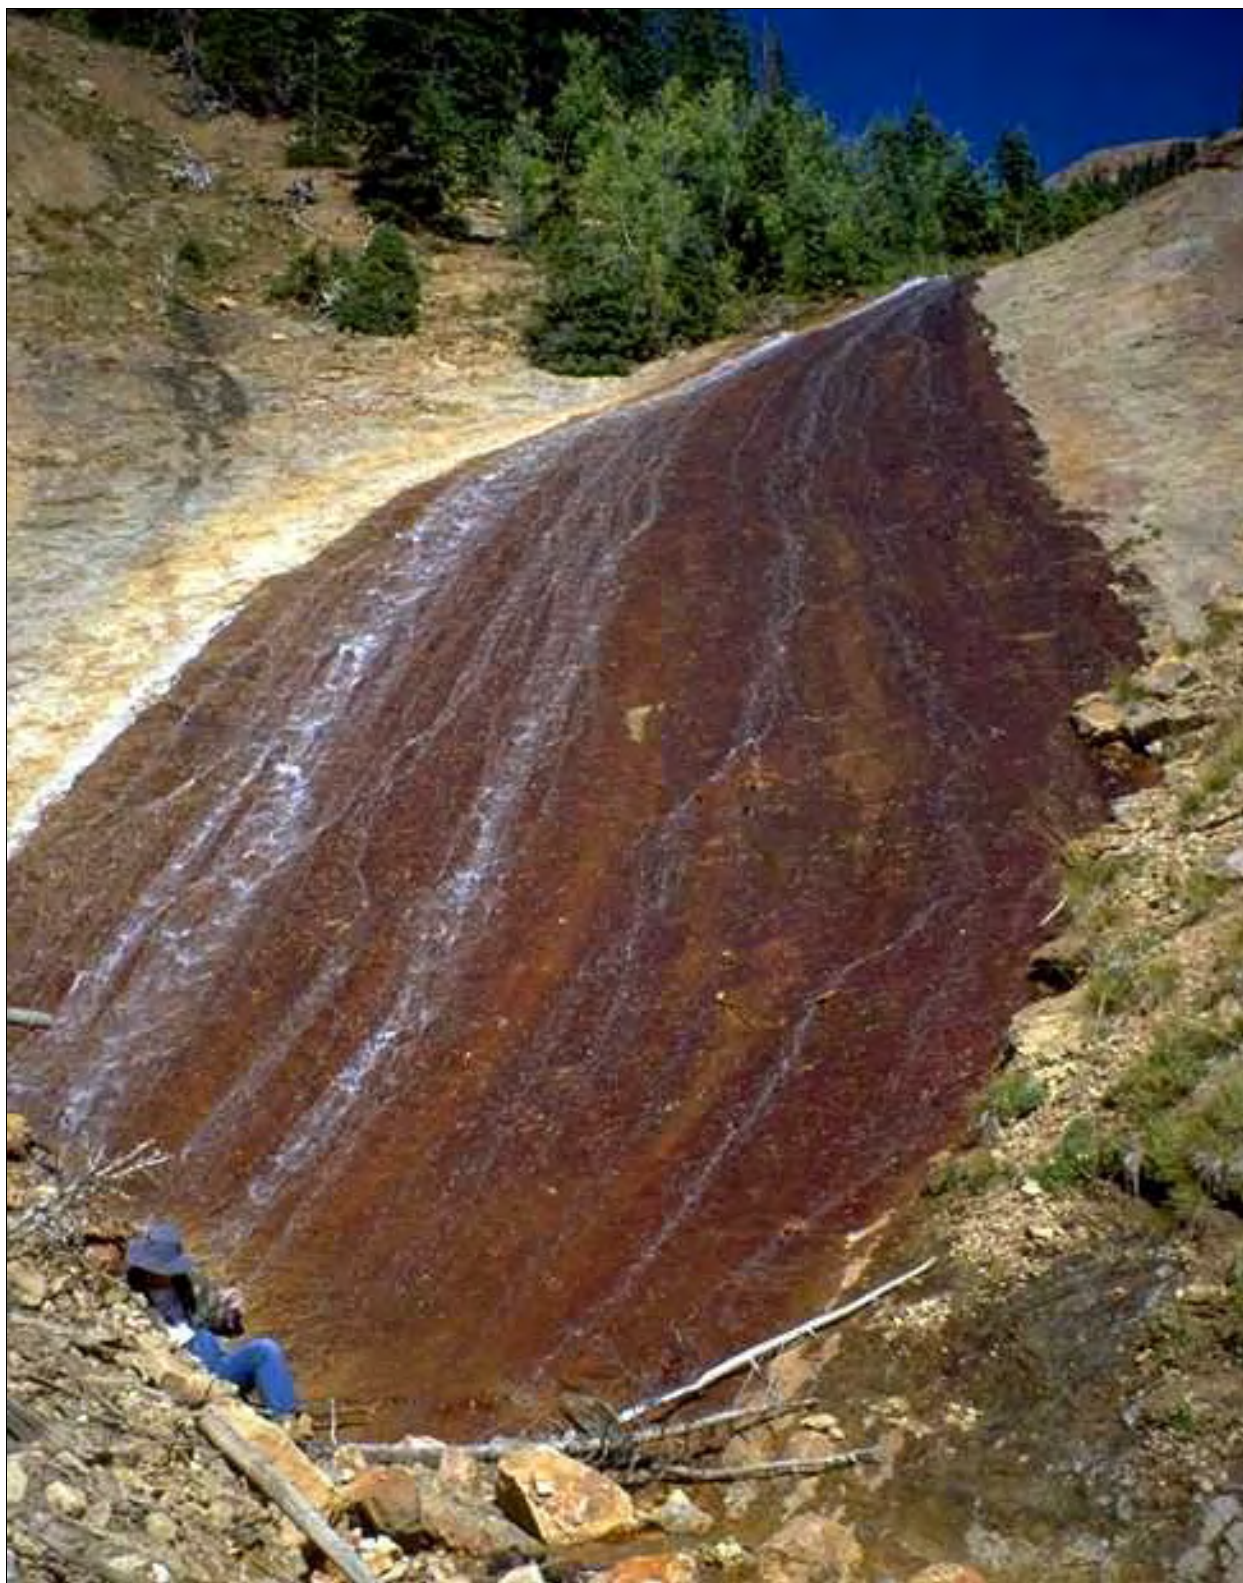
**Figure 28. Photograph showing sample site NW70 at base of cascade in Bedrock Creek.**

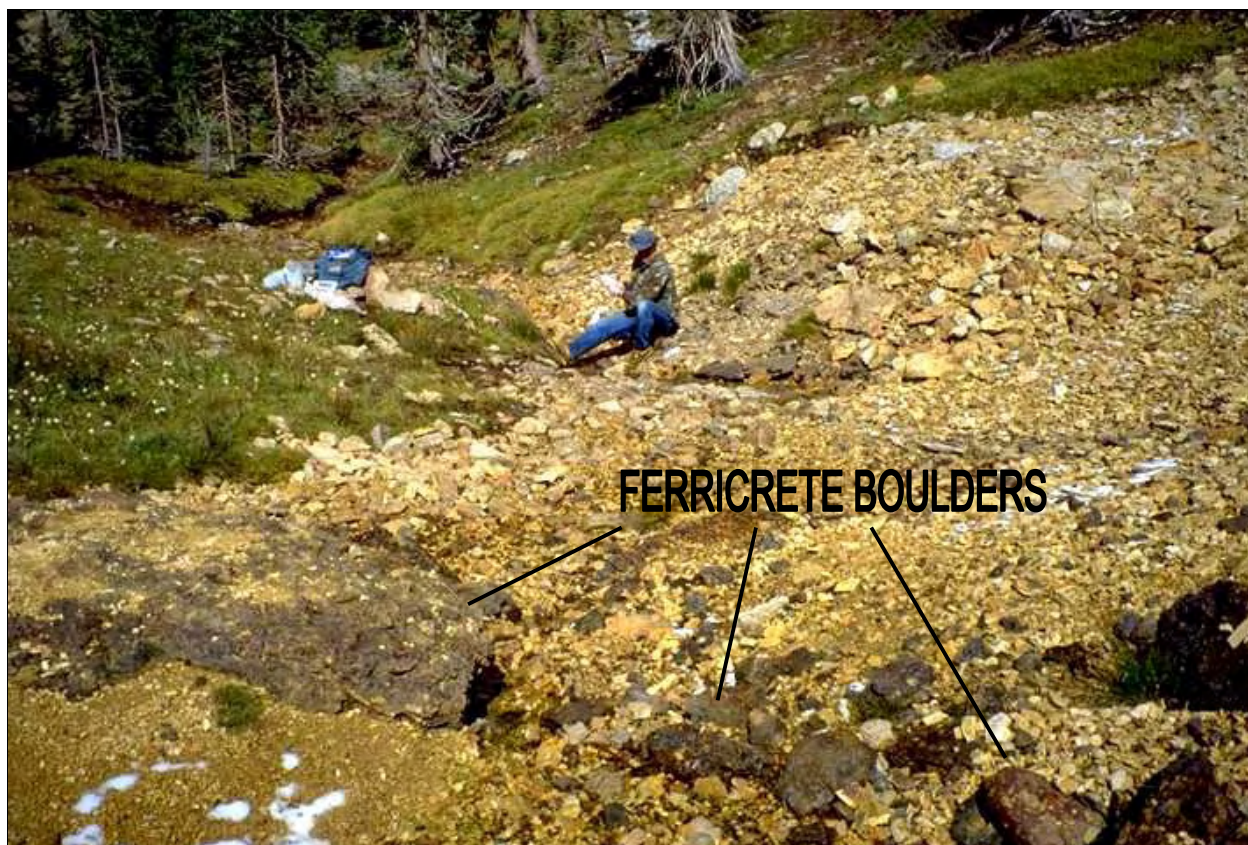
**Figure 29. Photograph showing weathered ferricrete at sample site NW76.**

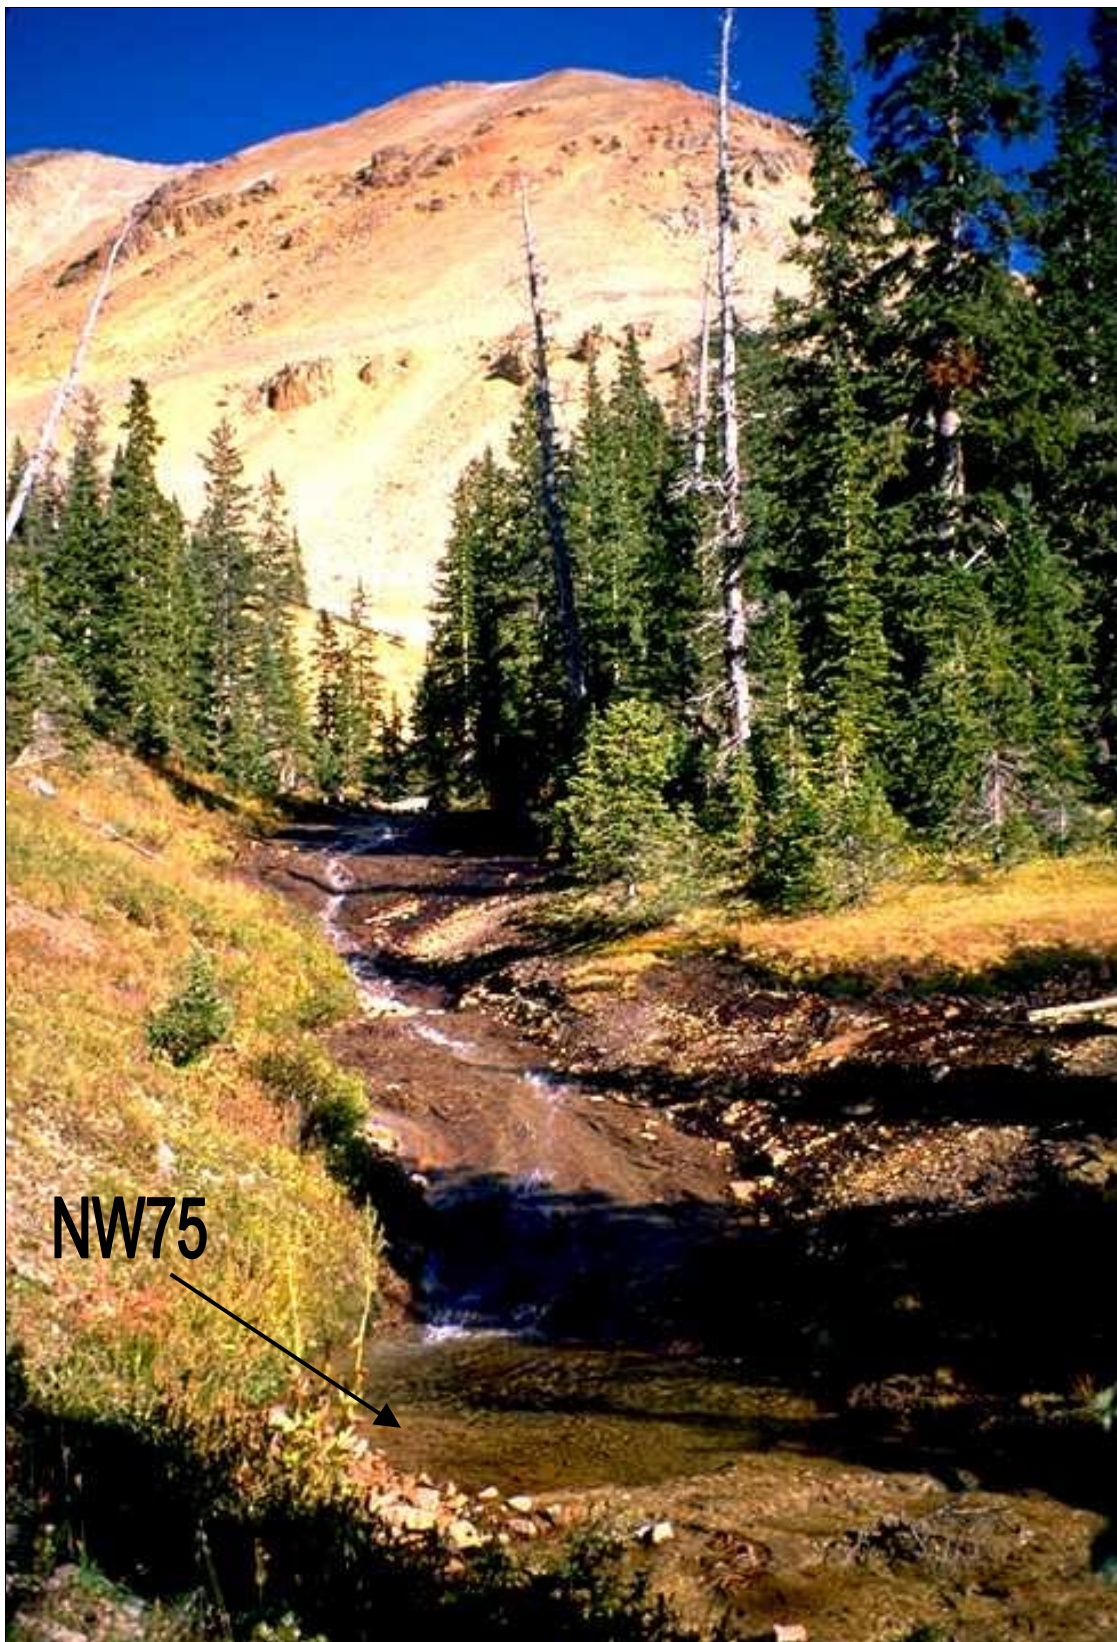
**Figure 30. Photograph showing sample site NW75 and terracettes of ferrosinter.**

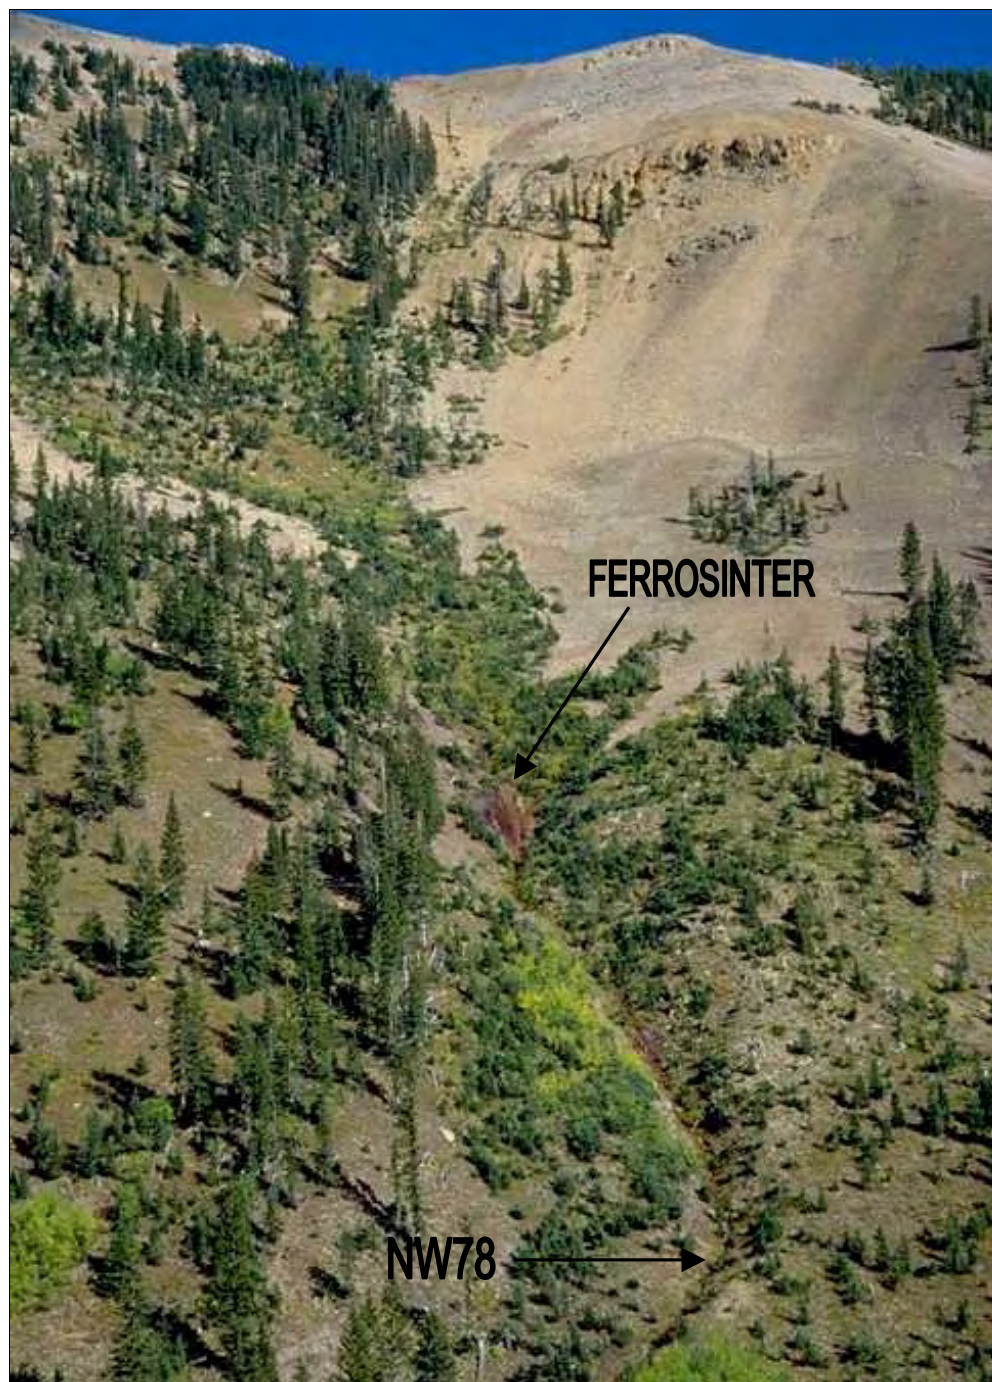
**Figure 31. Photograph showing ferrosinter deposit on the west side of Gibbs Peak and sample site NW78.**

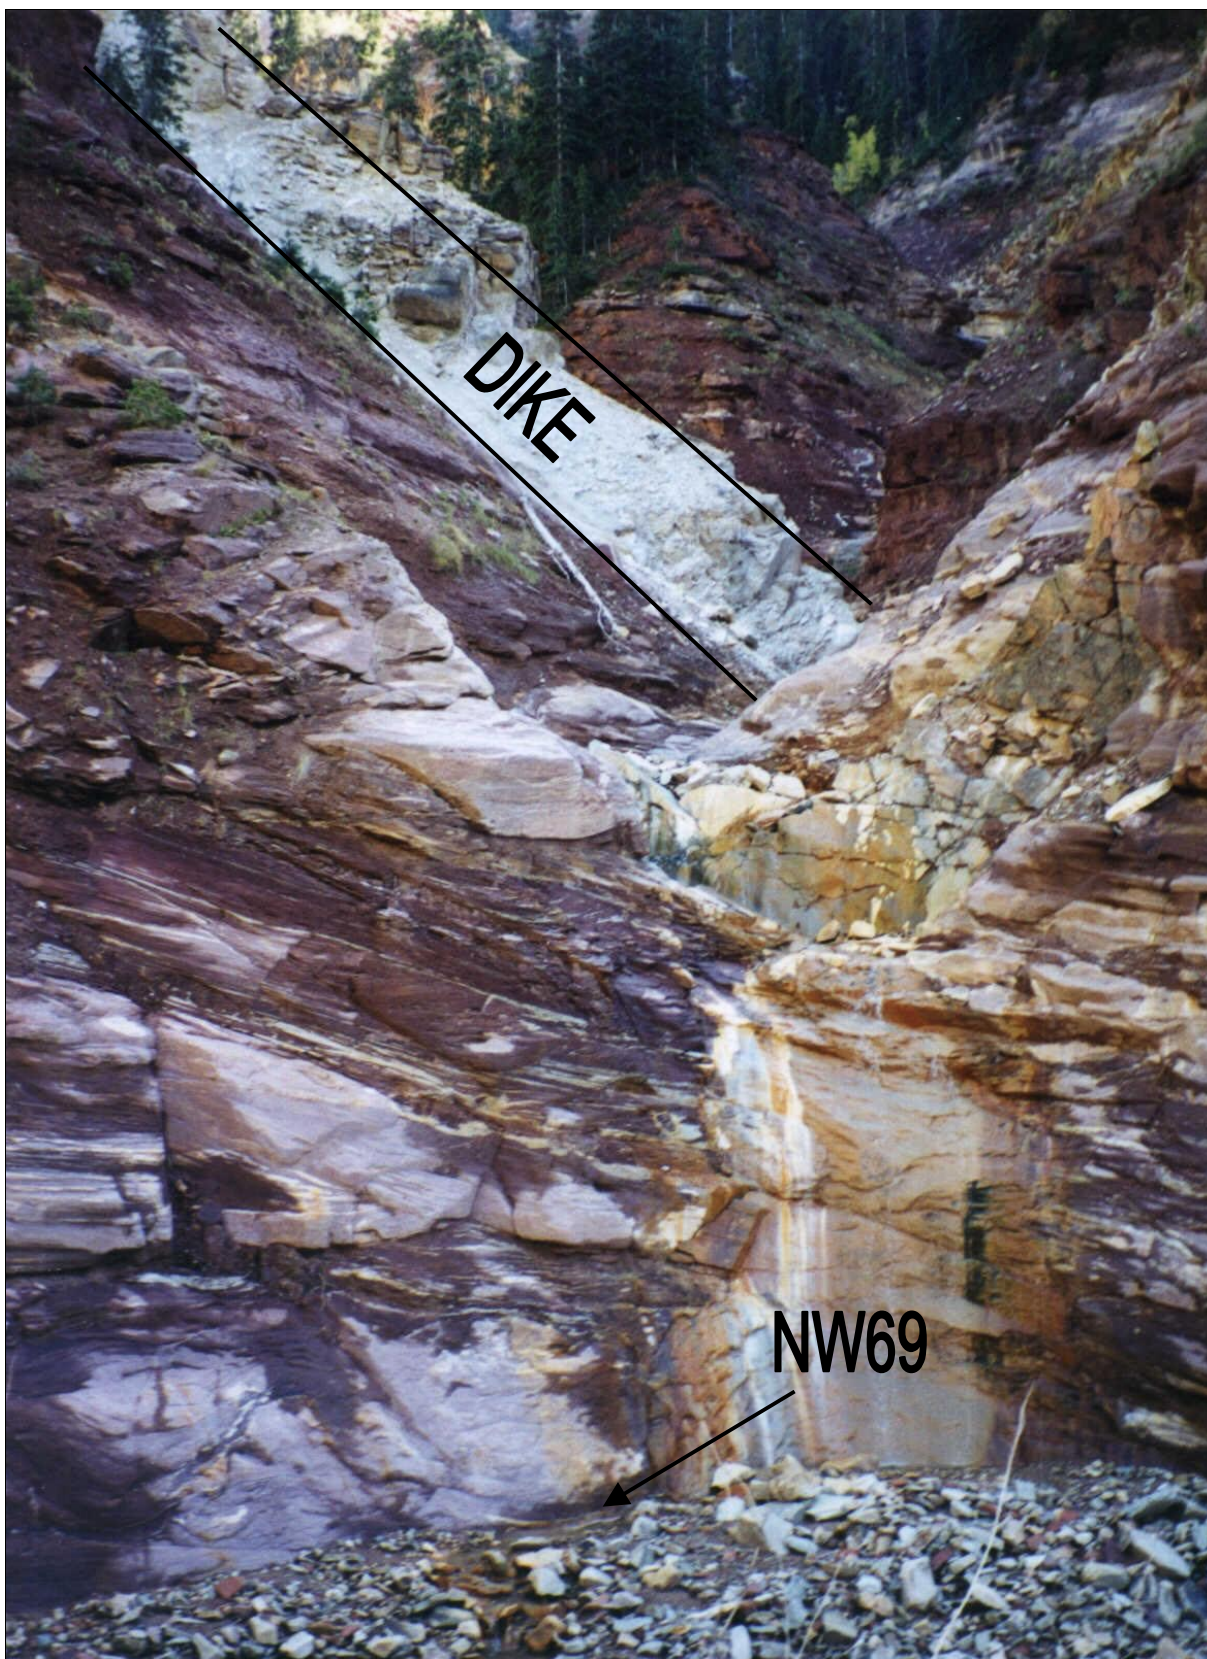
**Figure 33.** Photograph showing sample site NW69 and porphyry dike in upper Silver Creek.

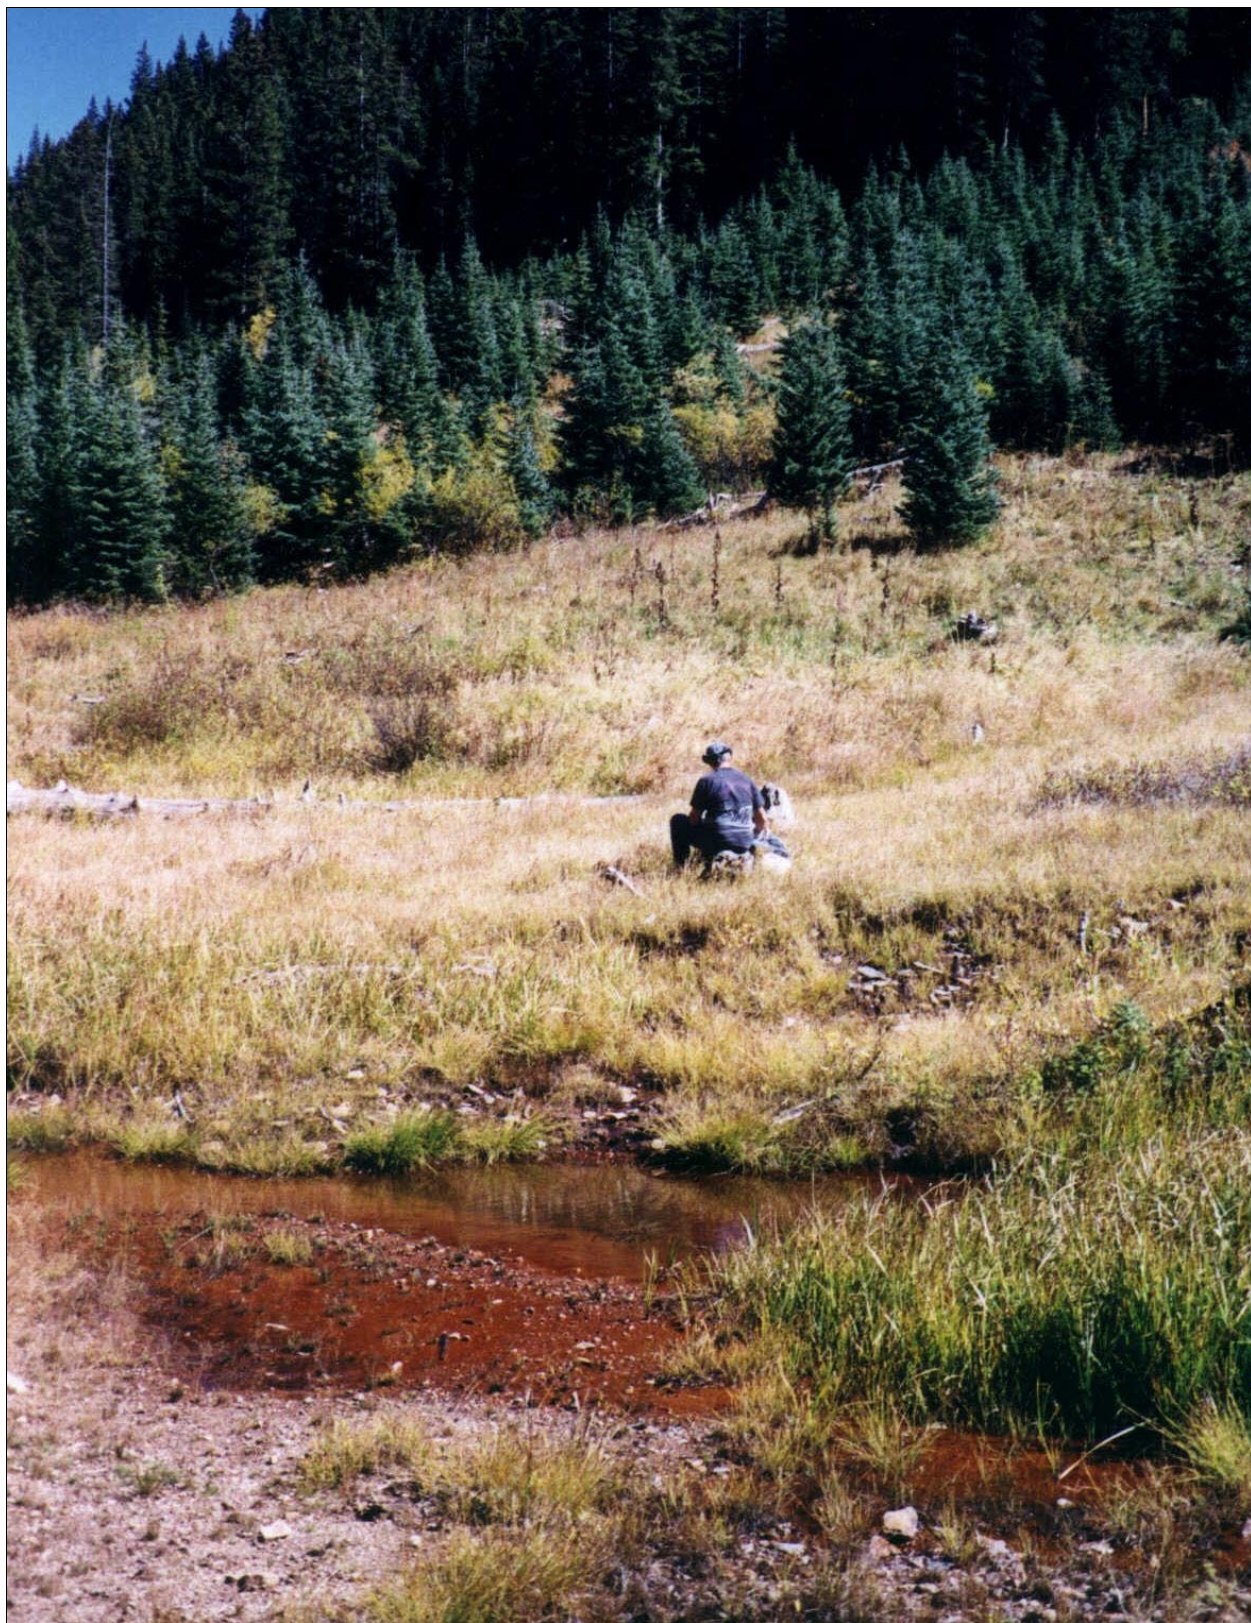
**Figure 34. Photograph showing sample site NW81 at wetlands with iron bog along Horse Creek.**

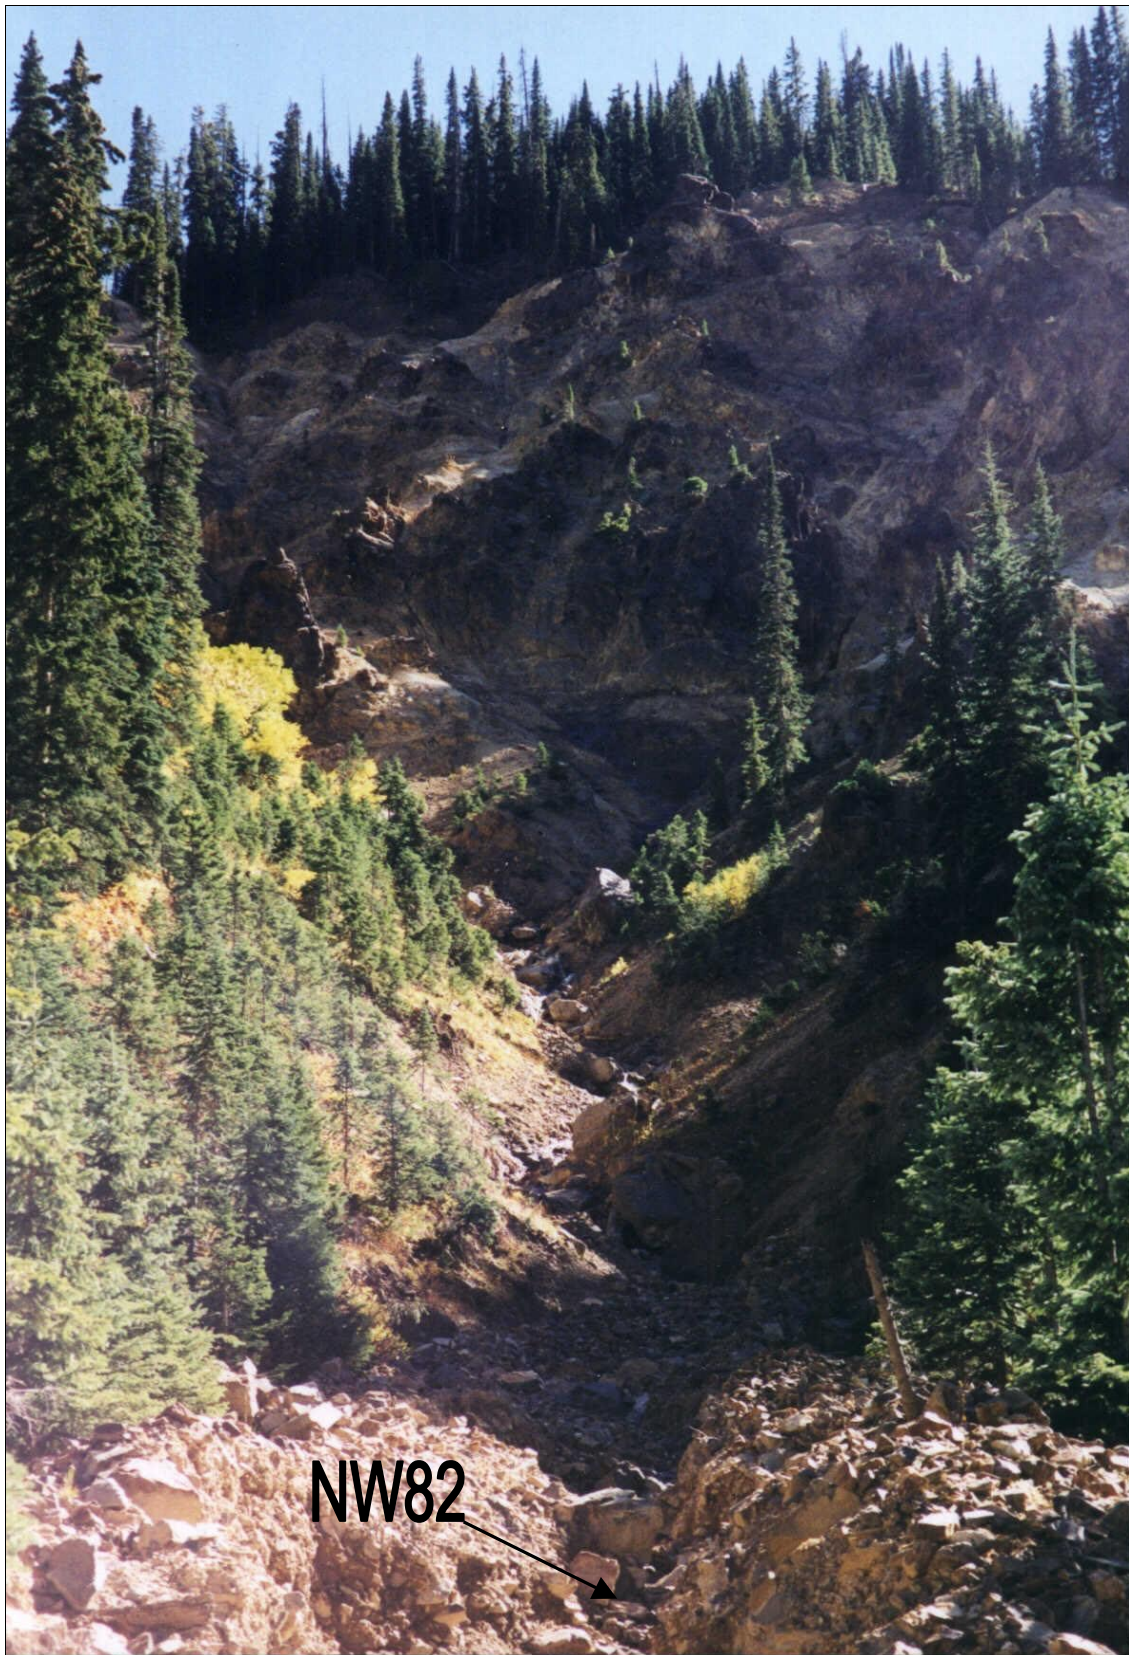
**Figure 35. Photograph showing sample site NW82 at altered gulch draining into Horse Creek. This entire mountainside is mapped as a landslide deposit (Pratt and others, 1969).**

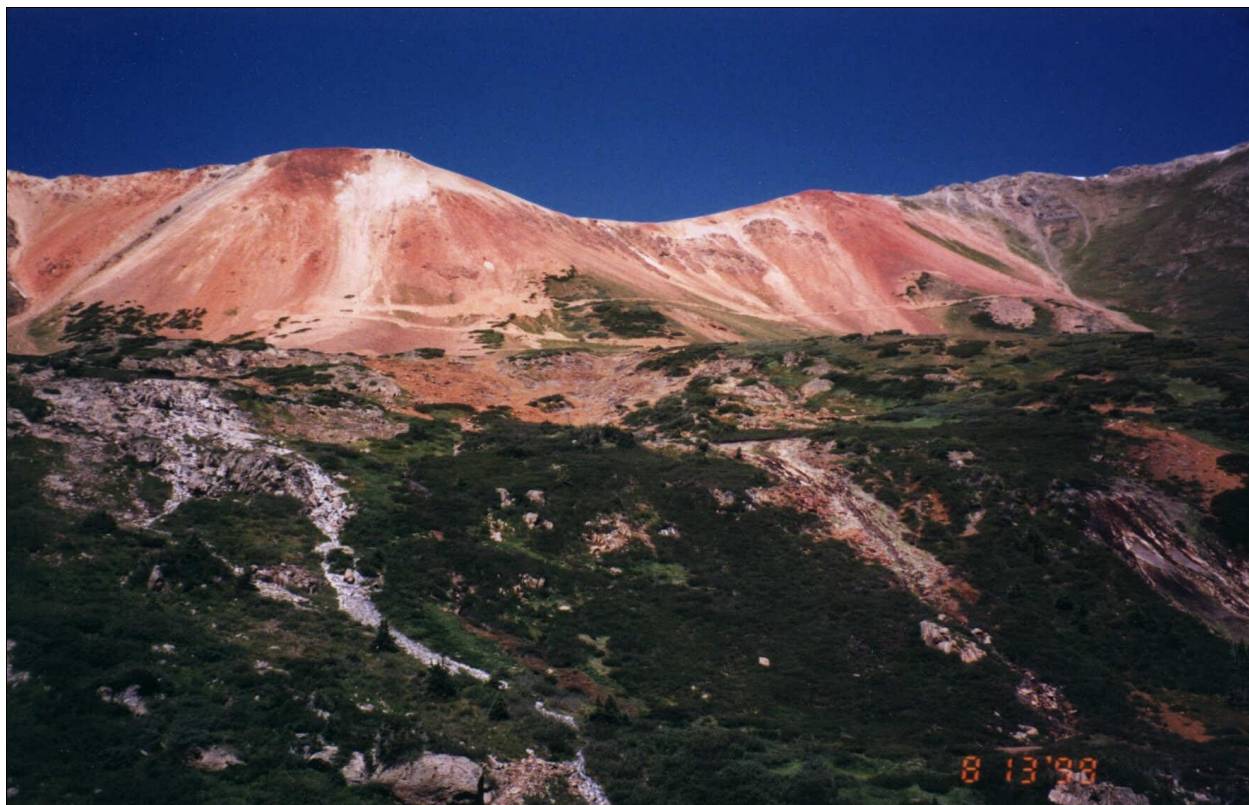
**Figure 36. Photograph showing west side of Peekaboo Gulch. Ferrosinter deposits are on the lower right. White stream shows where aluminum hydroxides precipitate when clean water from upstream begins diluting the acidic, metal-laden spring waters seeping from the walls of the gulch.**

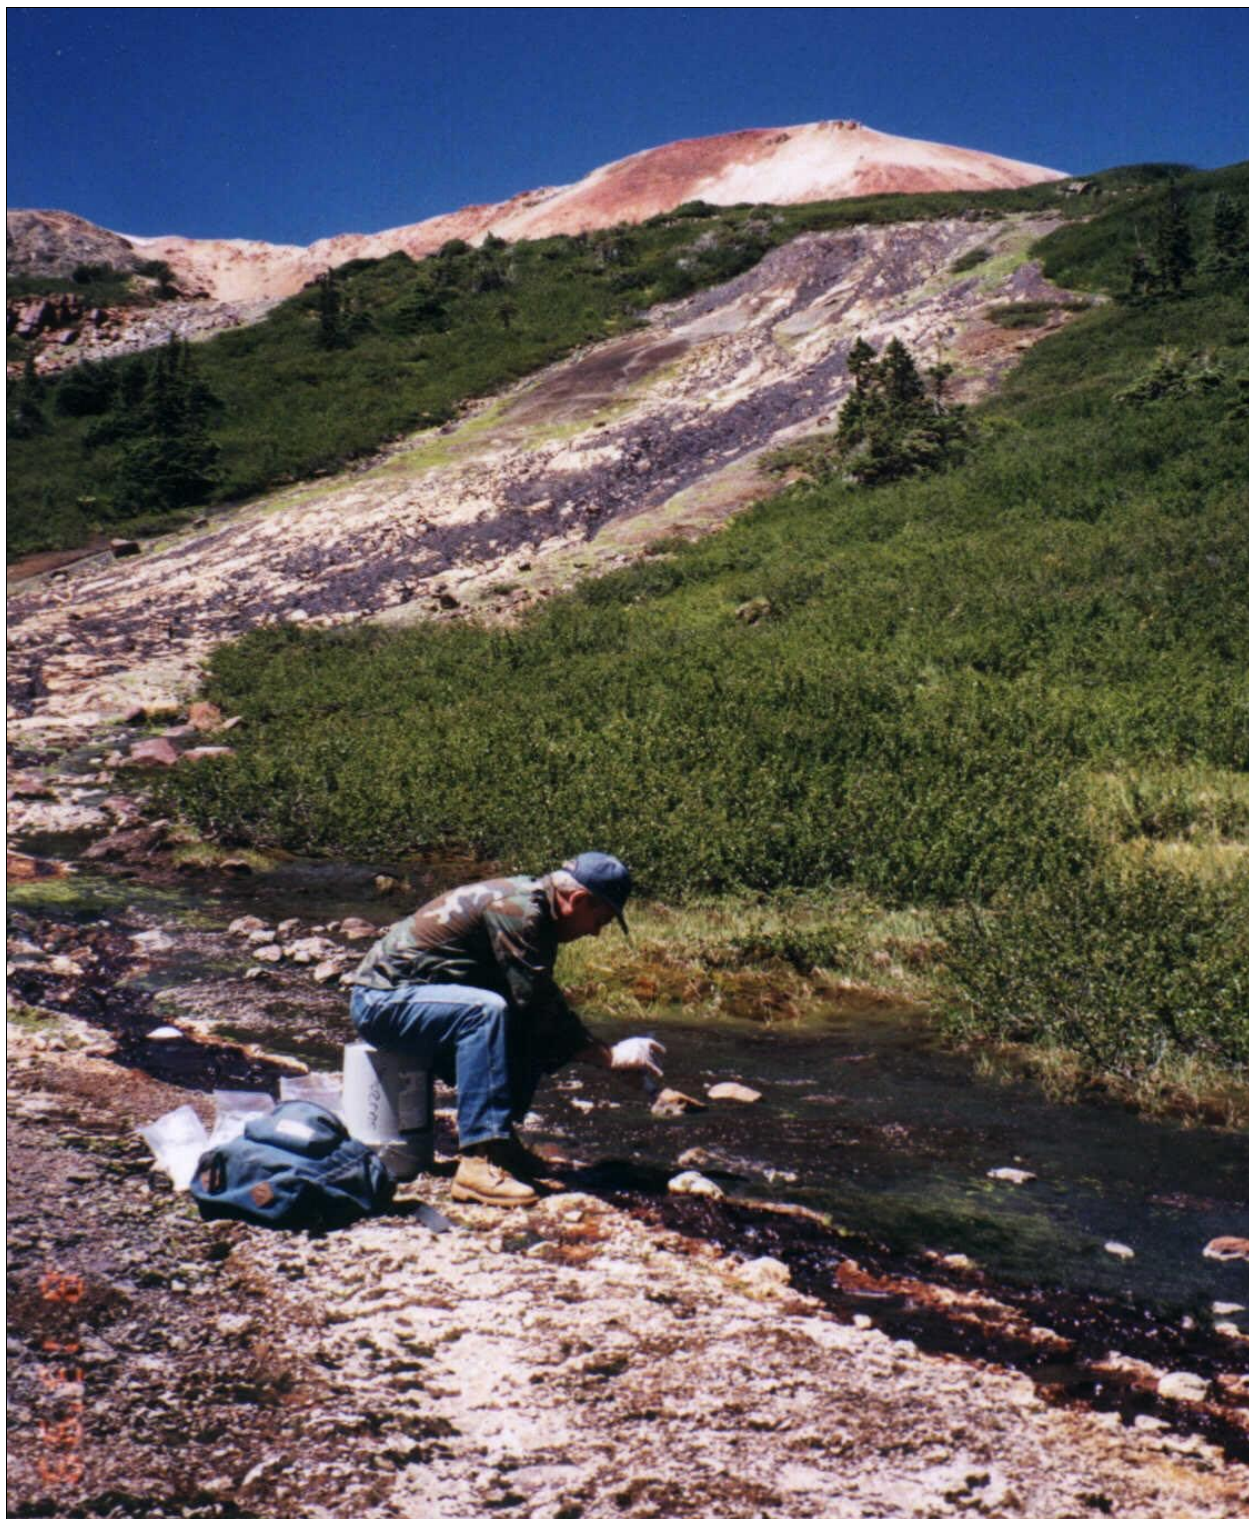
**Figure 38. Photograph showing sample site NW33 and ferrosinter deposit.**

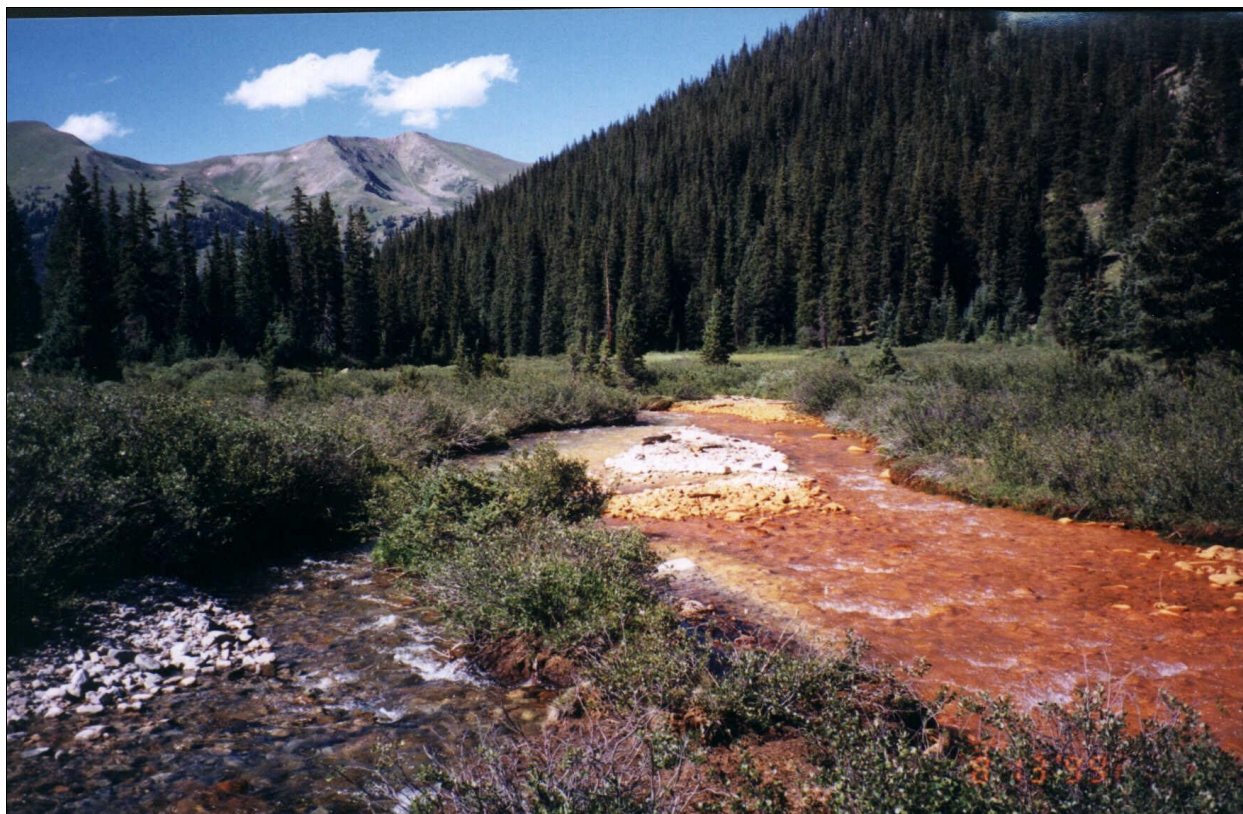
**Figure 40. Photograph showing mixing zone of east fork and Sayres Gulch, looking downstream.**

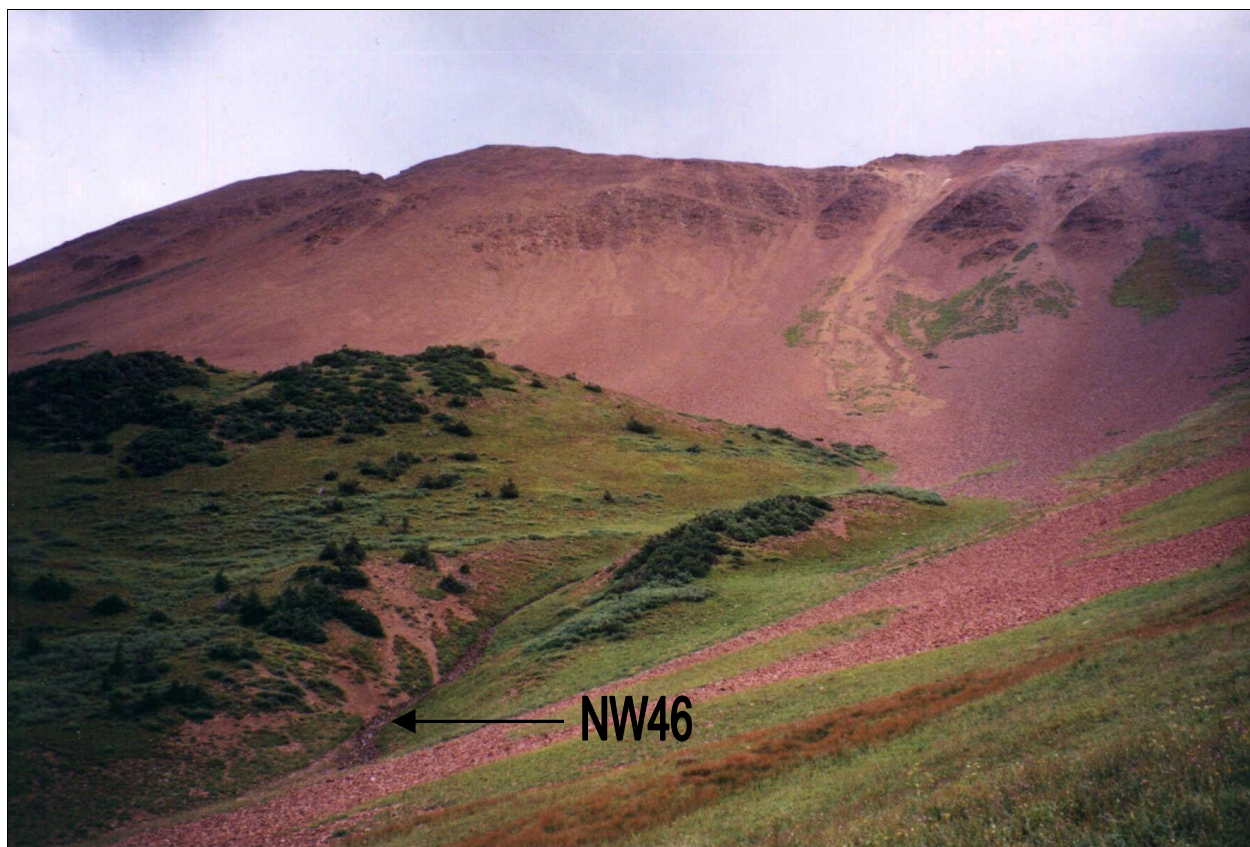
**Figure 41. Photograph showing sample site NW46 and the altered bedrock and talus of Paradise Basin.**

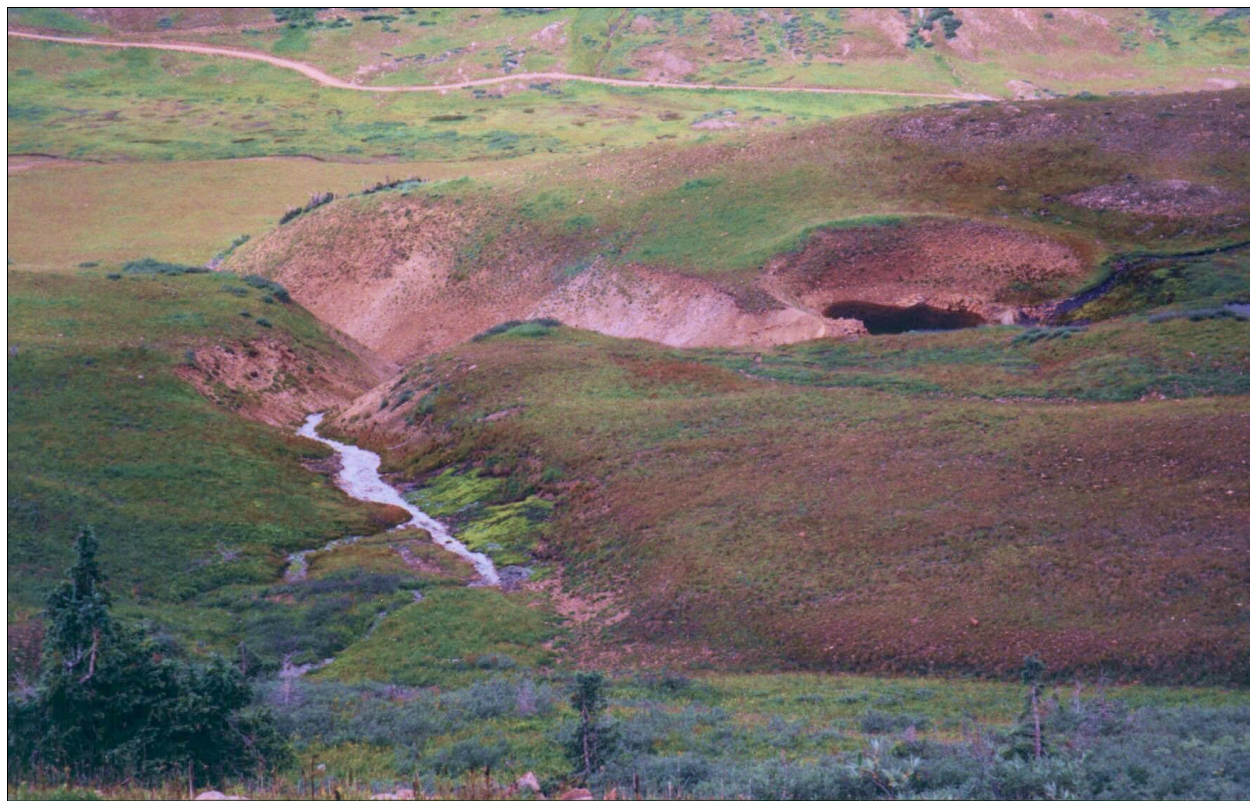
**Figure 43. Photograph showing mixing of waters in Paradise Basin. Sample NW47 was collected from the tributary on the left, above the mixing zone. The series of seeps to the right are acidic.**

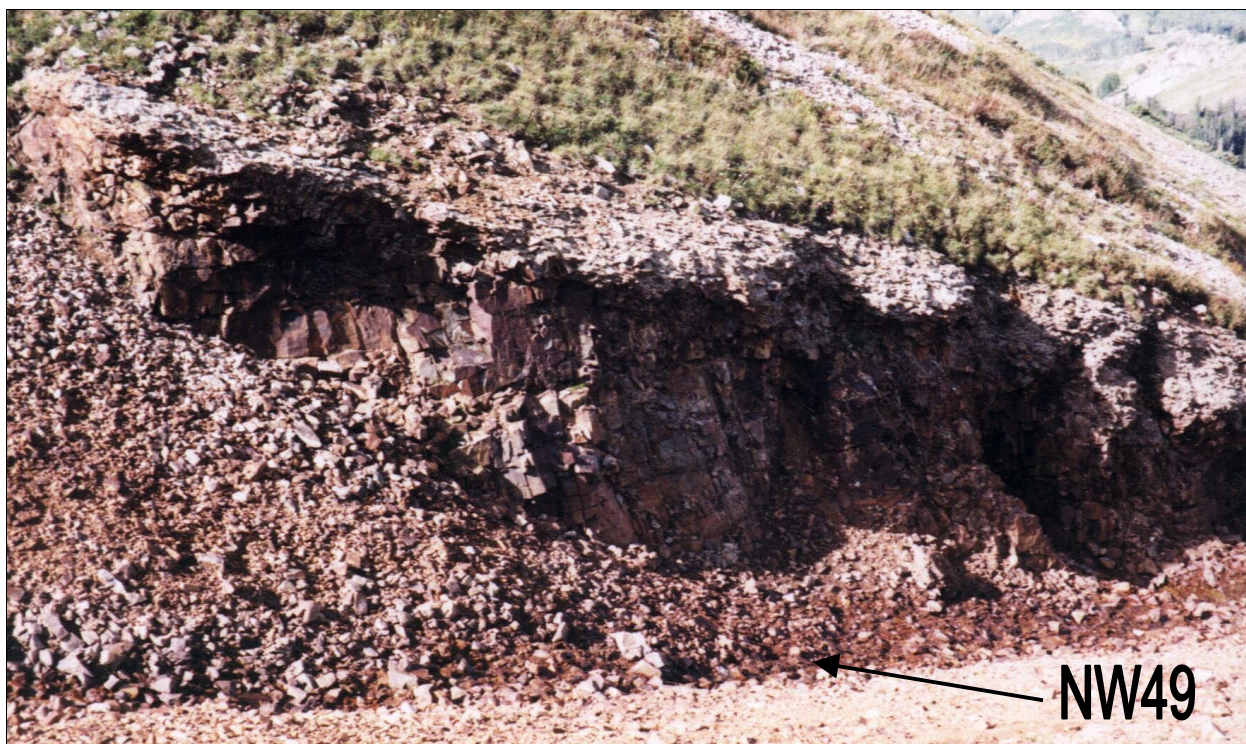
**Figure 45.** Photograph showing sample site NW49 and ferricrete cap rock about 8 feet above the present stream channel in upper Gold Creek.

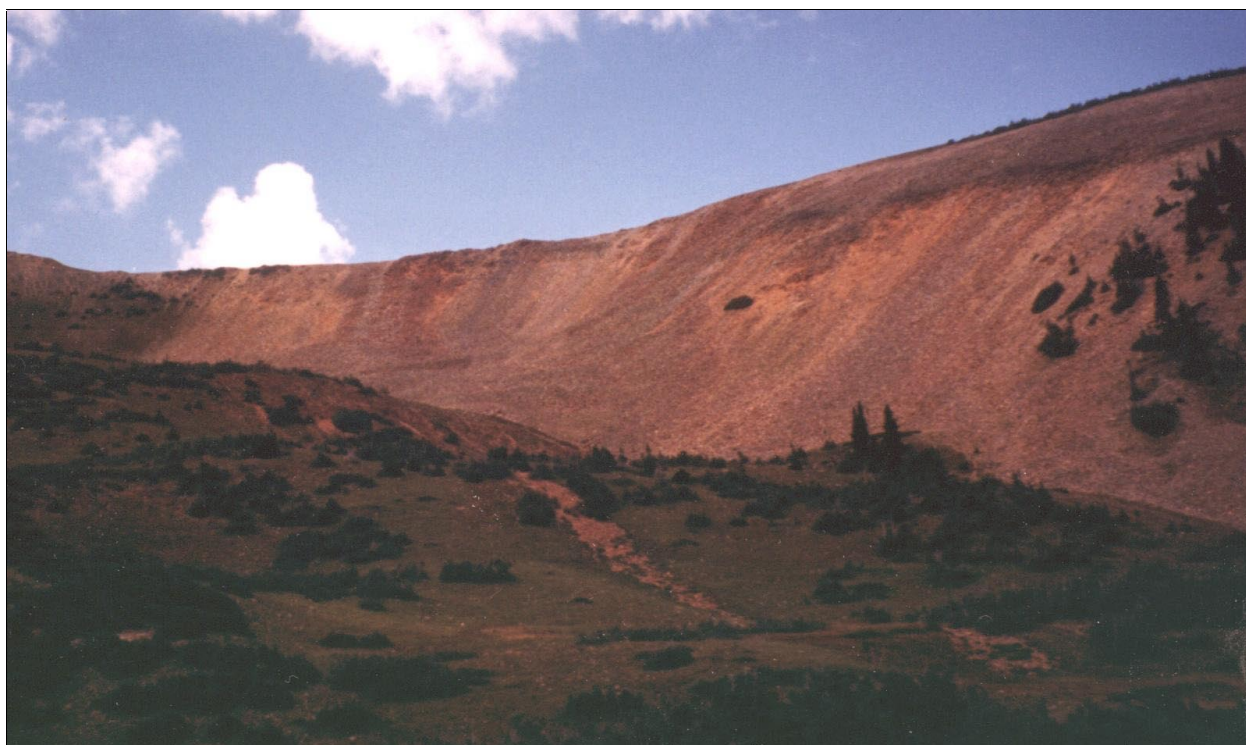
**Figure 46.** Photograph showing altered bedrock and talus in Red Lady Basin.

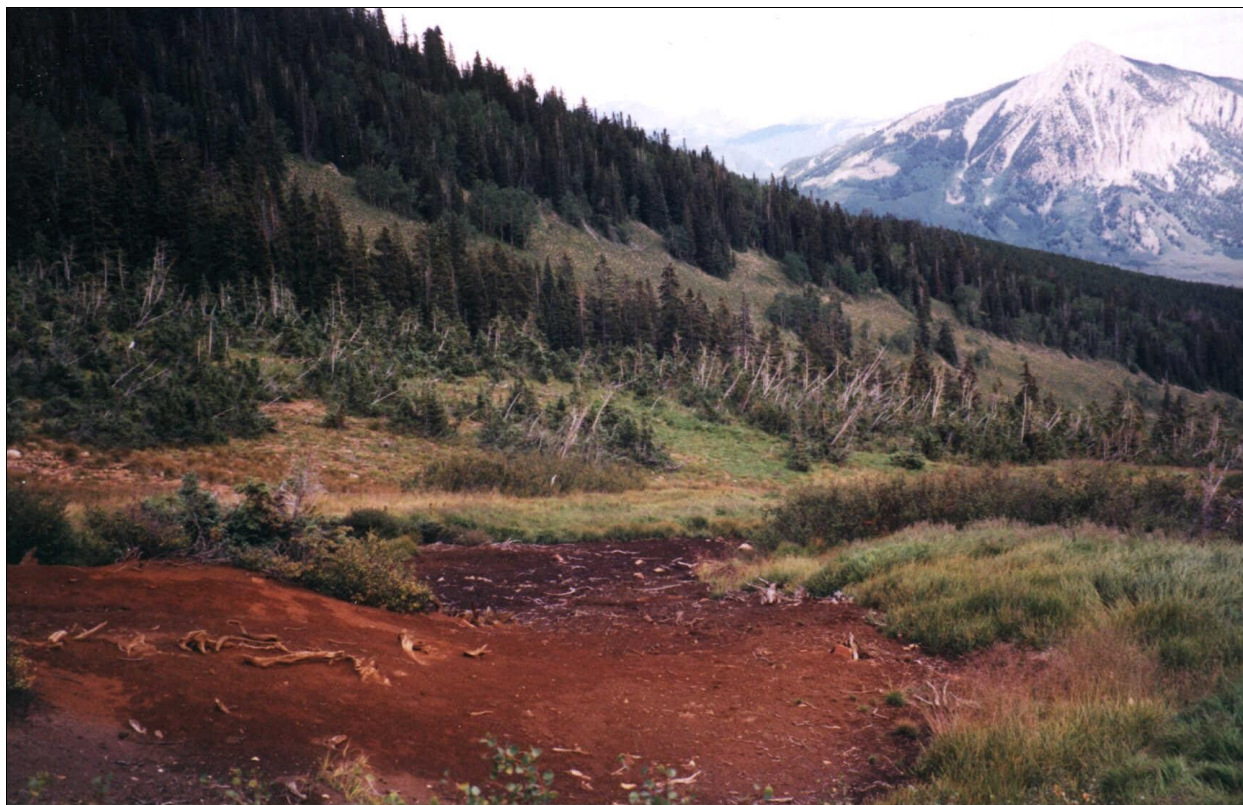
**Figure 47. Photograph showing partly weathered ferrosinter deposit in Red Lady Basin.**
