OPEN-FILE REPORT 00-16

# **Naturally Degraded Surface Waters Associated with Hydrothermally Altered Terrane in Colorado**

By John T. Neubert

Colorado Geological Survey  
Department of Natural Resources  
Denver, Colorado  
2000

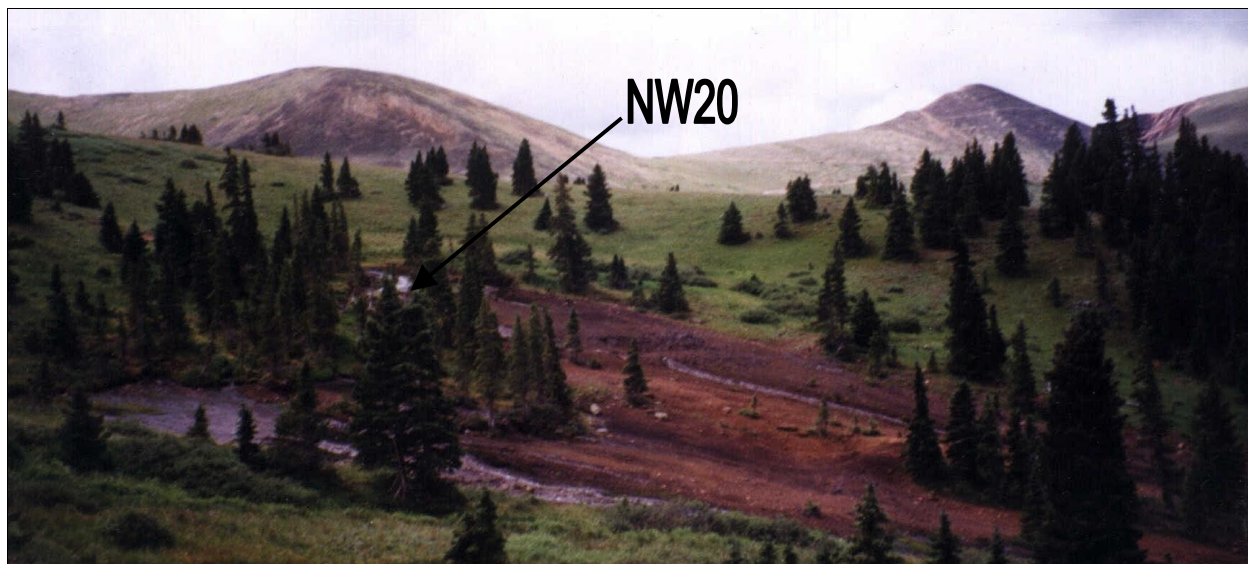
**Figure 53. Photograph showing sample site NW20 at ferrosinter deposit.**

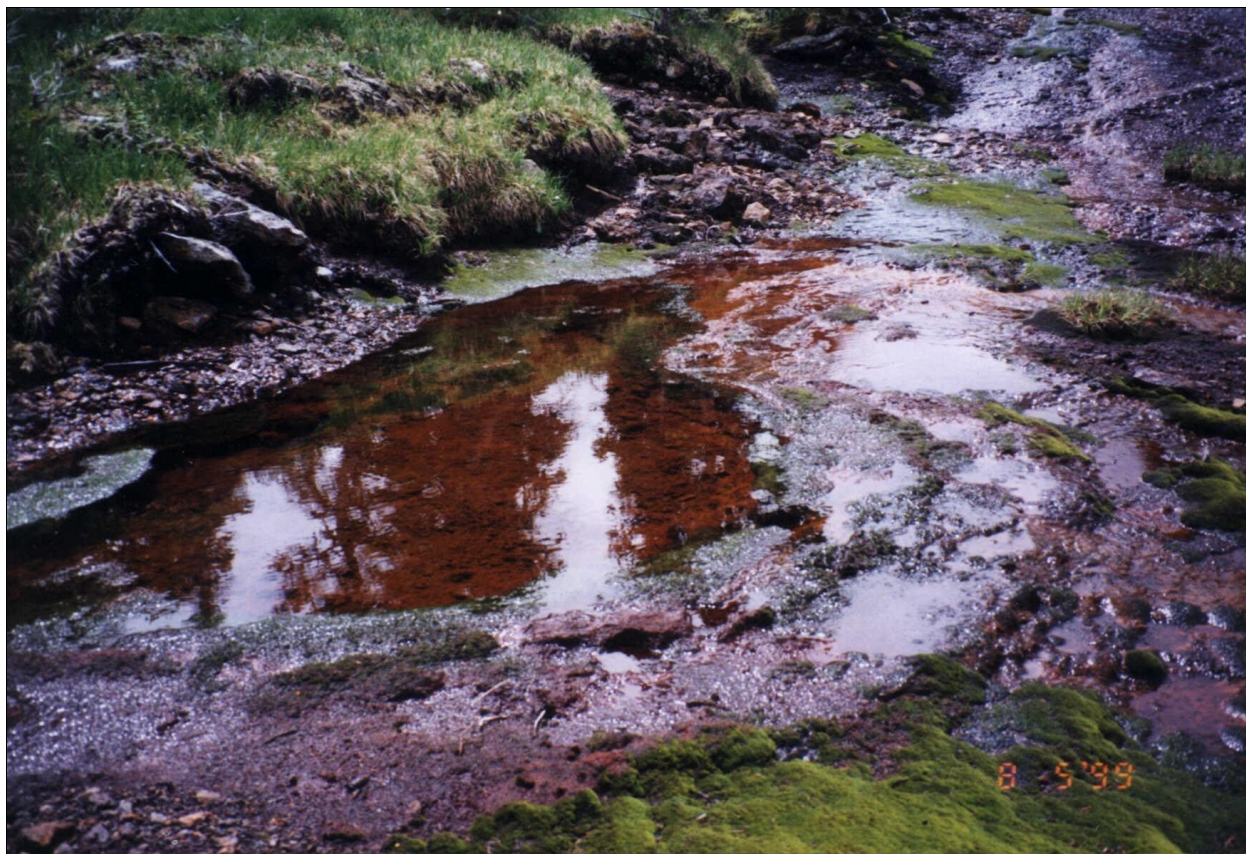
**Figure 54. Photograph showing pool of water in ferrosinter at sample site NW20.**

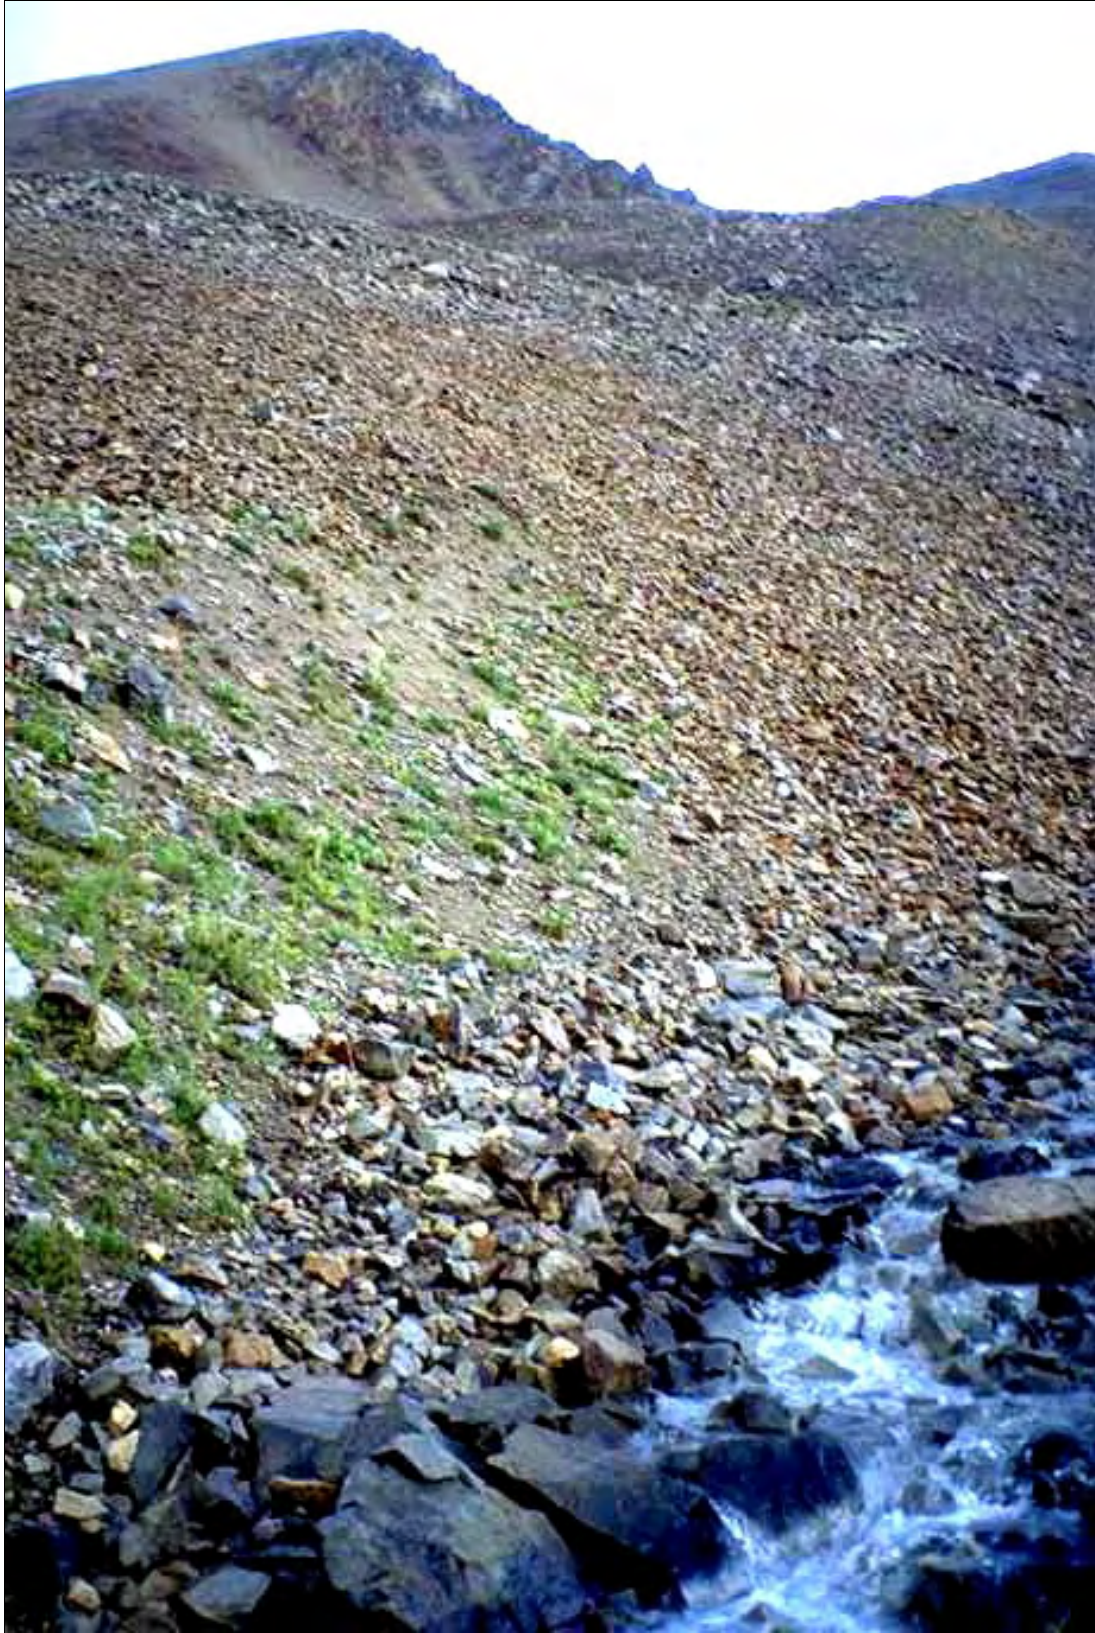
**Figure 56. Photograph showing stream about 20 feet upstream of sample site NW52 and the western flank of Red Amphitheatre.**
