# Neutralization of Acidic Discharges From Abandoned Underground Coal Mines by Alkaline Injection

By William W. Aljoe and Jay W. Hawkins

**Report of Investigations 9468**

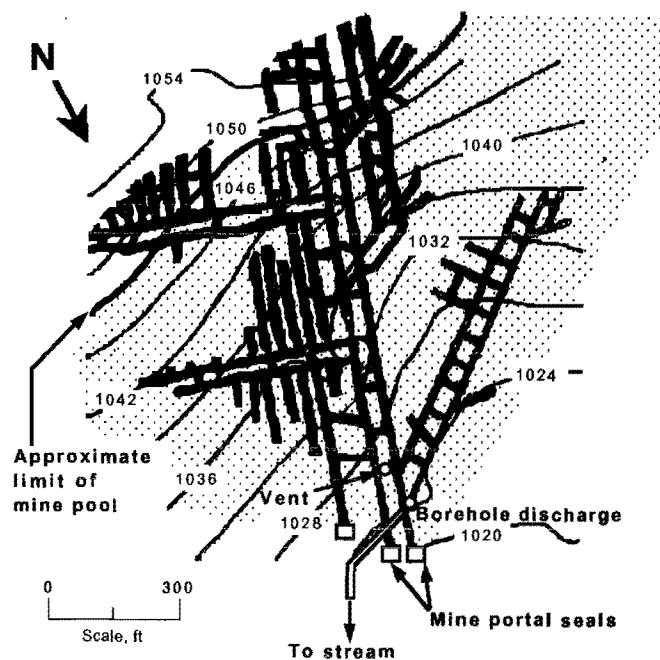
Figure 7.—Mine floor contours and pool limit, Keystone site.

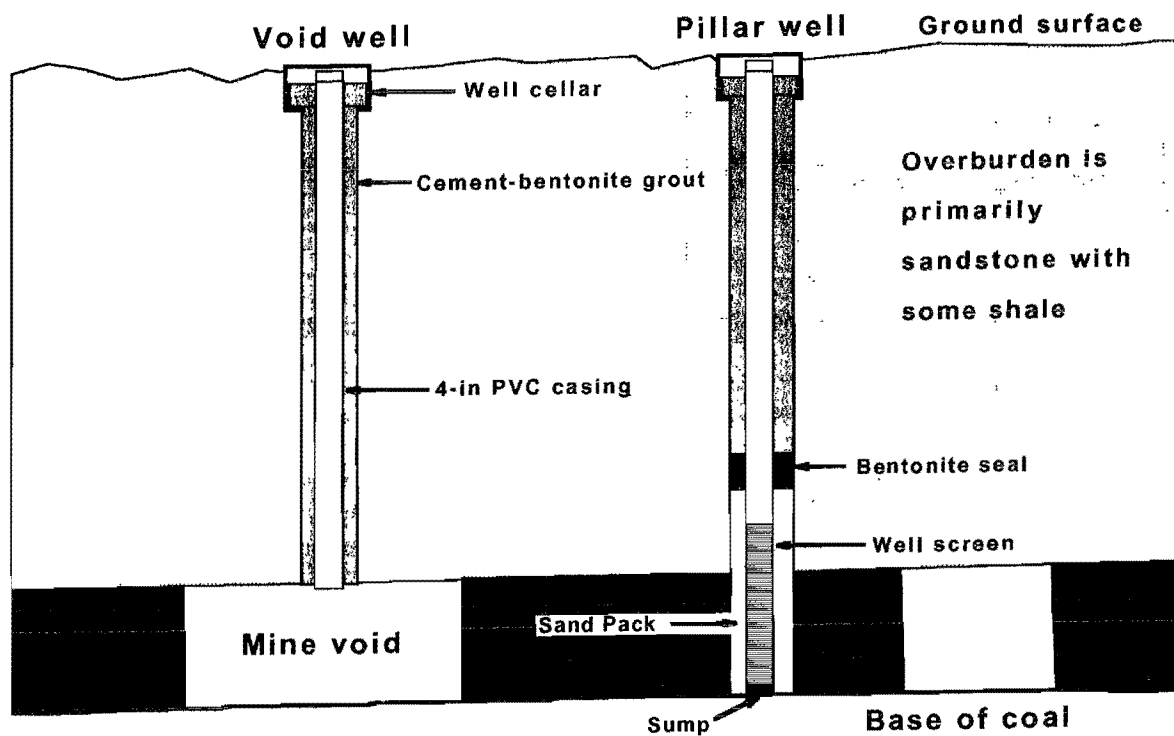
Figure 9.—Mine pool monitoring well construction.

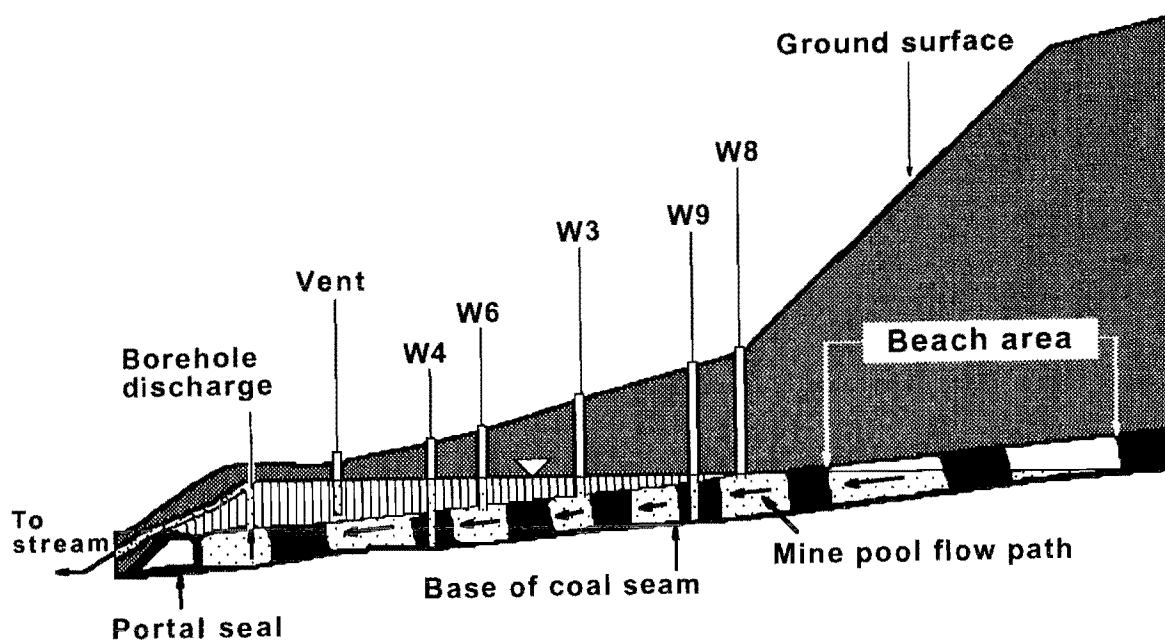
Figure 10.—Cross section of mine pool, Keystone site (vertical exaggeration 3.5:1).

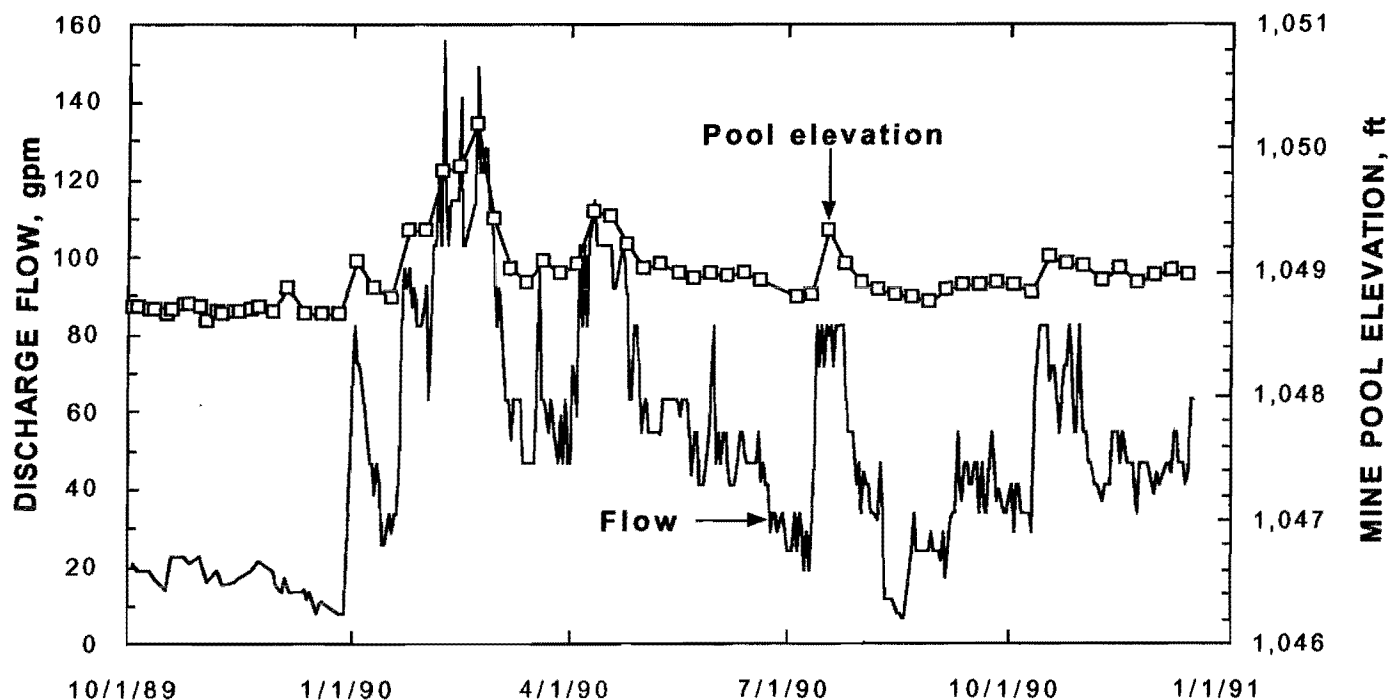
Figure 11.—Mine discharge flows and pool elevations, Keystone site.

Mine discharge flow rates were measured at least twice weekly with a portable flume for a period of more than 1 year. From October 1989 through mid-December 1990 the measured flow rates varied from 7 to 156 gpm, with a mean of 45, standard deviation of 33, and median of 37 gpm. Mine pool elevations were measured at least weekly throughout the study period. The average mine pool elevation showed little variation, fluctuating over a range of only 1.59 ft; however, a strong linear correlation was found between pool elevation and discharge flow rate. Figure 11 shows that the pool elevation and discharge flow rate rose and fell together throughout the study period, while figure 12 clearly illustrates the strong linear correlation (coefficient of determination,  $r^2 = 0.942$ ). This expected functional relationship is determined by both the head in the mine pool and the conditions at the discharge borehole.

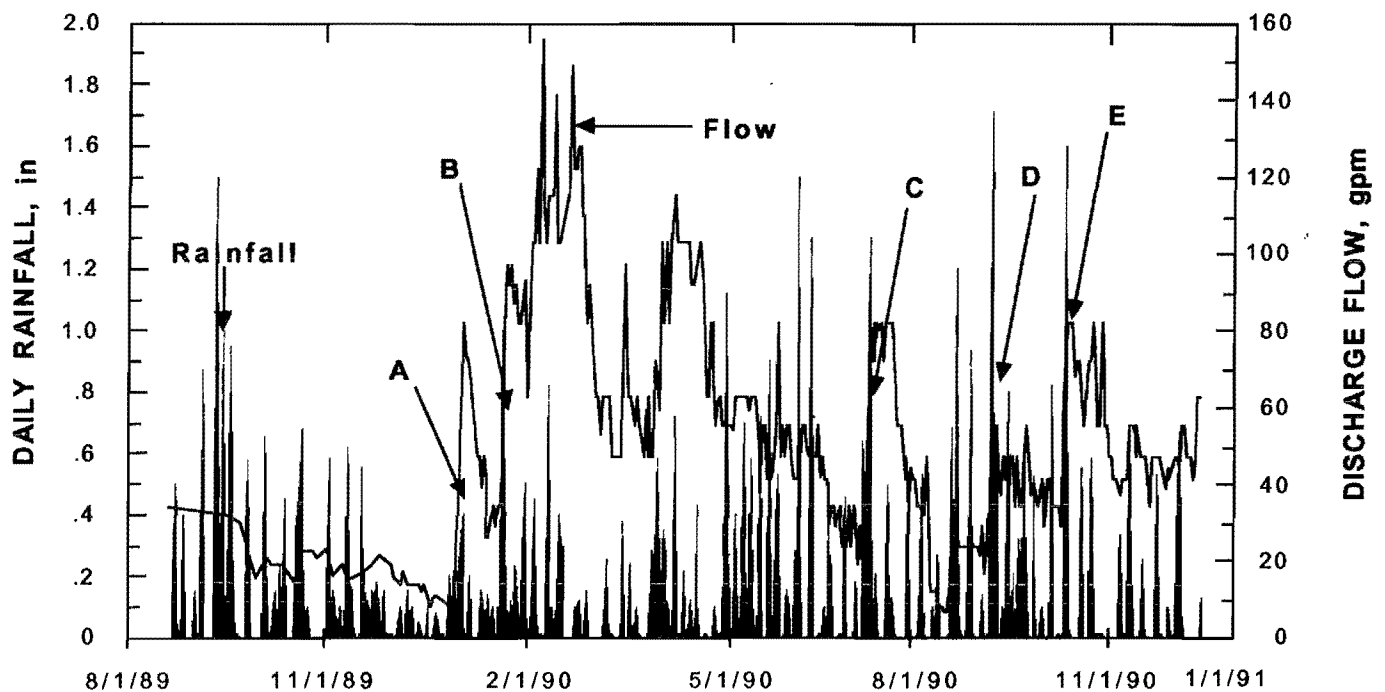
Figure 13.—Mine pool response to precipitation, Keystone site; events A and B denote winter response; events C, D, and E denote summer-fall response.

Note in figure 13 that the response of the mine pool to rainfall was much more pronounced during the winter and spring than during the summer and fall. For example, the pool did not respond significantly to large precipitation events that occurred during October and November 1989. One reason for this lack of response is that precipitation in the summer and fall often occurs in storms of relatively high intensity and short duration. During these events, a higher percentage of rainfall would become surface runoff (and less would infiltrate into the ground) than during events of lower intensity and longer duration. Also, although evapotranspiration rates were not measured, evapotranspiration rates in the Eastern United States are typically highest in the summer months. Therefore, the moisture-retaining capacity of the surface soils, subsoils, and fractures in the unsaturated overburden would have been relatively high in the fall. Much of the precipitation that infiltrated the surface during this time would have served to resaturate the soil and overburden and would not have recharged the mine pool. Conversely, large and

rapid pool responses coincided with rainfall and snowmelt events on December 26, 1989 through January 2, 1990, and January 18-22, 1990, (events A and B in figure 13), despite the fact that these events were no larger than those that had occurred during the fall. Prior to these responses, a steady series of rainfall and snowmelt events may have combined with lower evapotranspiration rates to allow the moisture content of the overburden to approach field capacity. The onset of additional precipitation and infiltration then would have caused rapid recharge to the mine pool and the subsequent increases in pool level and flow. This pattern of large, rapid pool responses continued through April 1990.

During May and June 1990 increased evapotranspiration (longer days and new plant activity) reduced the moisture content of the soil and overburden. The resulting decrease in pool recharge rate was probably responsible for the observed decline in flow during this period, since precipitation remained fairly consistent. However, during early July, September, and October 1990, rainfall events were apparently large and frequent enough to achieve the level of resaturation necessary to permit a noticeable pool response (events C, D, and E in figure 13). Note, however, that the magnitude of the pool response during events A and B was much larger than in events C, D, and E, despite the larger magnitude of precipitation in the latter three events. This supports the notion that the mine pool level

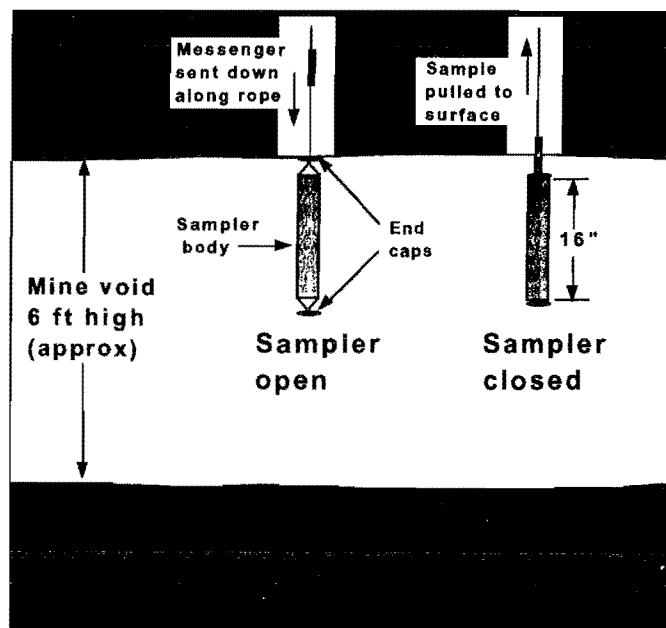
Figure 16.—Interval sampler used in mine voids.

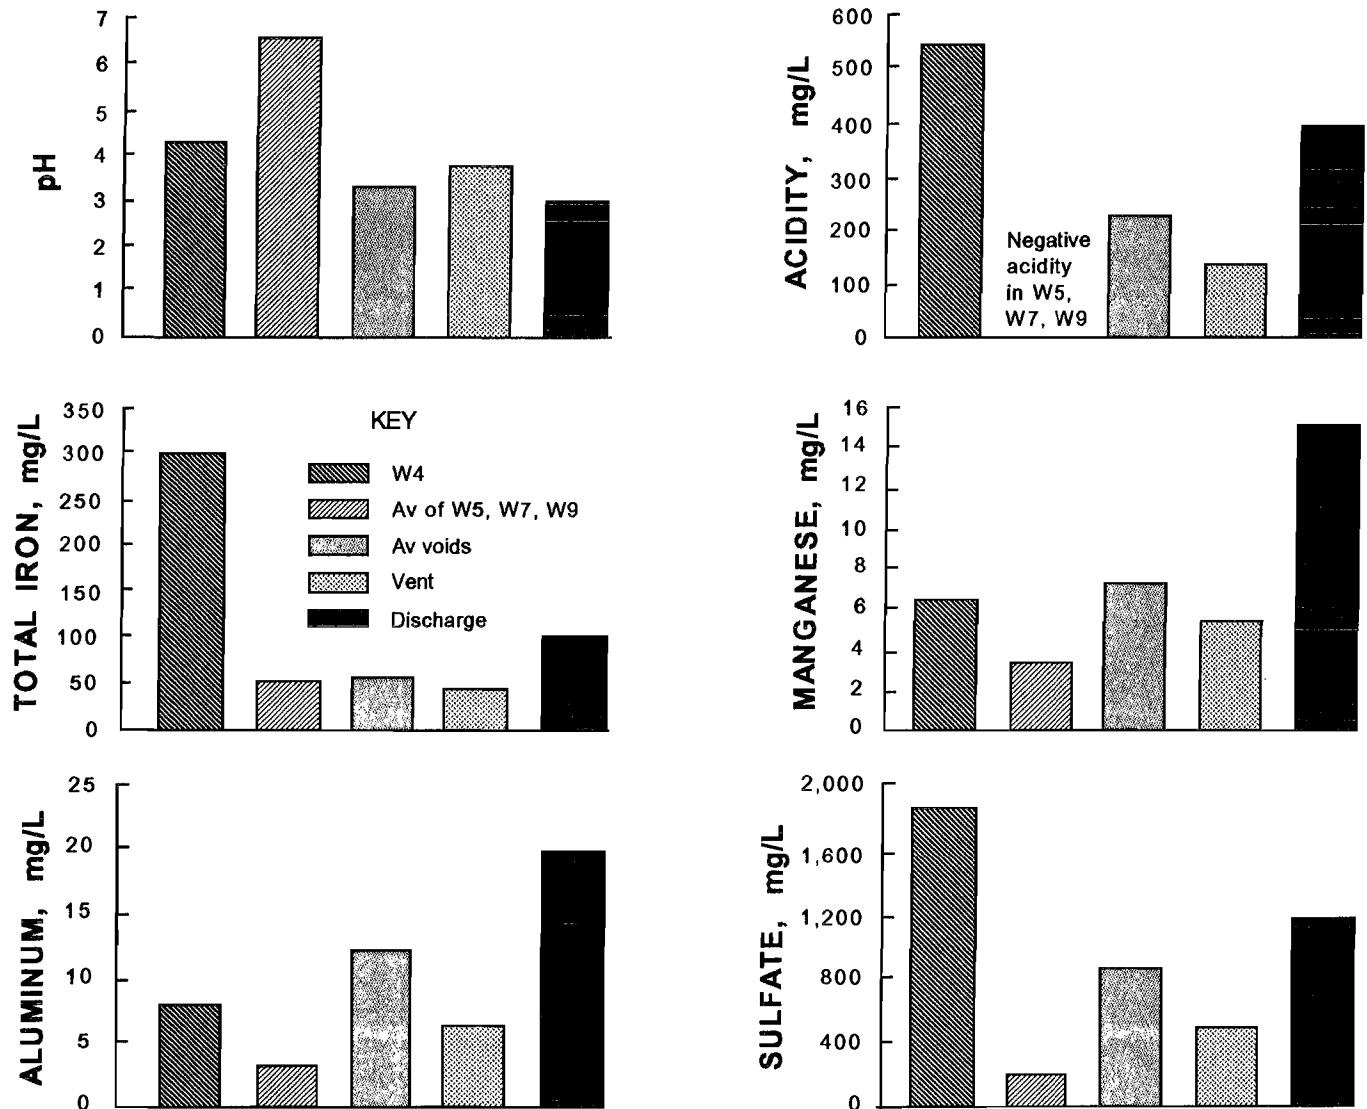
Figure 17.—Average water quality in monitoring wells and mine discharge, Keystone site.

In this regard, the extremely poor water quality of well 4 was quite anomalous. Acidity, total iron, and sulfate concentrations in well 4 were consistently higher than in either the voids or the discharge, while pH was higher and aluminum and manganese concentrations were lower. Clearly, acid mine drainage existed at well 4, but the source of the acidity cannot be accurately identified. For reasons described above, lateral flow from an adjacent contaminated entry was considered unlikely. One possibility is that a localized zone of pyritic overburden or coal existed at well 4. Further research to investigate the cause of the poor water quality at well 4 was beyond the scope of this study.

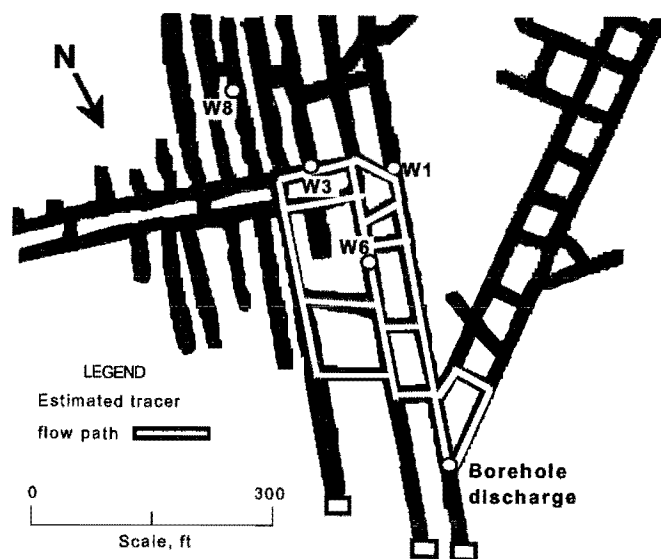
Figure 20.—Estimated flow path of bromide tracer, Keystone site.

Results of the tracer test suggested that flow was not uniform through all open entries. After 92 days of sampling, no trace of bromide was detected at the discharge or at wells 1 or 6, which were on the assumed flow path from well 3 to the discharge. During this time, the mean discharge flow rate was 76 gpm, or 14,644 ft<sup>3</sup>/d; under the uniform flow assumption, the flow velocity in the vicinity of well 3 would have been approximately 25 ft/d. Under these circumstances, traces of bromide would be expected in well 1 after 4 days, well 6 after 10 days, and at the

discharge after 22 days. Obviously, flow was not occurring uniformly through all open entries as first assumed. However, the apparent migration of bromide away from well 3 (fig. 21) indicated that water in that entry was not completely stationary. Immediately after tracer introduction and flushing, a sample taken at the center of the void at well 3 contained 468 mg/L of bromide; after 92 days, the concentration had declined to less than 1.0 mg/L (fig. 21). This decline could not be attributed to molecular diffusion because the initial bromide concentration was too dilute to produce significant solute movement via diffusion (16). Therefore, it was concluded that some flow, albeit slow, was occurring in the entry penetrated by well 3.

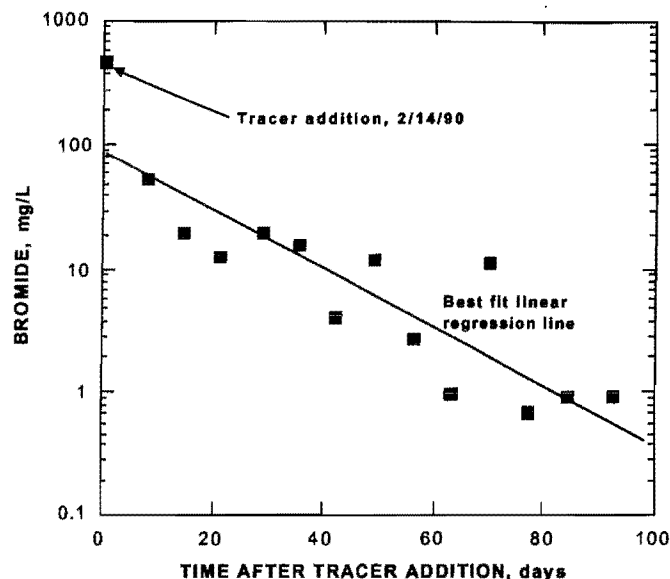
Figure 21.—Decline of bromide concentrations at well 3, Keystone site.

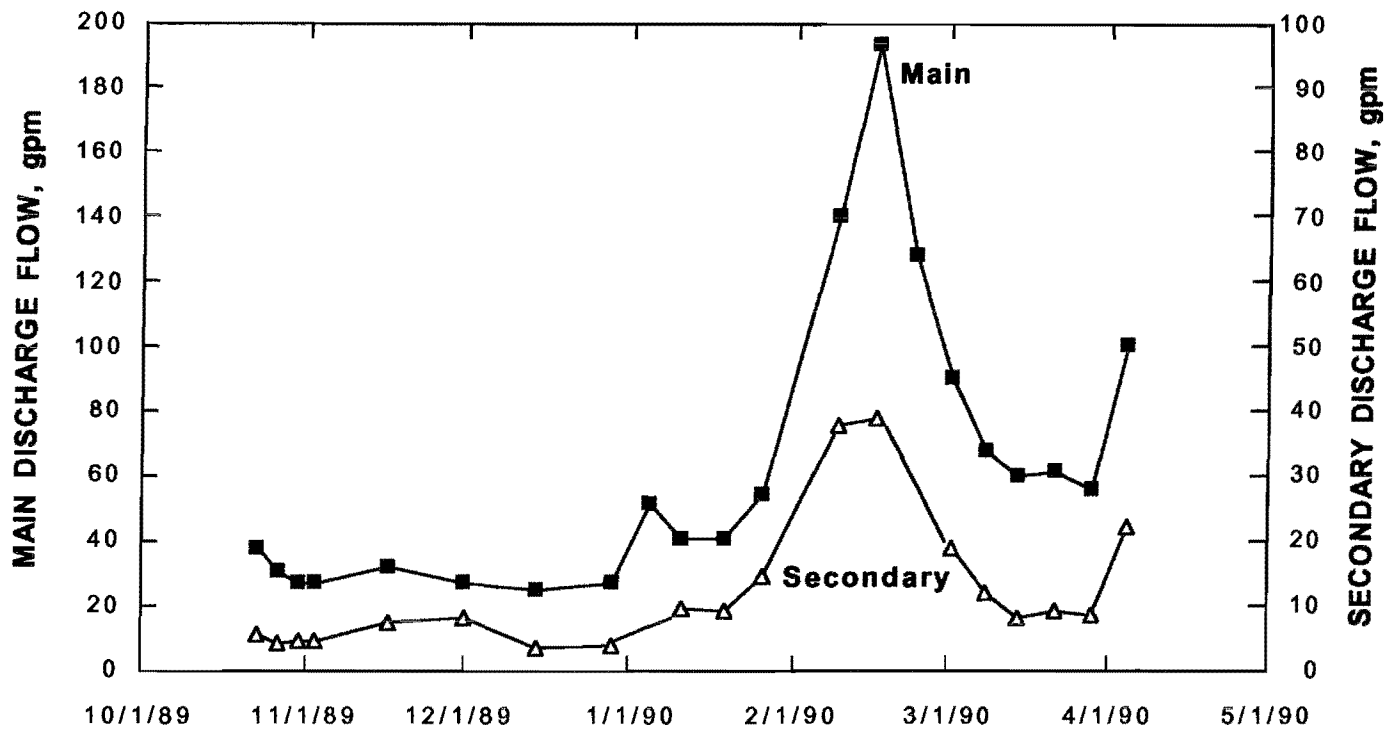
Figure 25.—Mine discharge flow rates, Friendship Hill site.

Figure 25 shows the flow rates of the two measured discharges over the 5-month period when secondary discharge flow rates were measured. The strong positive correlation between the flow rates at the main and secondary discharges (figure 26,  $r^2 = 0.832$ ) supported the assumption that the two were connected to the same mine

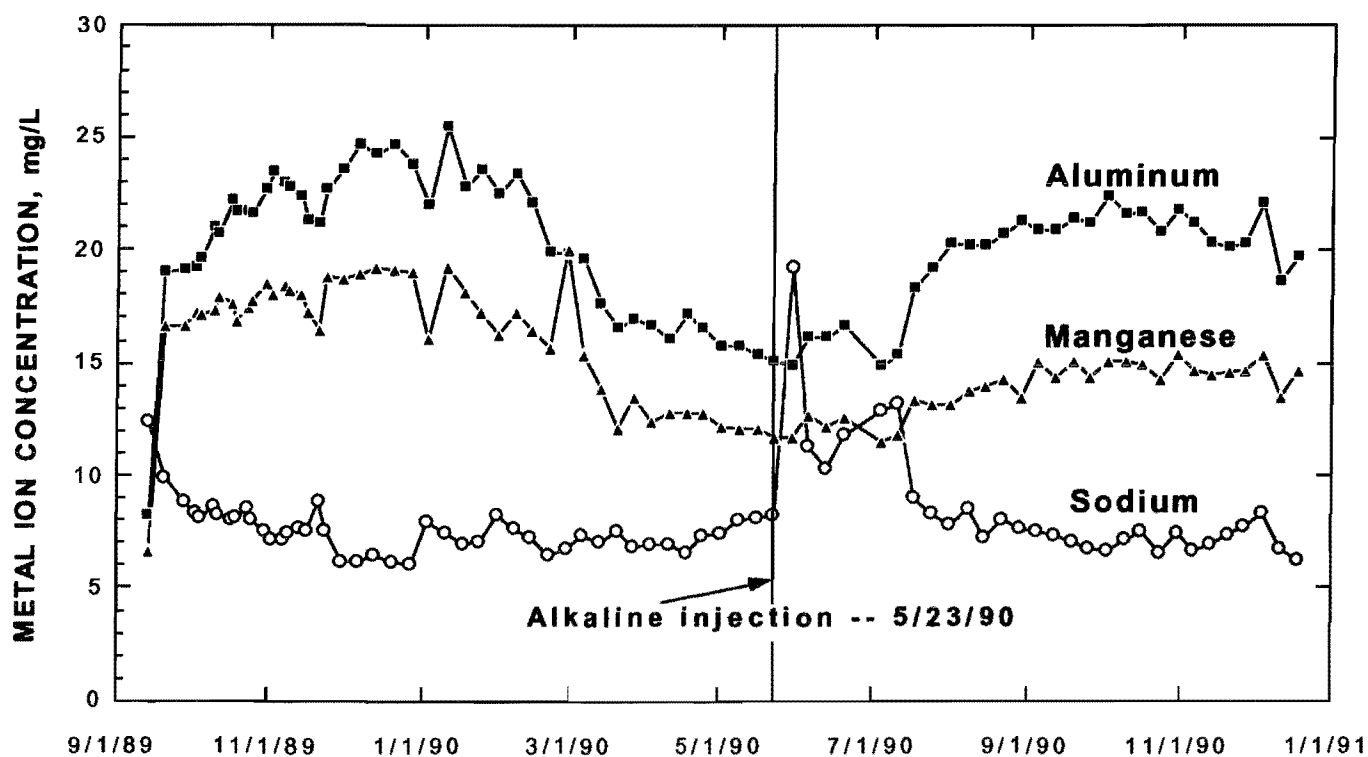
Figure 37.—Aluminum, manganese, and sodium concentrations at mine discharge, Keystone site, before and after alkaline injection.

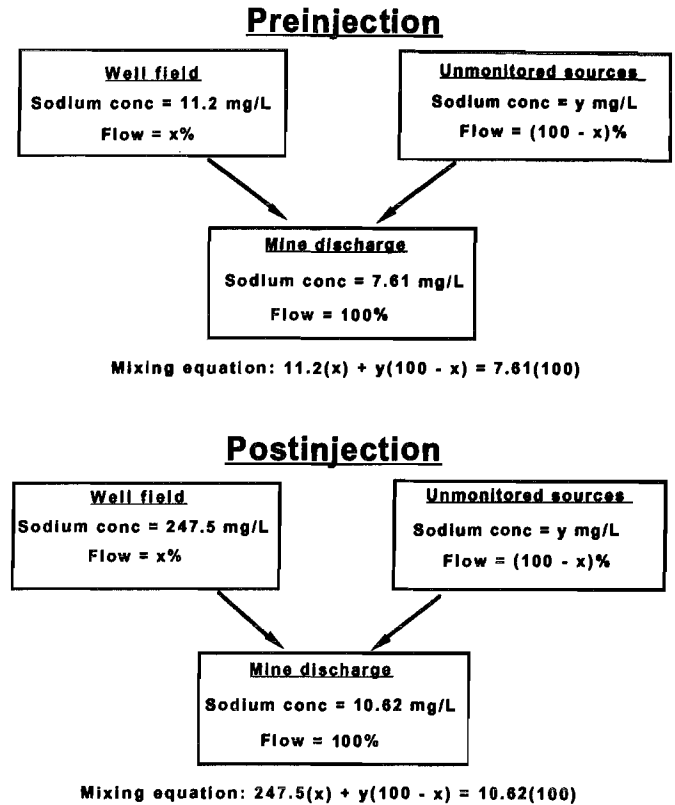
Figure 39.—Diagram of hypothetical sodium mixing process, Keystone site.
