## **PCBs, MINING, AND WATER POLLUTION**

**Dan W. Bench B.Sc., Min. Eng.**

Region 8 PCB Coordinator  
U.S. Environmental Protection Agency  
999 18<sup>th</sup> Street  
Denver, Colorado 80202-2466

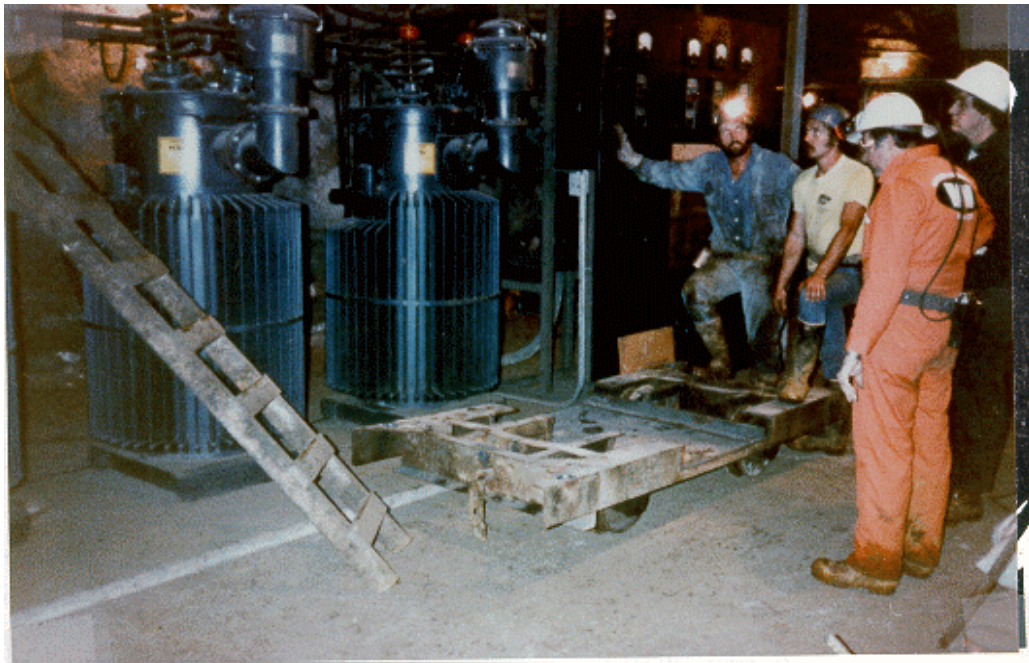
Figure 1.  
76 Gallon PCB (Pyranol) Transformers (Cylindrical Objects with Cooling Fins and PCB Marks) on the 20 level of the Eagle Mine at Gilman, Colorado during an EPA removal due to abandonment and flooding.

Underground mines are emphasized here because abandoned PCB-containing equipment is likely to cause water pollution that can affect the environment and the health of downstream fish, and wildlife, and human populations. PCBs are most likely to be in transformers, as shown in Figure 1, drums of used transformer oils, capacitors, as shown in Figure 2, and fluorescent light ballasts. Transformers may be grouped in permanent substations, located singly, or mounted on mine cars that can be transported throughout the working areas of the mine. Capacitors are generally found in locations similar to those of transformers. PCB-containing capacitors have been found in electric locomotives. In coal mines, capacitors are often in wheel or skid-mounted power centers as shown in Figure 3. The PCB regulations require these items be identified by PCB marks (or labels) if they contain 500 ppm (0.05%) or more PCBs and they are termed PCB transformers or capacitors.

In 1984, Region 8 conducted an Immediate Removal Action, under the Comprehensive Environmental Response Compensation and Liability Act (CERCLA)<sup>21</sup> (or the "Superfund" law) in which the author participated in the Eagle Mine at the town of Gilman, a few miles from Vail, Colorado. CERCLA regulates cleanup of uncontrolled or abandoned hazardous-waste sites. The mine consisted of a 400 ft vertical shaft from the surface to the 16 level, the main haulage level. From the 16 level there are two inclines, the 1620 and the 1623, both servicing the 20 level. Levels were 100 ft vertically apart. Below the 20 level, the mine was flooded to the bottom at the 28 level. The mine consisted of about 100 miles of drifts<sup>22</sup>, most of which were inaccessible due to flooding, bad air, and an active fire encompassing the 1623 incline. The entire mill with PCB-containing electrical equipment was underground, so that only concentrates destined for a smelter and tailings left the mine. The owner had been advised in writing by EPA to remove the PCB-containing electrical equipment from areas of the mine in danger of flooding before funds became insufficient to maintain the pump station at the 20 level. No action had been taken when the electrical service was discontinued. EPA assumed the electrical bills and removed three 76-gallon Pyranol (PCB) transformers and 27 large Pyranol capacitors during a three-day operation. Three previously drained 76-gallon Pyranol transformers were left at the 1623 incline substation because of the hazards and cost of removal from an active fire area. Whether or not PCB-containing electrical equipment

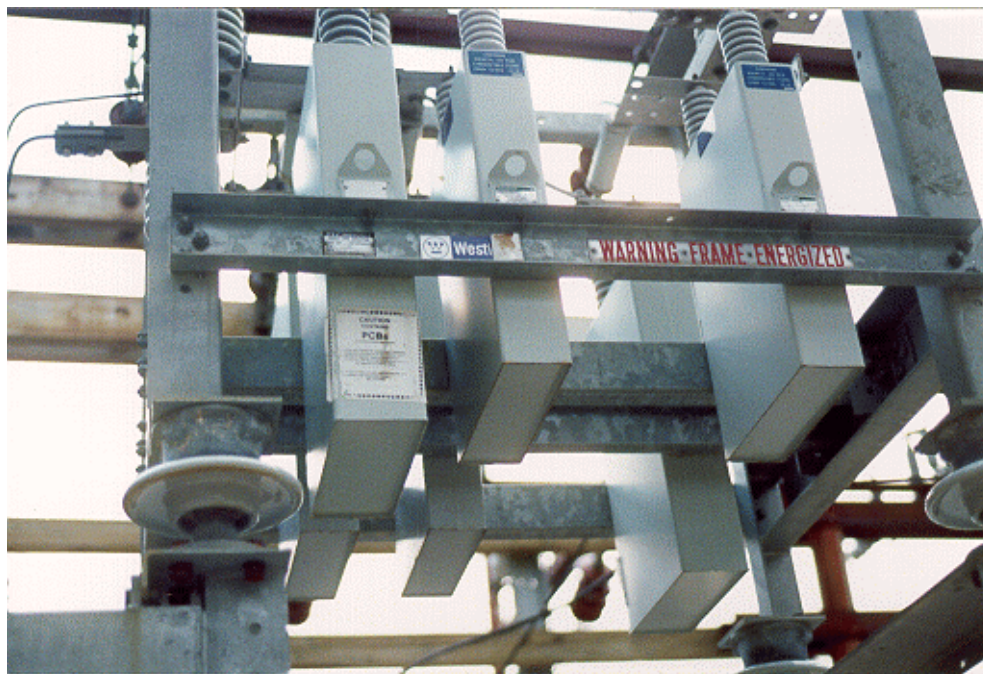
Figure 2.  
Looking up at PCB Marked Capacitor on the left

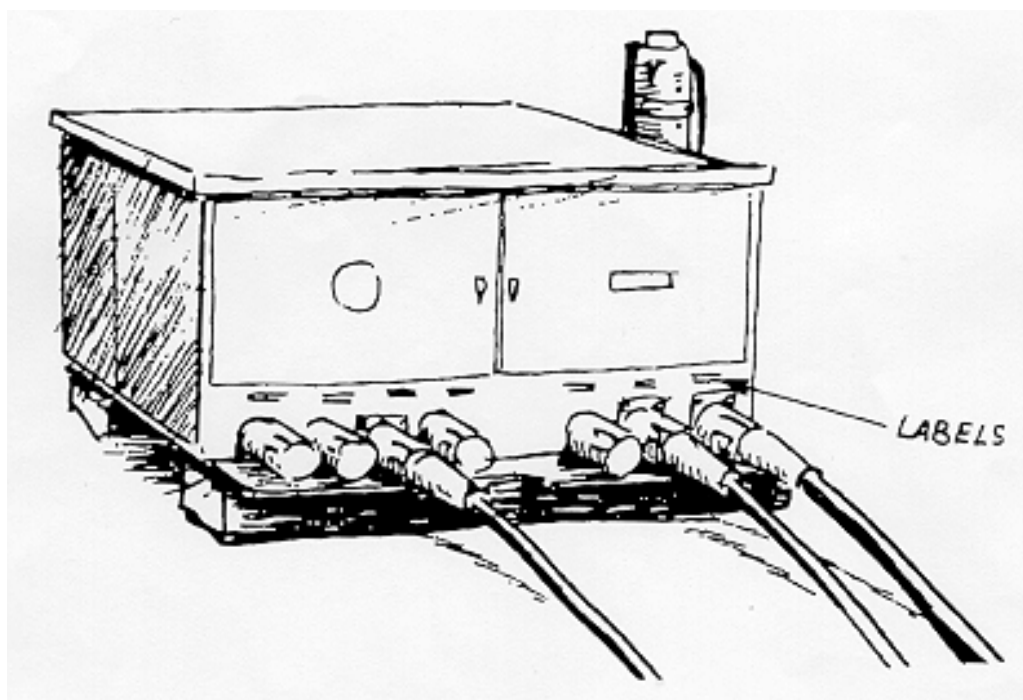
Figure 3.  
Mine Power Center Commonly Containing Capacitors

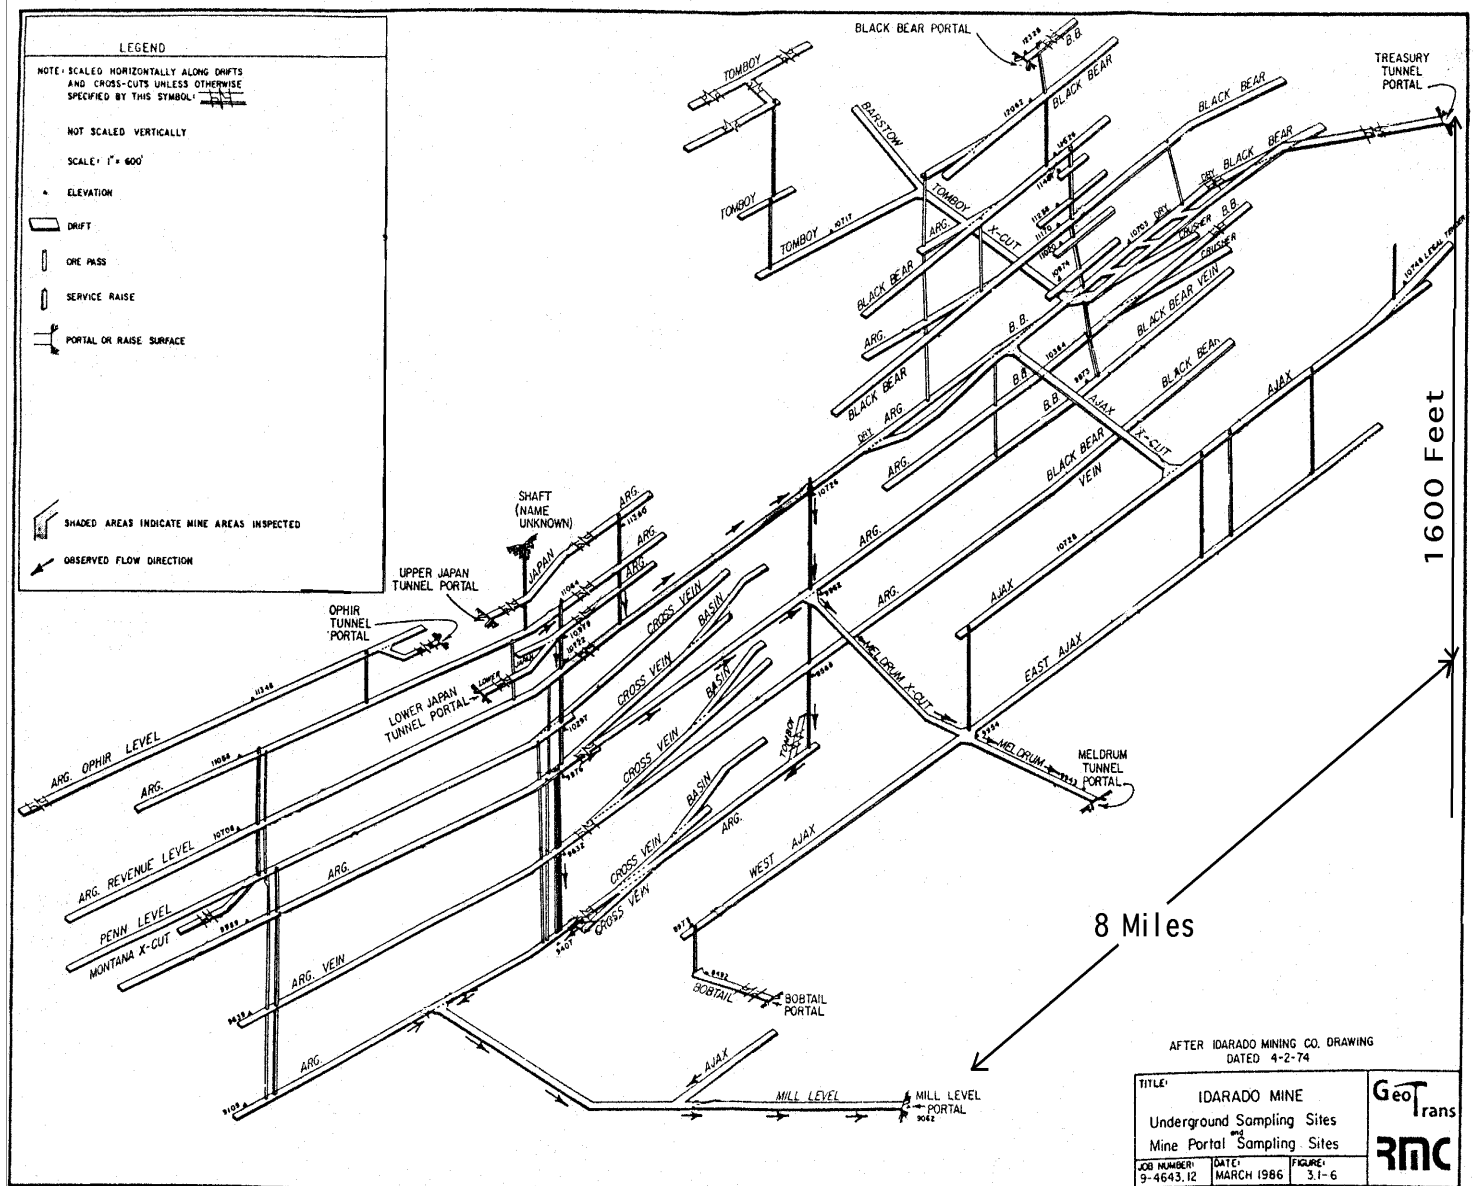
Figure 4.  
Idarado Mine, Telluride, Colorado

[Note water drains from the upper levels to the Meldrum, Bobtail, and Mill Level Portals which contribute to the San Juan River. There are no shafts or winzes with bottoms for PCBs to sink to.] The distance "as the crow flies" between the Treasury Tunnel Portal, at the top of Red Mountain Pass on the Million Dollar Highway, in the upper right-hand corner, and the Mill Level Portal at Telluride, near the bottom center, is about eight miles. Only entries, major haulage drifts, and winzes appear on the map. The mining areas are not shown. This mine was confirmed to have PCB-containing electrical equipment underground during an EPA inspection in 1984.

Mines can be very extensive and complex. To illustrate this, Figure 4 is a map of the Idarado Mine
