# MINING Environmental MANAGEMENT

## PCBs, mining and water pollution

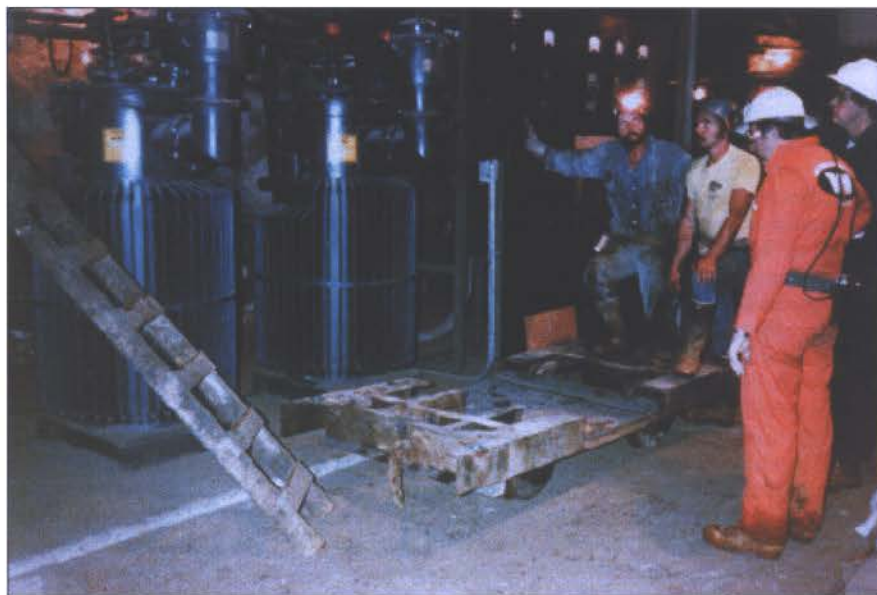
*76-gallon PCB transformers (the cylindrical objects with cooling fins and PCB marks) on the 20 level of the Eagle Mine at Gilman, Colorado during an EPA removal due to abandonment and flooding.*

Underground mines are emphasised here because abandoned PCB-containing equipment is likely to cause water pollution that can affect the environment and the health of downstream fish, and wildlife, and human populations. PCBs are most likely to be in transformers, as shown in Figure 1, drums of used transformer oils, capacitors and fluorescent light ballasts. Transformers may be grouped in permanent substations, located

In 1984, Region 8 conducted an Immediate Removal Action, under the Comprehensive Environmental Response Compensation and Liability Act (CERCLA)<sup>18</sup> (or the 'Superfund' law) in which the author participated in the Eagle mine in Colorado. CERCLA regulates cleanup of uncontrolled or abandoned hazardous-waste sites. The mine consisted of a 122-m vertical shaft from the surface to the 16 level, the main haulage level. From the 16 level there are two inclines, the 1620 and the 1623, both servicing the 20 level. Levels were 30 m vertically apart. Below the 20 level, the mine was flooded to the bottom at the 28 level. The mine consisted of about 160 km of drifts<sup>19</sup>, most of which were inaccessible due to flooding, bad air, and an active fire encompassing the 1623 incline. The entire mill with PCB-containing electrical equipment was underground, so that only concentrates destined for a smelter and tailings left the mine. The owner had been advised in writing by EPA to remove the PCB-containing electrical equipment from areas of the mine in danger of flooding before funds became insufficient to maintain the pump station at the 20 level. No action had been taken when the electrical service was discontinued. EPA assumed the electrical bills and removed three 76-gallon Pyranol (PCB) transformers and 27 large Pyranol capacitors during a three-day operation. Three previously drained 76-gallon Pyranol transformers were left at the 1623 incline substation because of the hazards and cost of removal from an active fire area. Whether or not PCB-containing equipment remains in the accessible portions of the mine and below the 20 level is unknown. This lack of information is typical of abandoned or flooded portions of mines. Although this operation may appear hazardous, the risks were known and controlled, and MSHA inspectors were present throughout the entire removal. If there had not been an EPA inspection, the PCB transformers and capacitors would have been undetected, and today would be under more than 215 m of water that drains into the Colorado River.

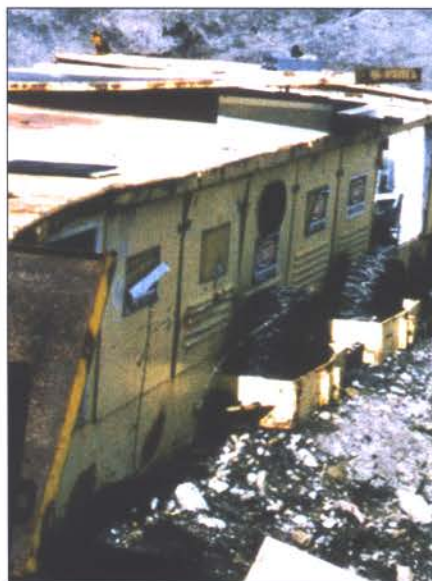
Mine Power Center Commonly Containing Capacitors

singly, or mounted on mine cars that can be transported throughout the working areas of the mine. Capacitors are generally found in locations similar to those of transformers. PCB-containing capacitors have been found in electric locomotives. In coal mines, capacitors are often in wheel or skid-mounted power centres. The regulations require these items be identified by PCB marks (or labels) if they contain 500 ppm (0.05%) or more PCBs and they are termed PCB transformers or capacitors.

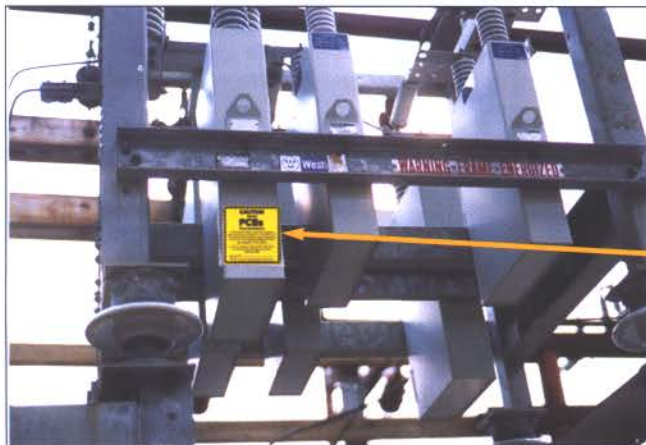
Looking up at PCB Marked Capacitor on the left (graphic below)
