The origins and treatment of derelict land in County Durham

**The University of Durham
Department of Geological Sciences
January 1998**

This thesis is submitted in partial fulfilment of the requirements for the
degree of M.Sc. in Environmental Management Practice

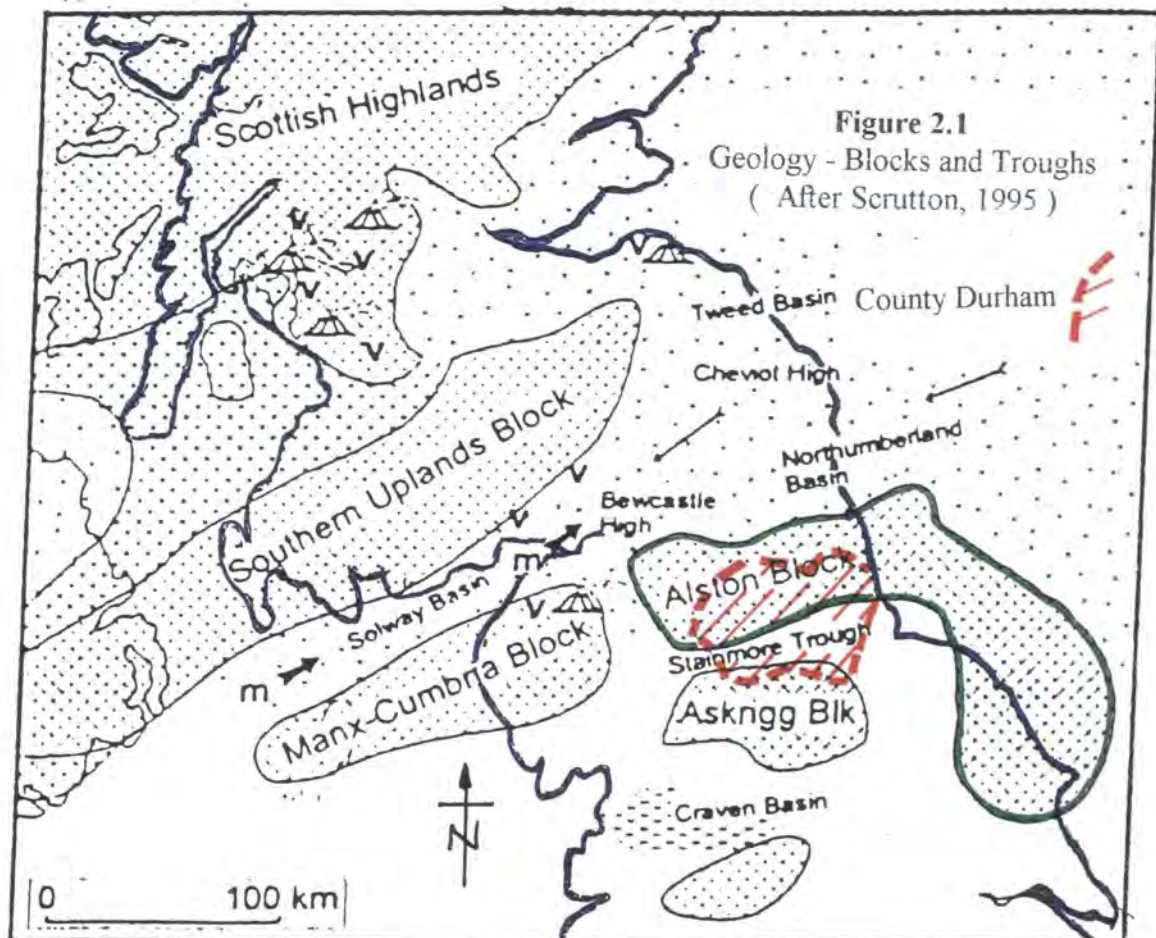
The Durham Coalfield forms part of the Upper Carboniferous (Westphalian) stage, extending in a belt across Europe from Great Britain, through northern France and Belgium, to the Ruhr and beyond. The coalfields of Scotland and the extreme north of England differ from the fields immediately to the south, having been formed towards the margins of a major basin resulting from crustal subsidence on the Carboniferous shelf (Anderton, Bridges, Leeder and Selwood, 1979). This has influenced the pattern of coal mining in County Durham. The basement surface on which sedimentation commenced was made up of structurally contrasting blocks and troughs. The blocks, consisting of pre-Carboniferous intrusions, of which the dominant one of interest in this area is the Alston block, were less dense and consequently more buoyant and resistant to subsidence than adjoining areas of the crust (Fig. 2.1).

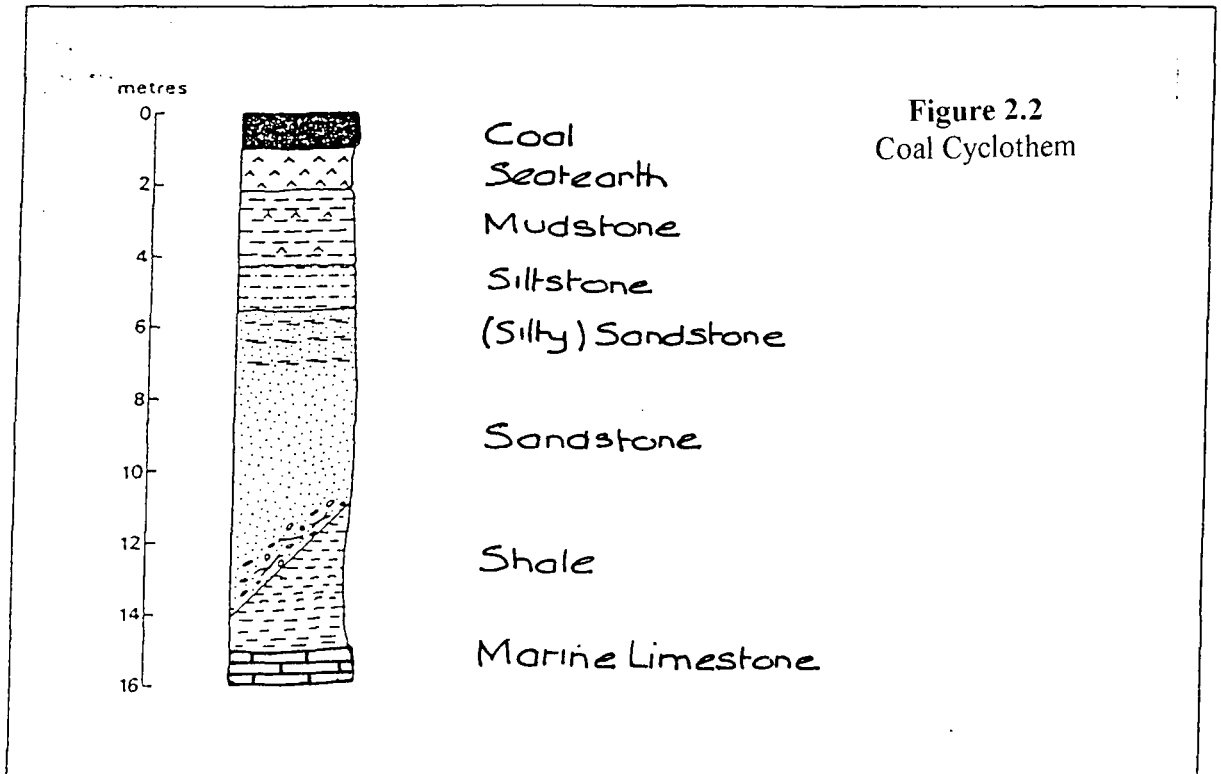
Cyclic or rhythmic sequences, or cyclothem which characterise the coal measures, began with an abrupt change of sea level, giving marine or near marine conditions (Fig. 2.2).

In general the cycles consisted of marine limestone followed by a calcareous shale, ferruginous shale, silty shale, shaley sandstone, seat earth or ganister and finally, coal. In Coal Measures times truly marine invasions were infrequent and periods of coal formation were longer. Since sedimentation more or less kept pace with subsidence, the result was a series of deltaic strata containing many coals of workable thickness, as the sequence has been repeated many times due to this more or less random combination of subsidence, sedimentation, channel formation and marine incursions.

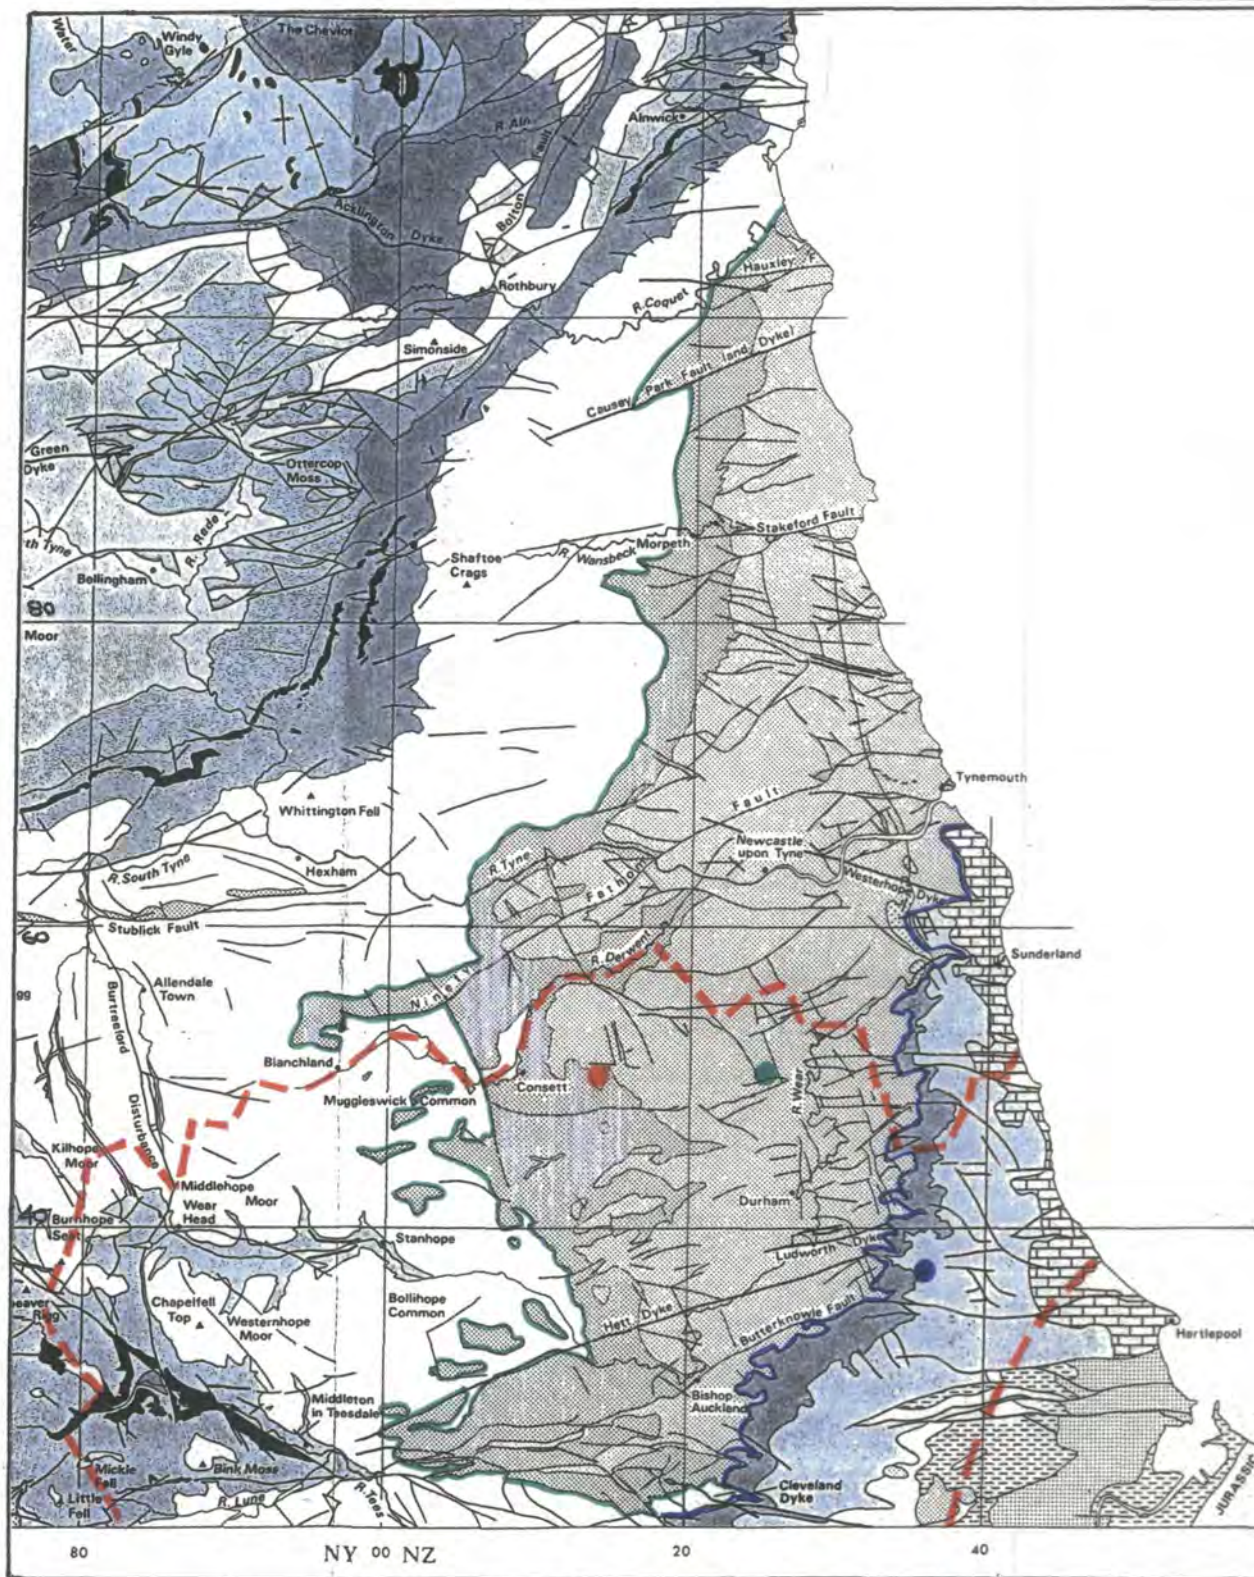
Figure 2.3 Northumberland and Durham

The western edge of the Coal Measures outcrop, resulting from this process, is an indented line extending from Amble on the Northumberland coast to Barnard Castle in the south of County Durham. The measures dip to the east where they are concealed under the overlying Permian strata before continuing under the North Sea (Fig. 2.3). Productive coals in County Durham are concentrated in the Lower and Middle Coal Measures, the Upper Coal Measures and other sediments having been largely eroded prior to the Permian strata deposition. The Upper Limestone Group of the Dinantian or Lower Namurian strata, which can contain coals, is barren of coal in this area apart from the poor 0.45 m Oakwood coal in Upper Weardale and an inferior seam, known as the Winston, near Barnard Castle. Deep boreholes at Crook and Chopwell, which were

- Edge of Coal — Iveston ●
- Permian Limestone — Waldrige ●
- County Boundary - - - East Hetton ●

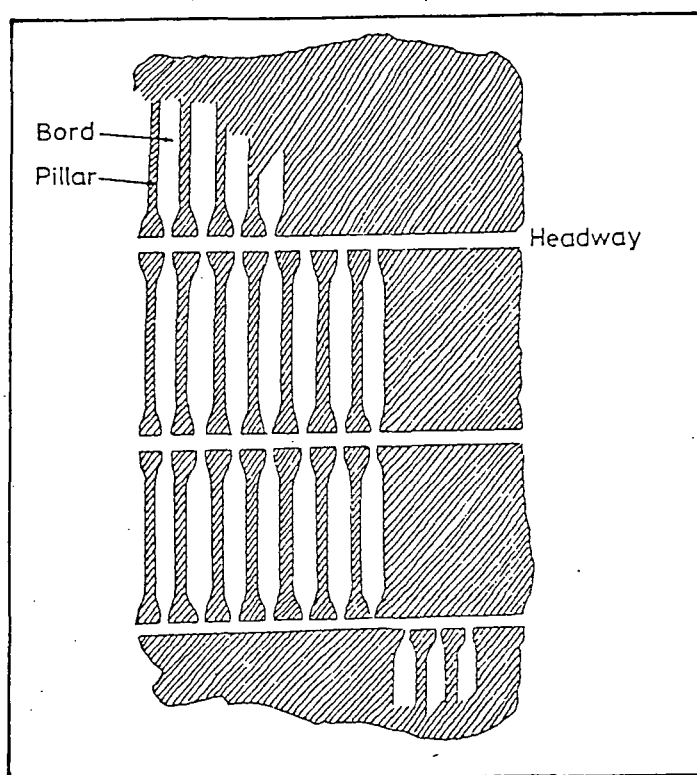
Fig. 2.4 Bord and Pillar Working

or to the dip with drainage outlets. Little support was used and remnant pillars would be left unworked to retain the roof but these would often only survive for the limited life of the mine. During the 16th. century, restrictions on the use of timber for fuel and increases in exports, particularly to France, led to a growth in production. From the late 17th. century better mechanical appliances for pumping and improved methods of removing coal were developed and a system of roads and pillars was used which was a pre-cursor of the later pillar and stall, or locally, bord and pillar working (Fig.2.4).

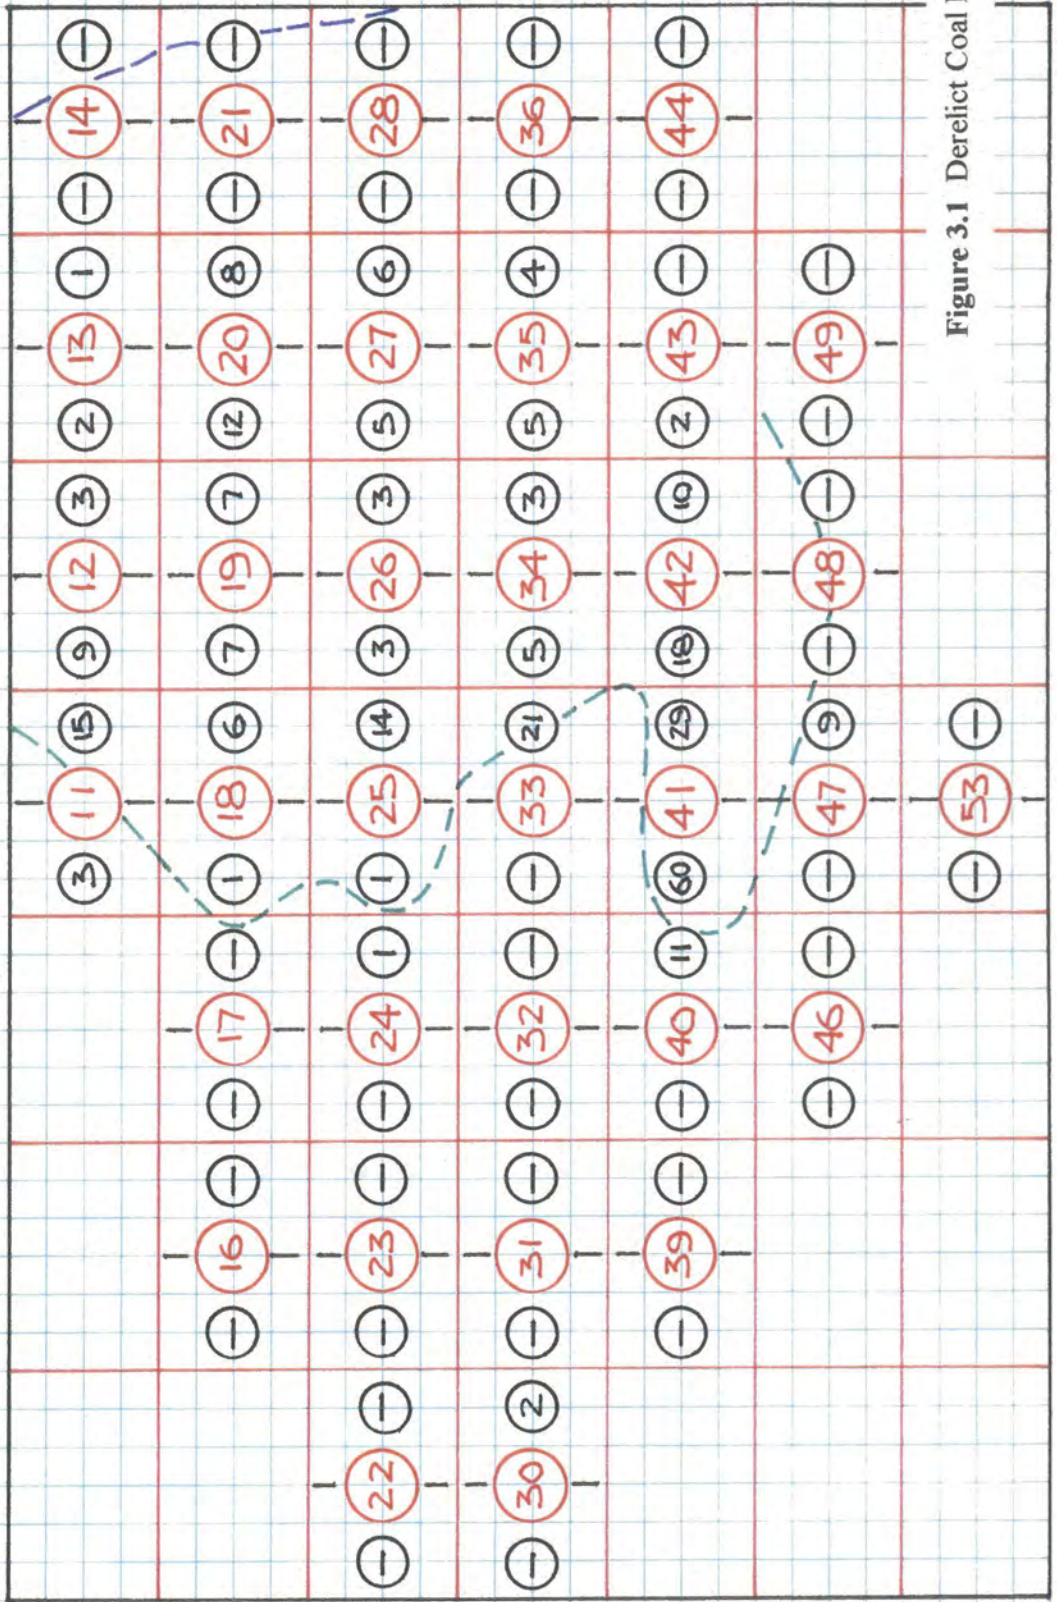
Figure 3.1 Derelict Coal Mines by Grid Square

Mines in the extreme west of the coalfield were on the outcrop and consequently were worked very early and on a small scale with records of some of these workings perhaps being incomplete. In the east of the coalfield, mines were opened post 1826 in the era of large pits and they were therefore fewer in number, more easily identifiable and the obvious targets of the large reclamation programme when closure occurred. In the centre of the coalfield it could be expected that neither of the above scenarios would be dominant. Some mines were worked relatively early in the life of the industry with the records of these being vague and not easy to trace. Others were worked later and were comprehensively recorded. Figure 3.1 shows the incidence of apparently unreclaimed sites and an East-West section through Sheets 40-44 demonstrates a consistent decrease in the number of mines, unadjusted for the impact of opencasting. The same pattern is generally repeated in the two sections

to the north, but inconsistencies appear on the section through Sheets 18-21. The increase in unreclaimed sites reflects in broad terms the sequence of development in the coalfield and the early concentration on mining along the Wear valley. Sheet 41 also shows evidence of the move to the south west corner of the coalfield at the end of the 18th. century.

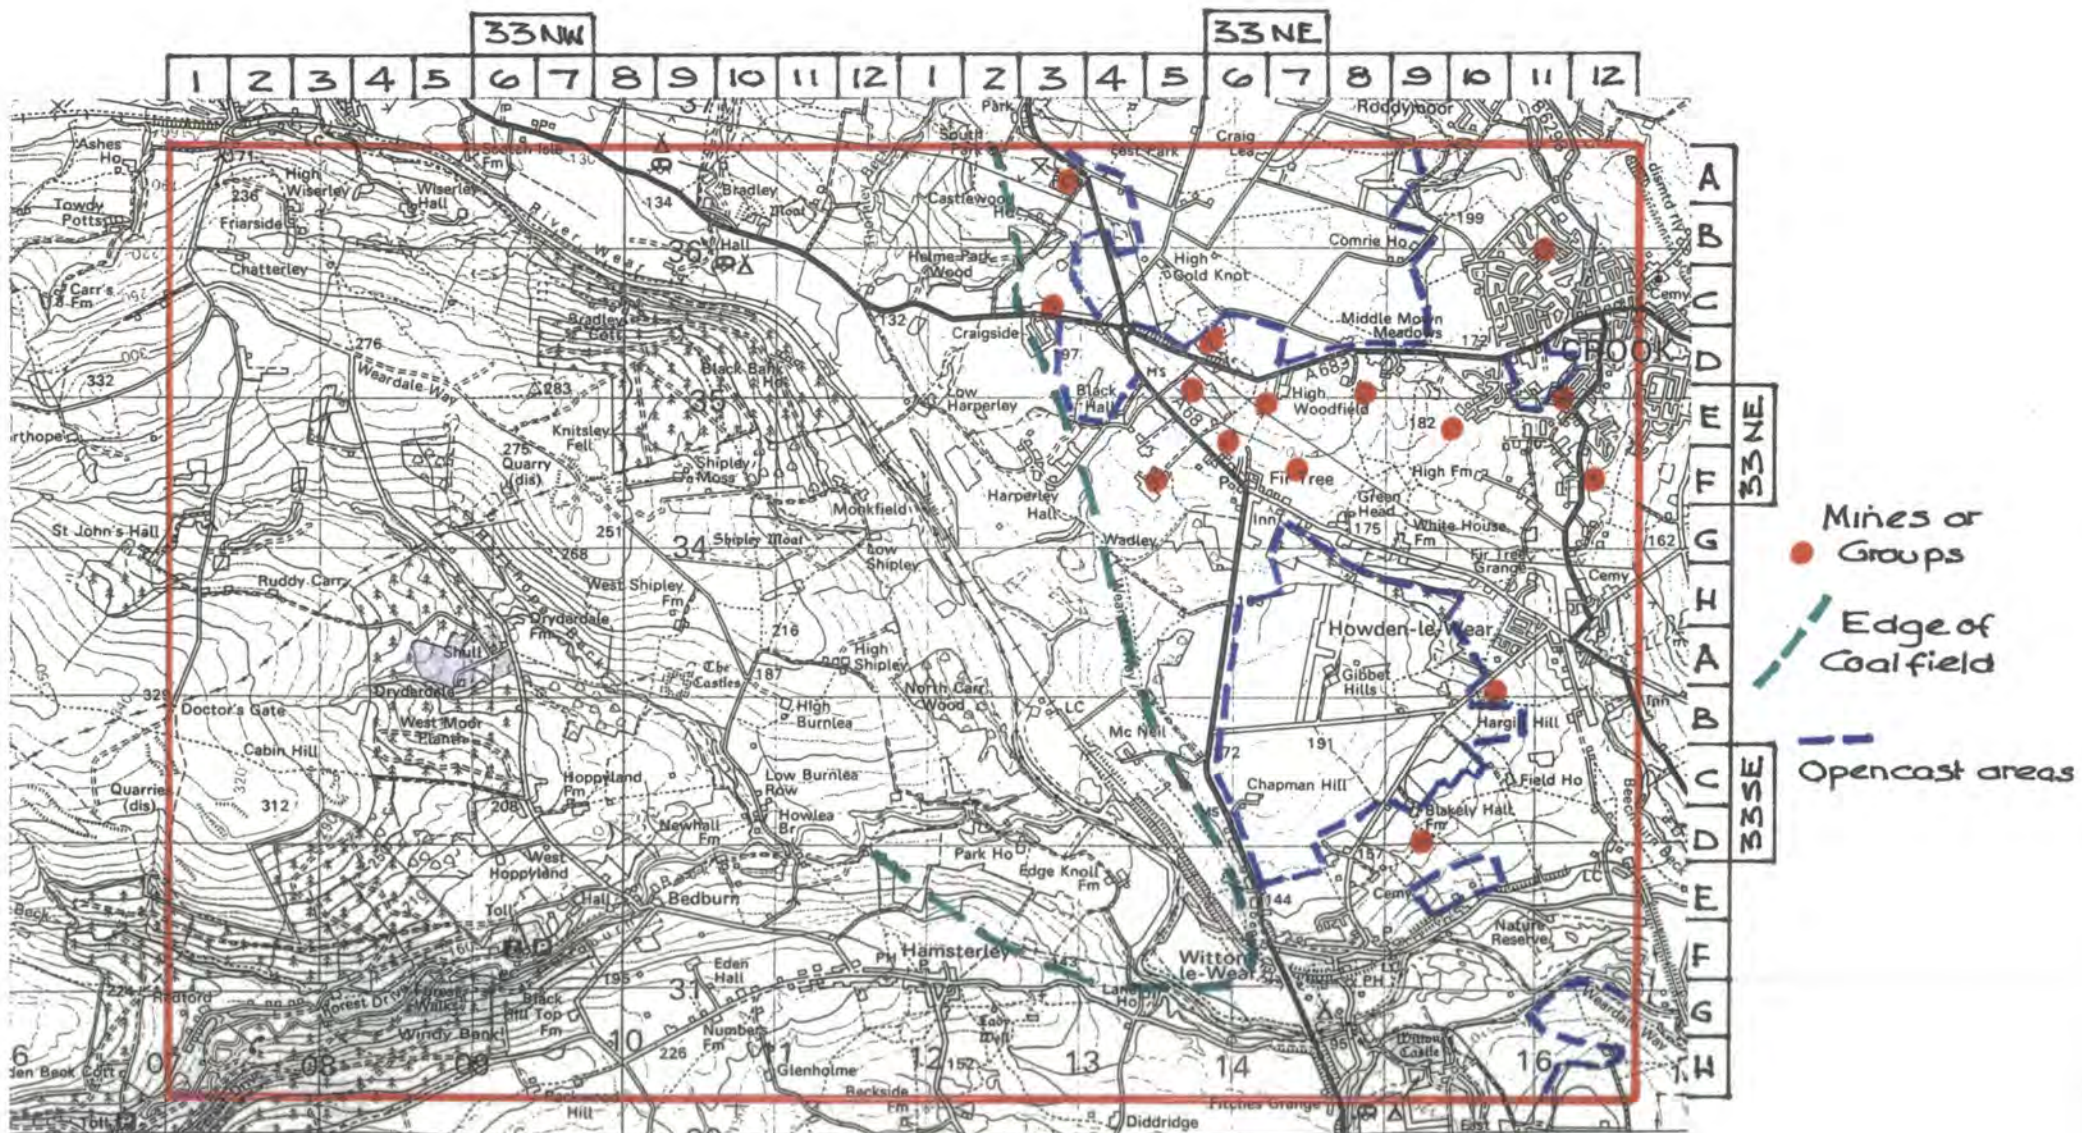
Figure 3.2 Coal Mines - OS Sheet 33

In view of the large numbers of mines involved, two pilot sheets were selected for further analysis which were considered to be representative of the different areas of the coalfield. Sheet 33 is typical of the western areas whereas Sheet 27 represents typical eastern conditions (Figs. 3.2, 3.3).

(a) Results - Sheet 33. Initial screening, by name alone, of Sheet 33 produced twenty one mines not apparently treated, of which eight were subsequently found to be within opencast areas. Plots of the alphanumeric zone of interest for each mine showed, in a coarse way, the likely areas where unreclaimed coal mine workings could be suspected. One colliery was included in the local authority schedule of derelict land not justifying reclamation. In addition three areas of working, related to the Shafts and Levels entries by Parish in the N.C.B. records, were apparent on the old O.S. sheets (Appendix 3) when these were examined. In general it was found that few details were discovered from large scale early O.S. maps which were not recorded on the 6" version and for this initial screening therefore the smaller scale search could be quicker and sufficiently accurate. Succeeding, more detailed inspections may justify use of the larger scale and ultimately mine record drawings.

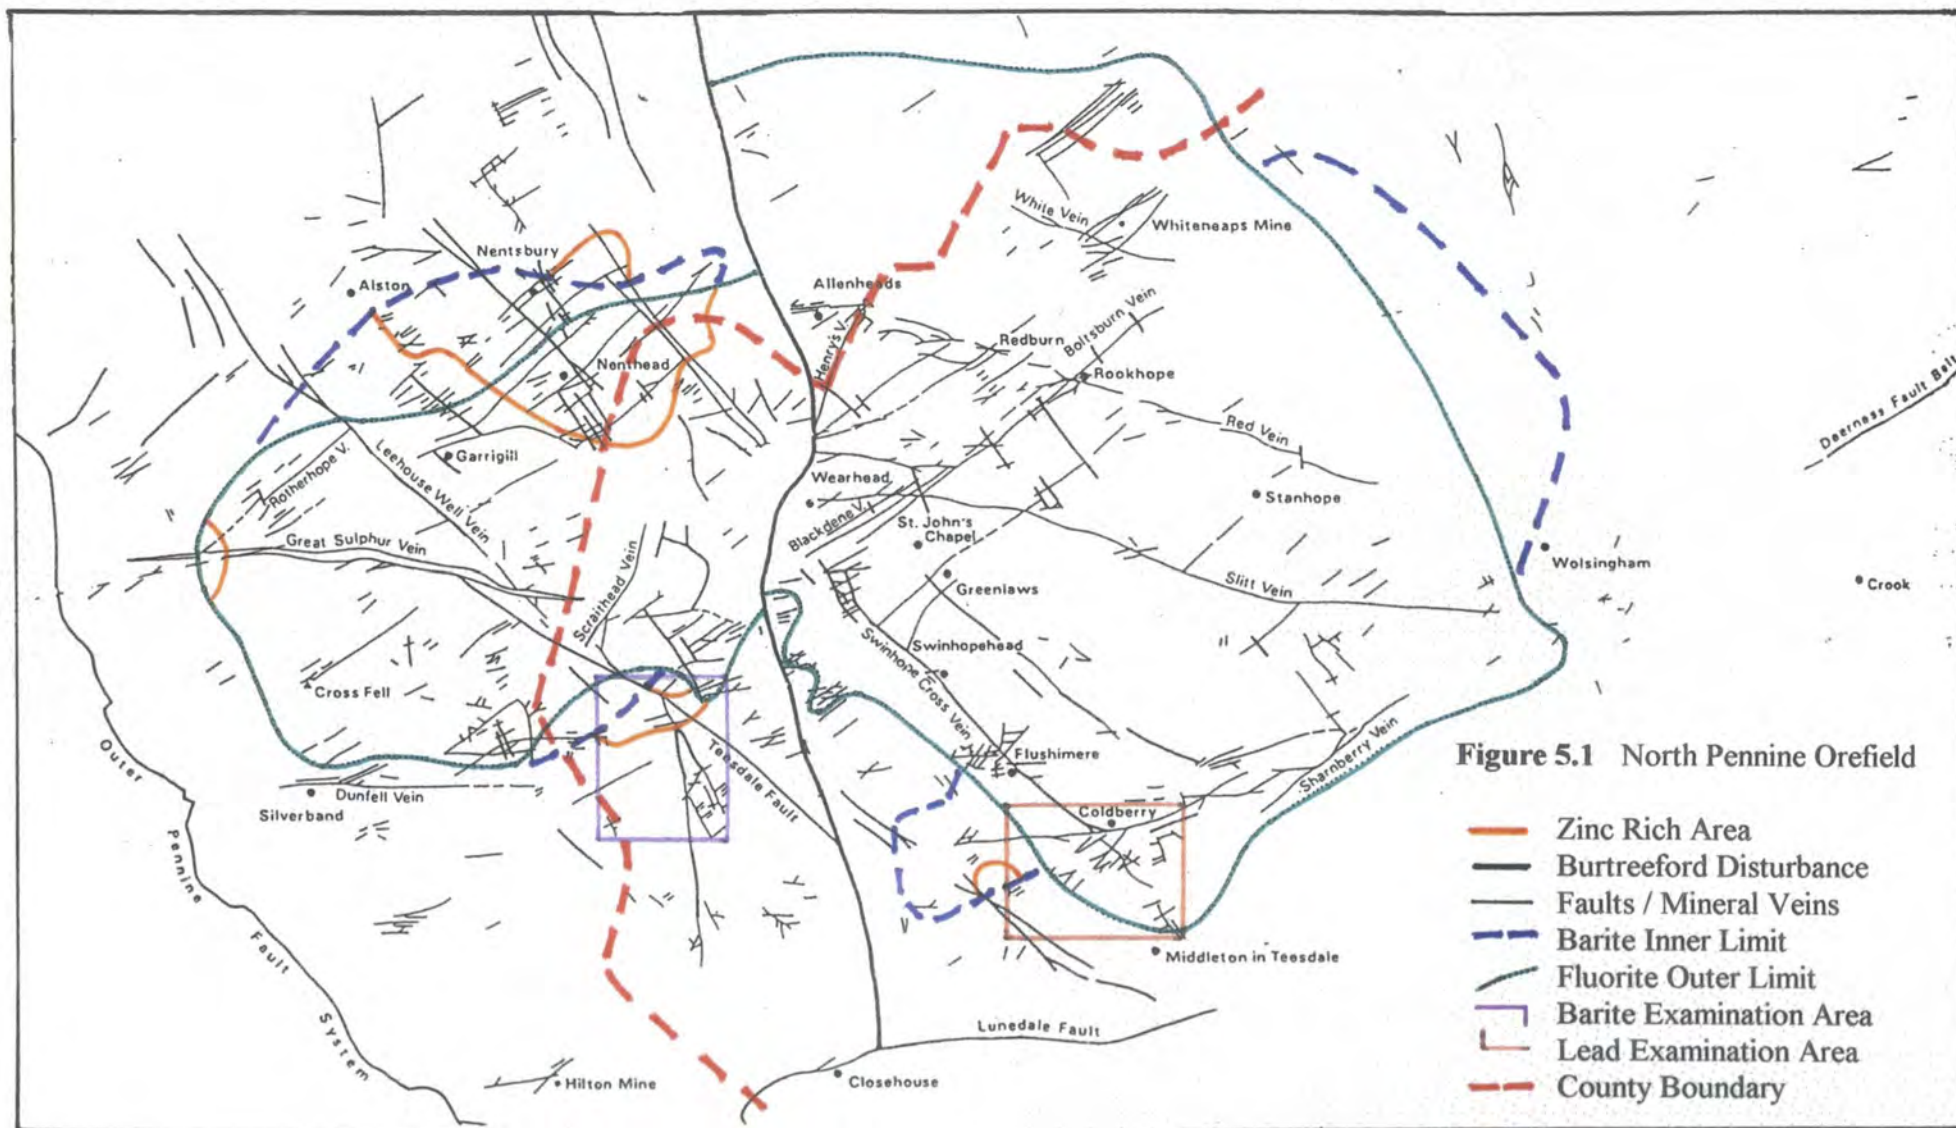
Teesdale was less important with the deposits being both more scattered than in Weardale and less productive. Once again the best locations lay along an EW vein, as at Flushiemere (Fig.5.1), which appears to be an extension of the

Swinhope vein in Weardale, and at Langdon Head which could be related to the Greenlaws vein system at Carricks, one of the main production centres in Weardale (Dunham, 1941).

Detailed examination of the mine groups in Weardale for this Study shows that 11 are related to the Red Vein running between Crawleyside and Allenheads, and eight to the Slitt Vein which can be traced from Frosterley to Wearhead (Fig.5.1). The recently worked Carricks complex contains one main group of mines and one subsidiary which are situated on the Swinhope vein, and in addition there are 10 mines which are quite remote from any of the main veins. Hardly any of this remote group have any evidence of appreciable tonnages being won, with most merely recording "evidence of workings" or "some ore obtained". Only four levels or adits have been identified and there are five opencast or outcrop sites plus one site where no details are given. In only two cases were shafts sunk primarily for iron extraction and it is consistent with patterns elsewhere that these were in the closest proximity to the Red Vein. At Hollywell, a notable exception, iron was worked with lead in an apparently large deposit. By contrast, the group of mines strung along the Red Vein were in general highly productive and of the 11 mine groups only two have not been extensively worked. A level on the Scarsike Vein, which significantly does not finally connect to the Red Vein, proved to contain not much ore and in early times the Mill Level

extracted up to 1977, over 85% came from the Red, White, Sedling and Slitt veins (Fig.5.1). Because of the close similarities in the location of fluorite to other minerals in the quarter point veins and the use which has been made of former lead mines there is relatively little in the way of unique characteristics to the extraction of the ore and its impact on the mining patterns of the area. Of most relevance is the recent expansion and the way in which this may have rationalised some earlier undertakings. It is recorded that in 1985 there were ten mines producing an equivalent amount to that obtained earlier from the Weardale and London Lead Companies, with two central processing plants, and in addition two recently worked mines had closed (Fig. 10.2). These constitute the main areas of interest and the only other examples of mines reworked extensively for fluorspar are the original prospecting site at Hope Level, Crawleyside and Sedling Mine. Crawleyside is a particularly early historic case of attempted diversification where fluorspar was looked at in 1854, and again in 1882, before being worked from 1914 to 1932. After closure the mine was reopened in 1941 only to stop again when the ore became too siliceous. In the case of Sedling the mine was worked originally for lead in the 19th. century but did not produce large quantities. It was however reopened by the Weardale Lead Company in 1900 to win fluorspar and by the time of closure in 1948 it had become the major producer in the area with over 166,000 tons extracted. Messrs. Hinchcliffe also mined fluorspar between 1926 and 1930 from an incline at High Sedling which was reopened unsuccessfully by the Weardale Company. In other locations fluorspar was extracted incidentally to lead mining but the quantities involved were not significant. By 1994 the County Council Structure Plan Review showed only one active operation and the treatment of the other, now abandoned, workings is a matter requiring further consideration.

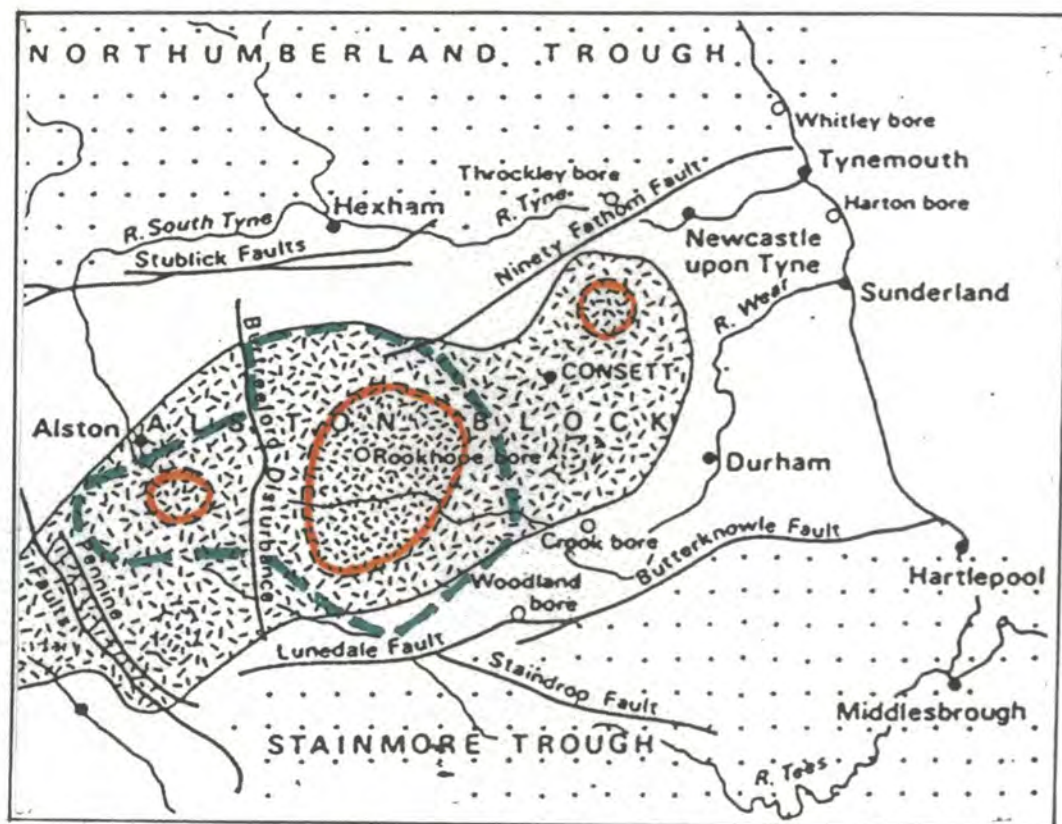
Figure 9.1 Alston Block
(After Jones & McGraw, 1980)

As discussed earlier in respect of the iron deposits, the structure of the sub-surface Alston Block affected folding, with stretching of the Carboniferous strata due to the buoyancy and rigidity of the block beneath (Fig 9.1). This folding, with some faulting and thrusting, produced a domed structure with a major monocline, the Burtreeford Disturbance, running generally north - south, and many faults which were dilated through deformation and formed the host structure for the mineralization process. The orefield is approximately 45km. east - west and 35km. north - south and is itself bounded by major faults on all sides except the east, where it is buried below the Upper Carboniferous and Permian rocks of the Durham Coalfield and coast. The vein structure formed was complex with three main groups and many subsidiary ones. The main productive veins run ENE, with a set of cross veins angled NNW and a group

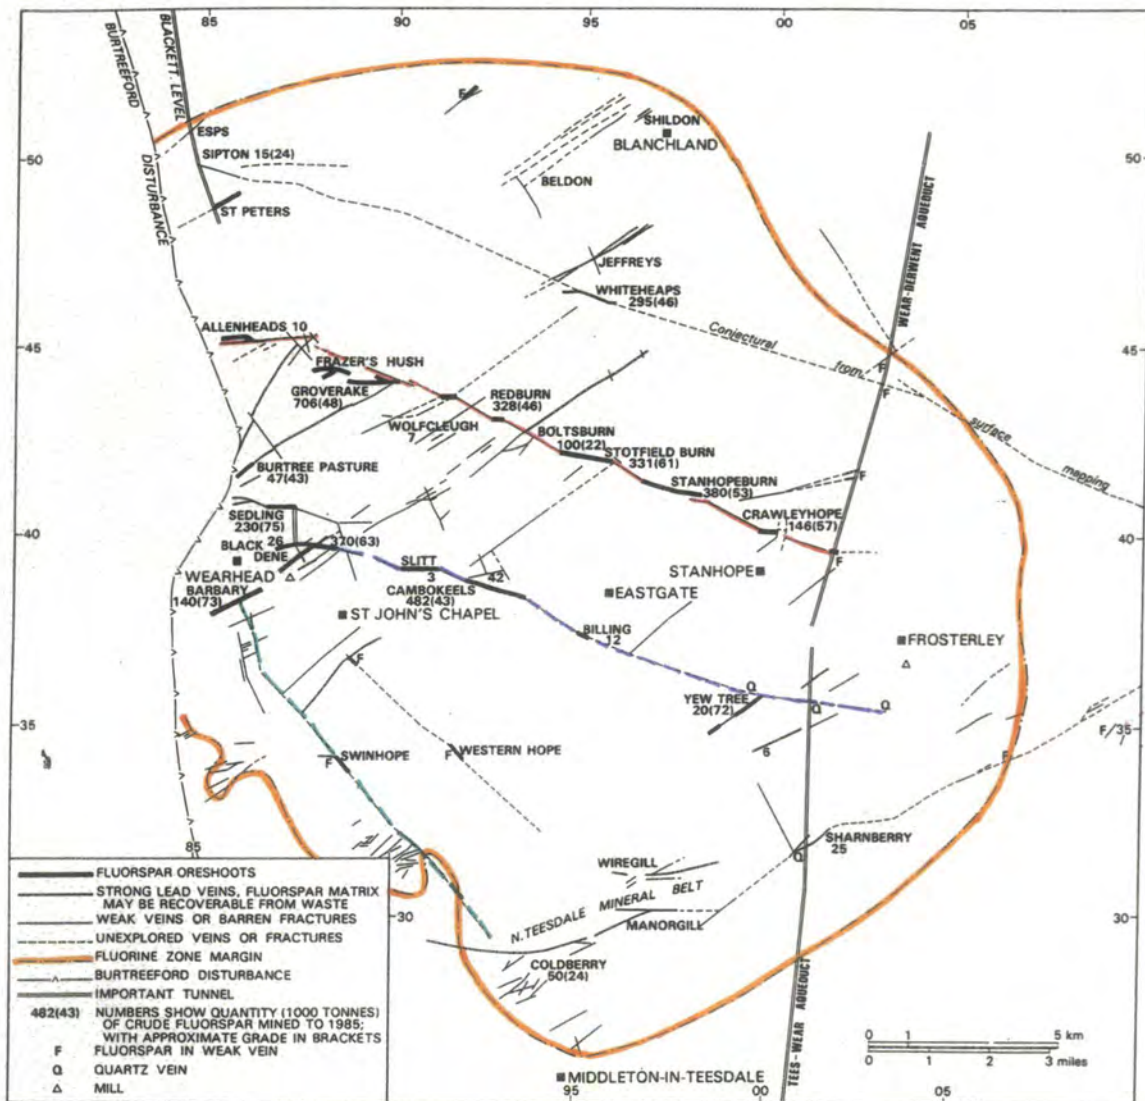
Figure 10.2

Fluorite Mines (After Dunham, 1990)

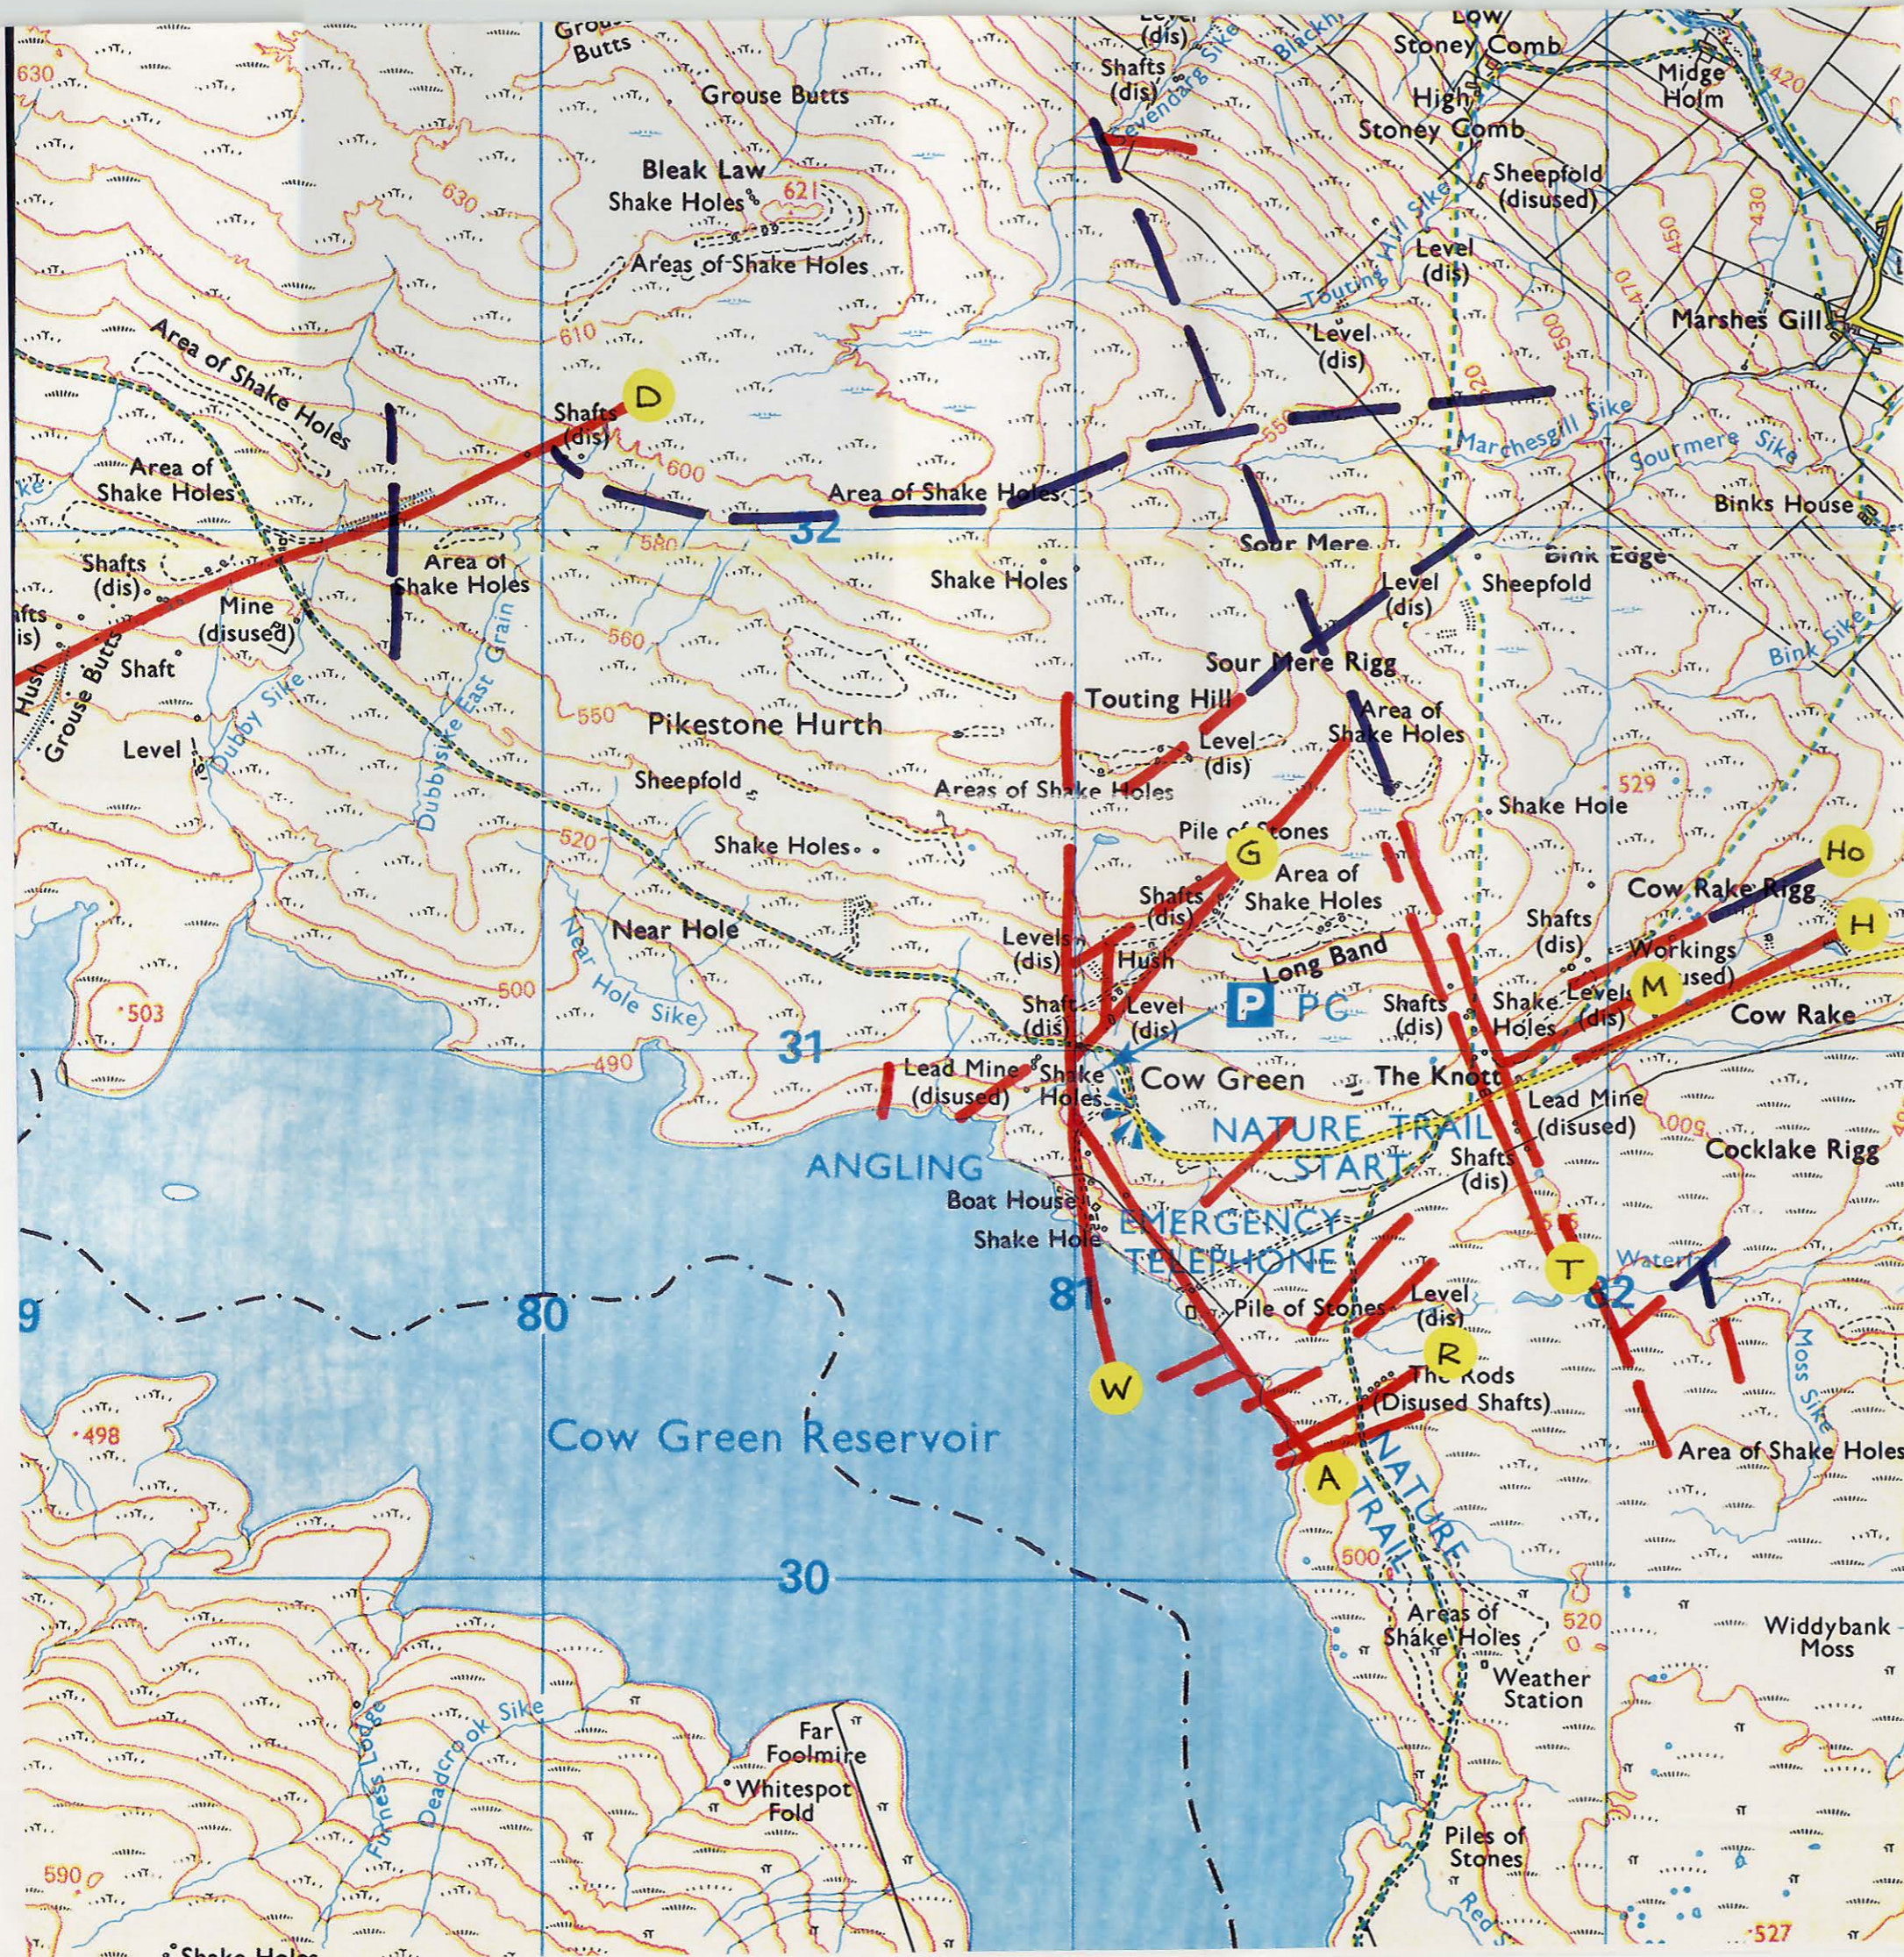
Figure 11.1
Barite Mines - Cowgreen

There is some lack of correlation between the information quoted in records, and that plotted on Ordnance Survey sheets. For example the adit (No.3) plots as a shaft with an adit some

distance to the south. Between the south westerly pair of entrances (Nos.4 - 5) and the north easterly pair (Nos.1-2) a line of old shafts is visible on the O.S. map on the line of the Dubbysike vein but none come close to the footpath. Only the more recent barite mines are in close proximity to public access and should be examined, as the unrecorded disused mine shown is some 300 metres distant to the south.

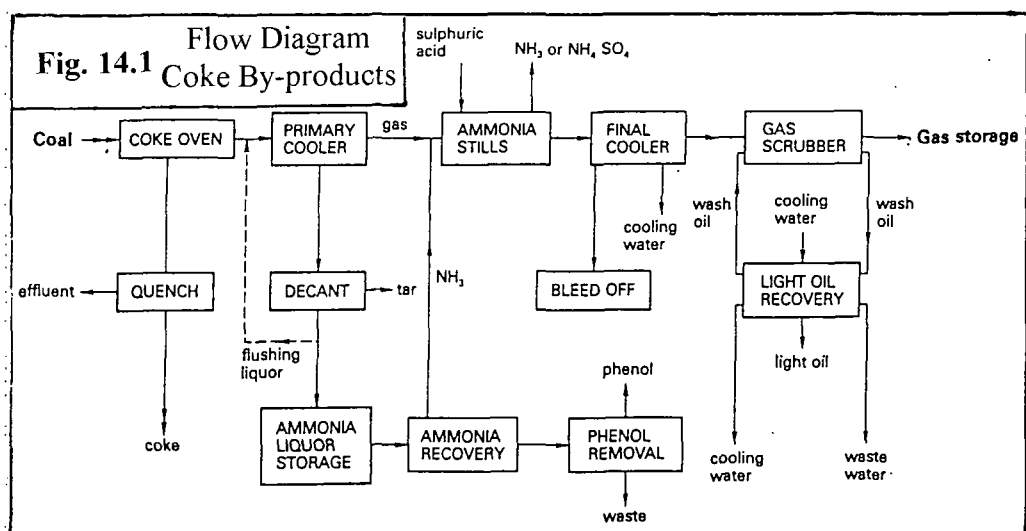
Although the advent of natural gas from the North Sea and elsewhere has superseded the use of town gas derived from coal, the gas made available is utilised in the iron and steel making process to maximise efficiency. A similar purifying activity takes place giving rise to by-products which are generally the most important compounds in respect of potential contamination. A typical process flow diagram is shown in Fig.(14.1).
