The origins and treatment of derelict land in County Durham

**The University of Durham
Department of Geological Sciences
January 1998**

This thesis is submitted in partial fulfilment of the requirements for the
degree of M.Sc. in Environmental Management Practice

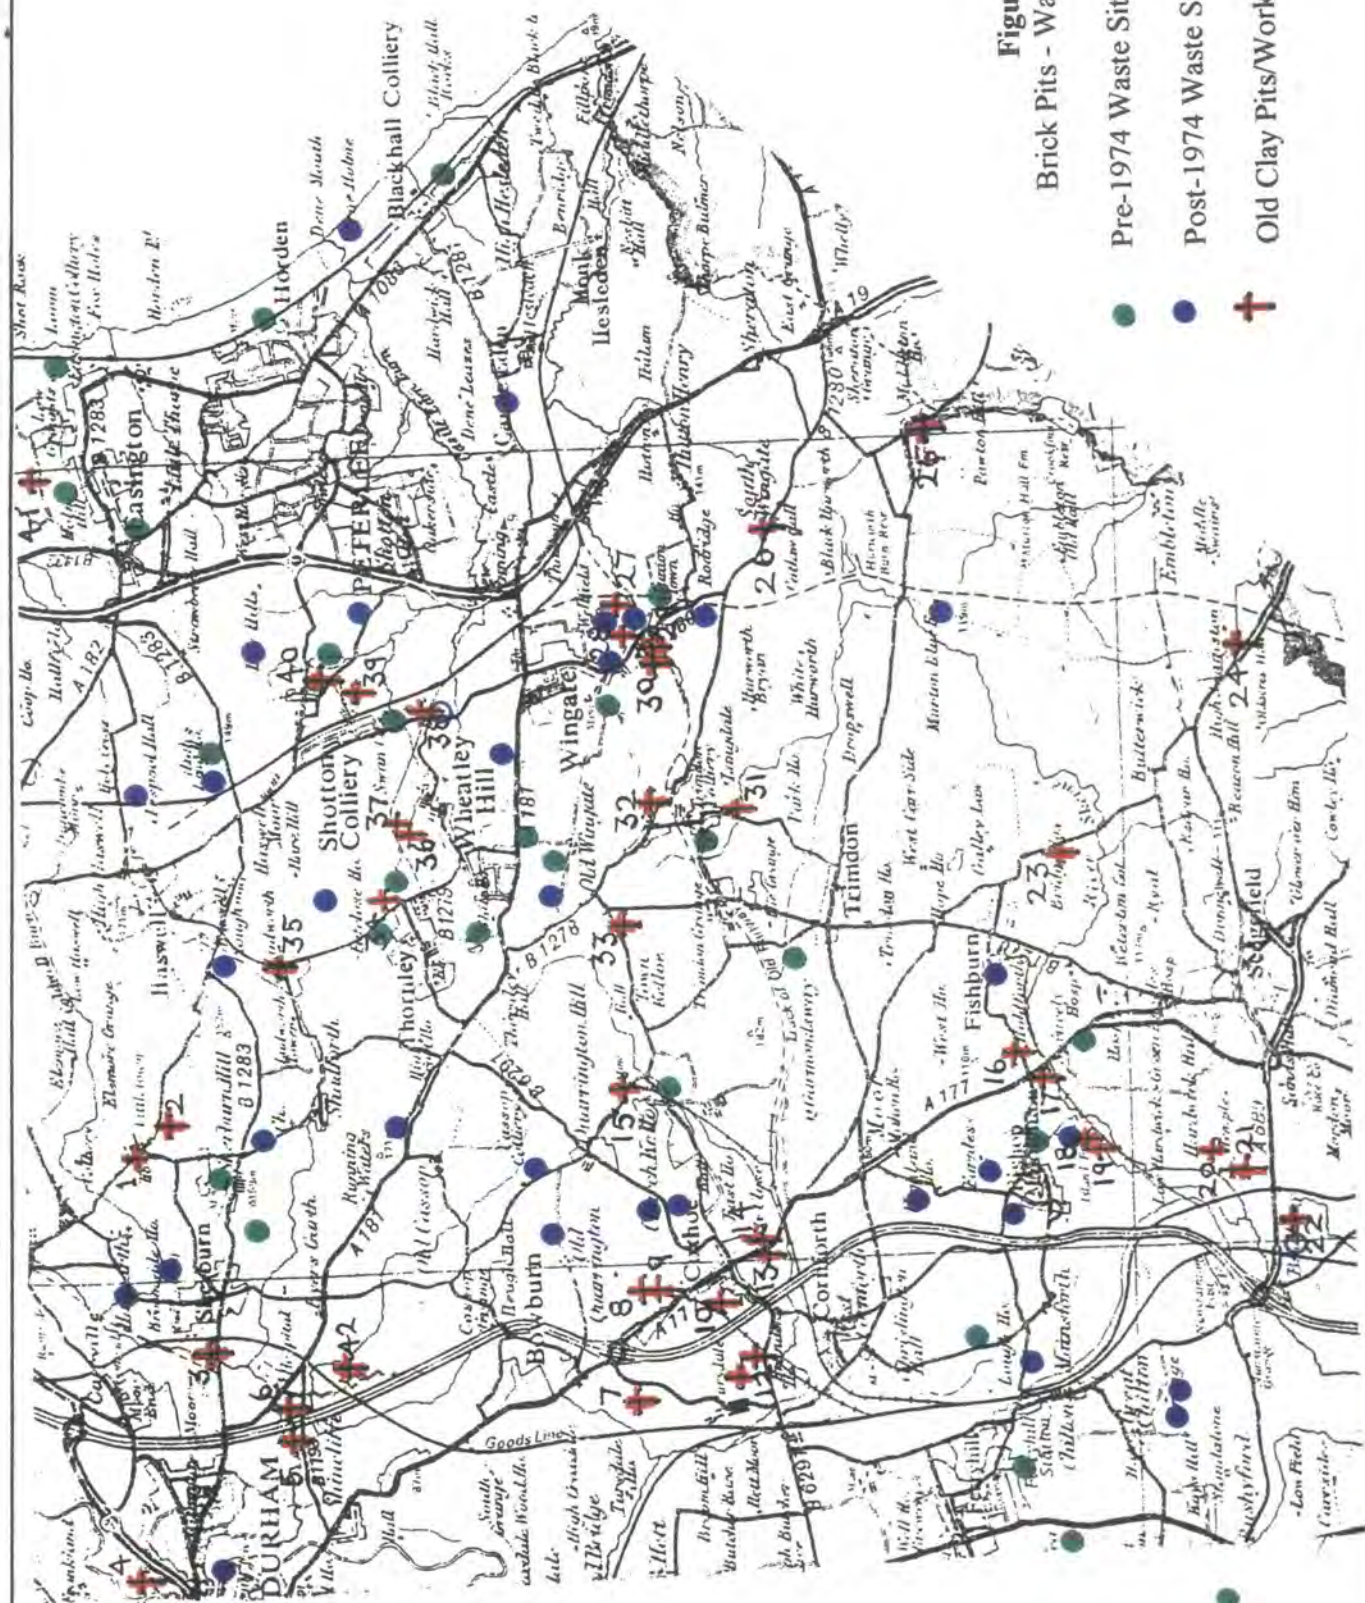
Figure 15.1

to be at, or associated with, collieries. Only five claypits are specifically identified and a further 15 could have involved extraction but are more probably concerned with production. Zone J in south east Durham, perhaps reflecting the presence there of laminated clays, has a lower proportion of sites associated with collieries, 23 out of 42 (Fig.15.1). Again however only five are clearly designated as claypits. Correlation between former claypits/brickworks and waste disposal sites, for this Study, shows there is little overlap. In south east Durham, Map J, only seven of the 42 sites could be related to landfill and all of these ceased working well before the start of 'modern' landfill. In south west Durham, Map H, only eight out of 68 could be suspect and only four of these continued until recent times. It can be concluded that brick clay extraction has had little impact on dereliction in the county, being mainly linked to the coal industry. In the cases where separate excavation has occurred only low risk surface workings were involved which have been restored with inert fill or have become water filled. The main risk potential comes from methane gas generation and major sites have been addressed by the screening operation of the Waste Disposal Authority. In particular locations where the voids overlie the Great Limestone or the Permian Yellow Sands, both of which are aquifers, then leachate could be a problem.

Brick Pits - Waste Disposal Sites
